IP Office Technical Tip

Tip no: 92

Release Date: 26 September 2005

“Line Error” displayed on Interquartz 9335-AV Analog Terminals

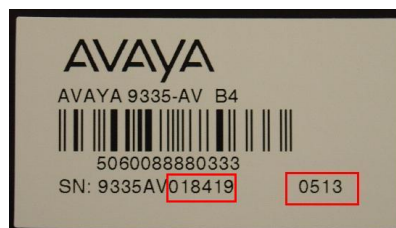
Locate the last 6 digits of the serial number and the four digit number on the product label (see below):

The four digit number represents the year and week the unit was manufactured. For example using the illustration above this unit was manufactured in the 13th week of 2005.
