PSN #	PSN028014u
-------	------------

Original publication date: 23- Jan-2024. This is Issue #08, published date: 21-March-2025.

PSN028014u – New Infrastructure Security Service Pack available for the ASP 4200 5.0 release

Avaya Solutions Platform 4200 5.0, ASP 4200 5.0

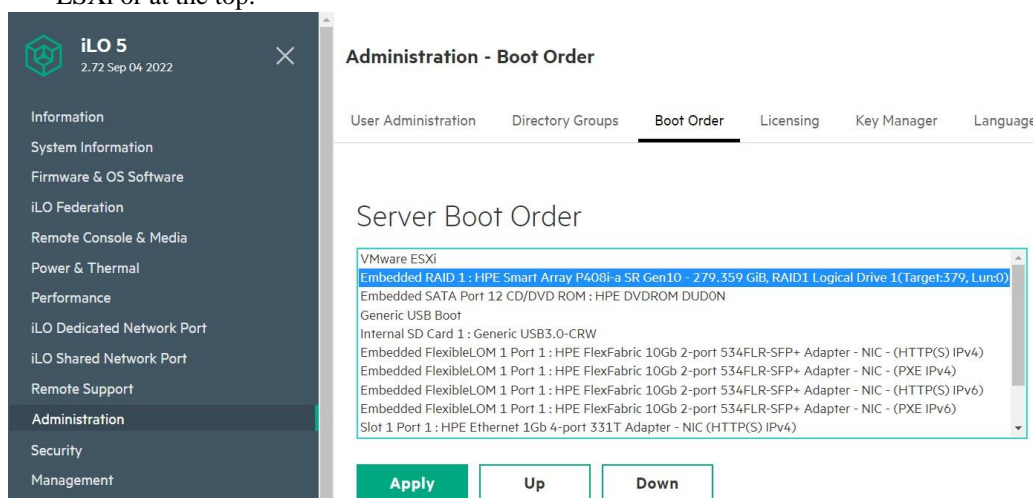
Embedded RAID 1: HPE Smart Array is moved to the bottom of the boot order.

When the server reboots, it tries to boot from the NICs first before booting from the ESXi OS located on the Embedded RAID 1: HPE Smart Array :

Note: This doesn't impact the overall ASP4200 solution, but if changes are not made, server boot-up could be delayed for 5 - 10 minutes until the server boot sequence gets to the Embedded RAID 1: HPE Smart Array.

- Open a web browser and go to the IP or FQDN of the host iLO.
- Log in with the administrative credentials (See the customer workbook for details).
- Go to Administration > Boot Order
- Under Server Boot Order, select and highlight the Embedded RAID 1: HPE Smart ArrayP408i-a SR Gen 10 and click up until it is moved under VMware ESXi or at the top.

- Click Apply to save the changes.

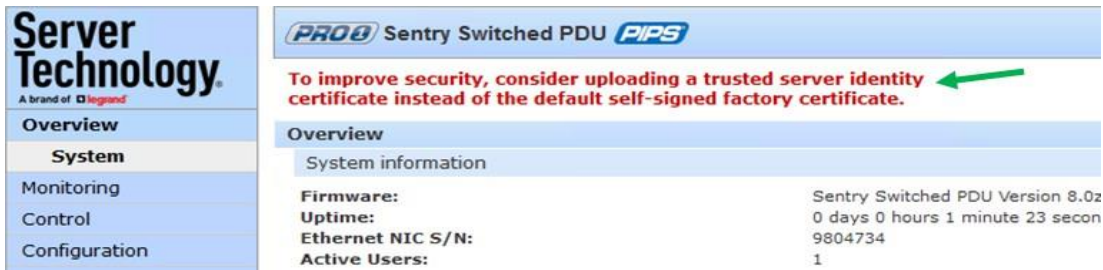
- After upgrading the Sentry4 PDU to version v80z, a message is displayed in the UI recommending user to install a CA-signed certificate instead of using the self-signed certificate.

Note: Avaya strongly recommends replacing self-signed certificates with CA signed certificates in production environments.

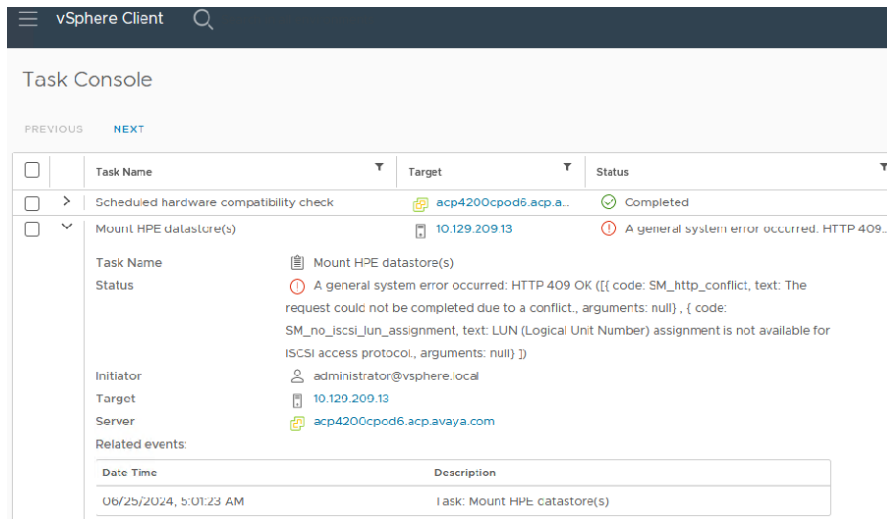
- COLLABPOD-3632 | Unable to mount or create VMFS volumes using the Nimble vCenter Plugin.

When Volume Scoped Target (VST) is enabled, the Host Bus Adapter static discovery will not have the array group path in it, which causes datastore creation using the vCenter plugin to fail.
