Product Support Notice

PSN # PSN020151u

Name of problem Issues to be aware of when running CM in a Virtualized Environment (VE) or on AVP.

Avaya Aura® Communication Manager (CM), Releases 6.2 and higher

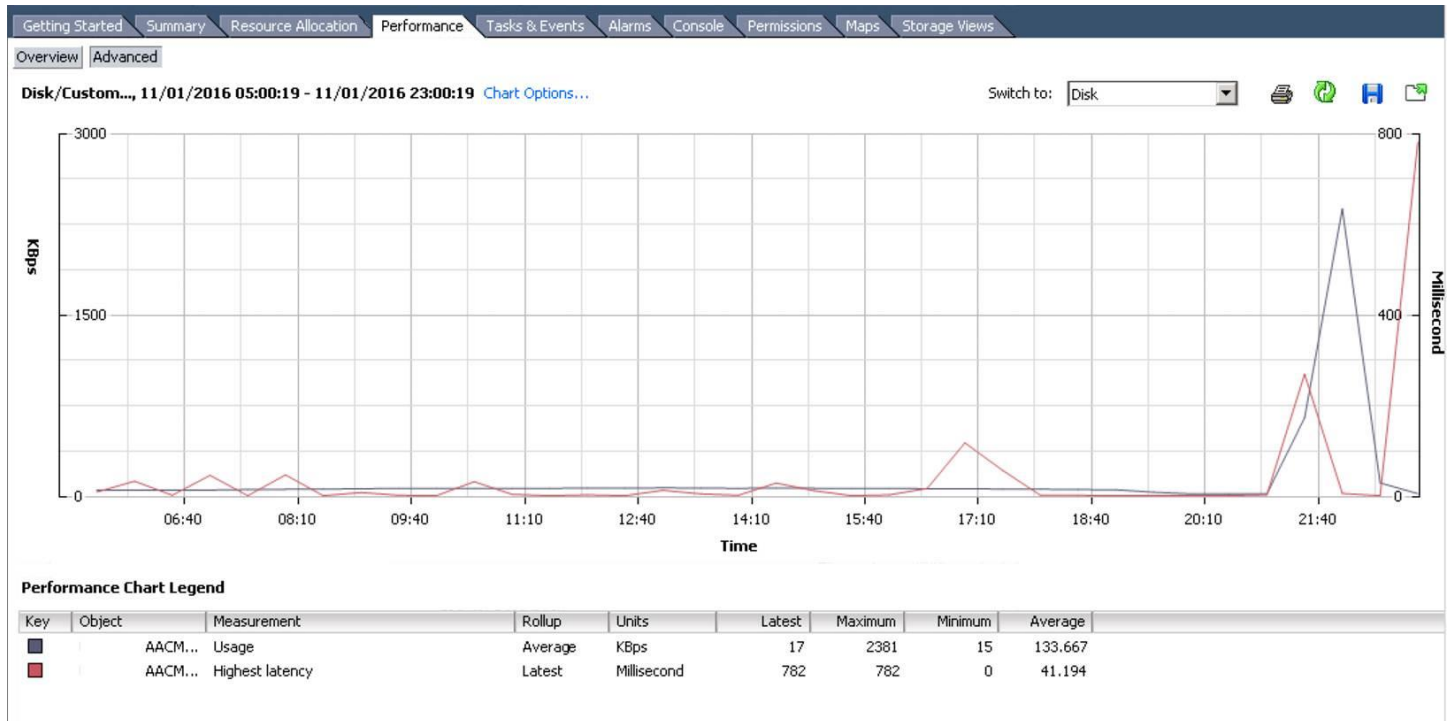
The problem might be caused by ESXi connectivity issues with the datastore/Storage Area Network (SAN). If this is the case, the disk usage chart will show something similar to the following. Note the end of the graph shows increased disk (datastore) latency going from virtually nothing to around 800ms (.8 seconds) for a disk write operation:

Storage arrays (datastores) should be architected to tolerate drive failures, controller failures, and connectivity issues without disruption to service. For increased reliability and redundancy and to minimize the impact of datastore/SAN connectivity issues it is recommended that active and standby CM duplicated servers use different/separate datastores.

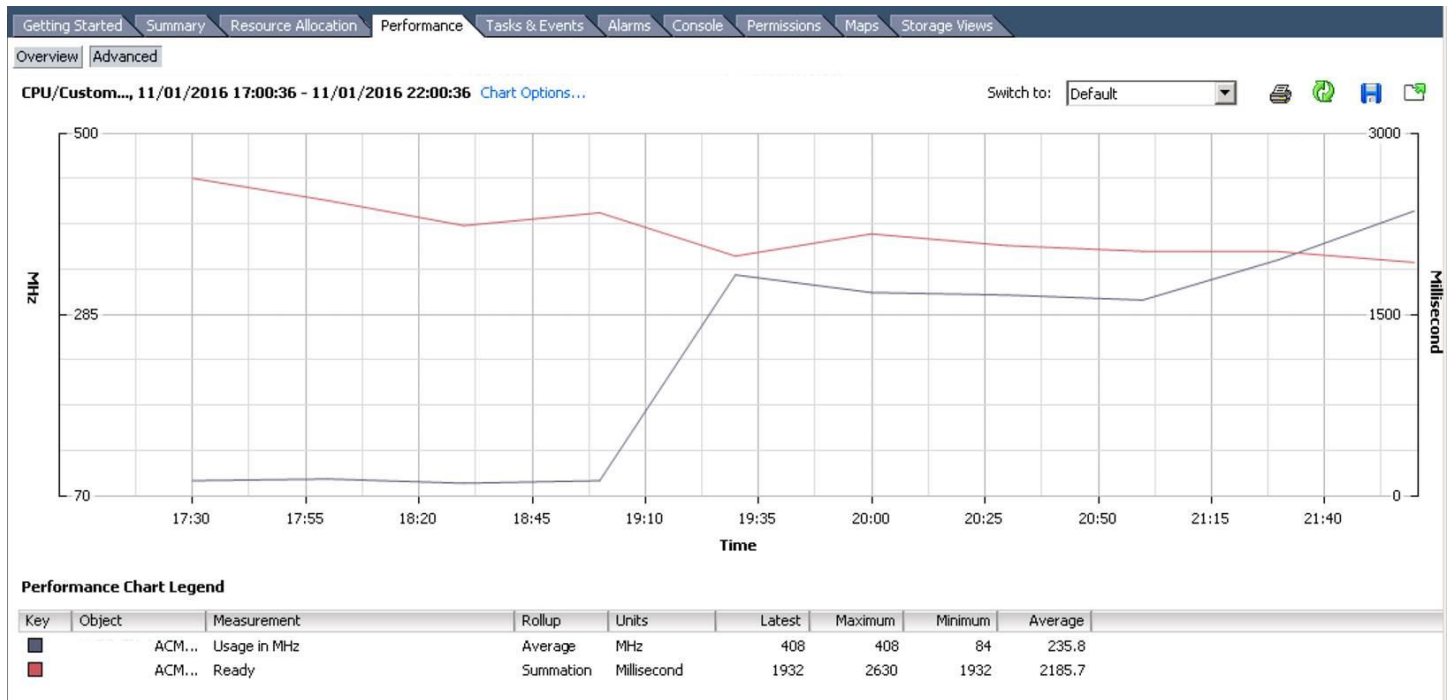
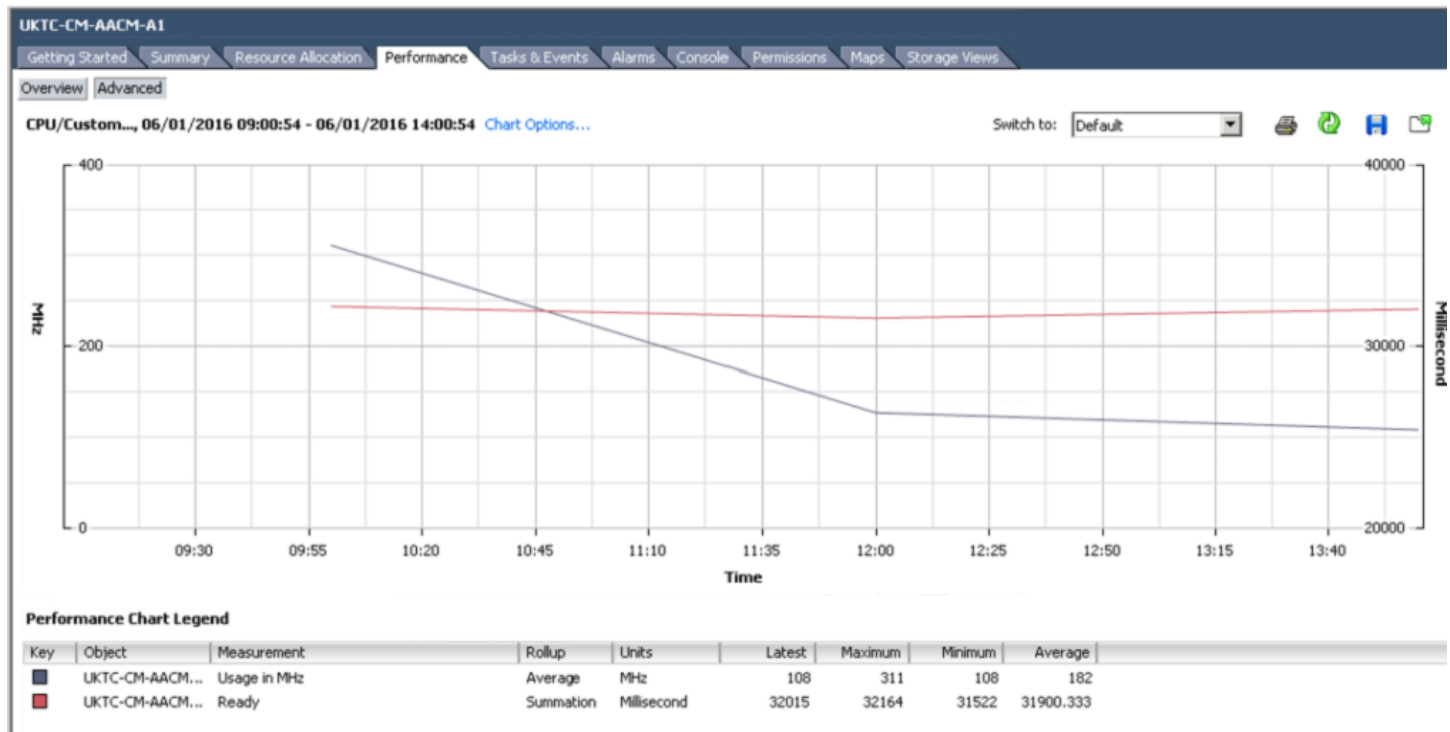
The problem might be caused by CM CPU starvation due to ESXi host over-subscription without using reservations. If this is the case, the CPU usage chart will show something similar to the following two screen captures. In the first screen capture note the CM VM CPU ready time increasing to 1.5 to 2 second delays. Note the second screen capture is more extreme and the CM VM has to wait 32 seconds to get CPU time from the host.

If ESXi hosts are over-subscribed, CM CPU reservations must be used. Refer to the [Deploying Avaya Aura® Communication Manager on VMware® in Virtualized Environment](#) (6.x VE only) and/or [Deploying Avaya Aura® Communication Manager in Virtualized Environment](#) (7.x VE and AVP) documents on Avaya Support for reservation guidelines. In addition, VMware recommends allocating to each Virtual Machine (VM) only as much virtual hardware as the VM requires. Provisioning a VM with more resources than it requires can, in some cases, reduce performance of the VM as well as other VMs sharing the same host. Refer to the [Performance Best Practices for VMware vSphere 5.5](#) document, especially the “ESXi CPU Considerations” section, for more detailed information.
