Product Support Notice

PSN # PSN005800u

New Infrastructure Security Service Pack including ESXi, vCenter Server, Nimble, VNXe3200, Avaya Orchestrator, HPE Gen8/Gen9/Gen10 server, PDU, and VSP software and firmware available for ASP 4200 4.0/4.1/4.1.0.1 releases

ASP 4200 4.x

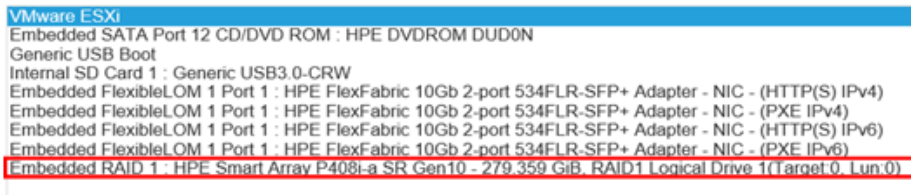
Server Boot Order

- On the Gen10v1/v2 servers after the SPP firmware upgrade, the boot order may get changed moving the Embedded RAID 1 Logical drive (HPE Smart Array) to the bottom of the boot order. If this occurs, then when the server reboots it will try to boot from the server's NICs first and timeouts will occur increasing server boot-up time. The server will boot from the Embedded RAID 1 controller after the NIC boot timeouts, but an increased boot-up time of 5 -10 minutes will result. This was further discussed with HPE, and this is expected behavior as designed.

Server boot order after firmware upgrade:

Embedded RAID 1: HPE Smart Array is moved to the bottom of the boot order.

When the server reboots, it tries to boot from the NICs first before booting from the ESXi OS located on the Embedded RAID 1: HPE Smart Array :

Note: This doesn't impact the overall ASP4200 solution, but if changes are not made, server boot-up could be delayed for 5 - 10 minutes until the server boot sequence gets to the Embedded RAID 1: HPE Smart Array.

Procedure to change the boot order back to as expected:

- Open a web browser and go to the IP or FQDN of the host iLO.
- Log in with the administrative credentials (See the customer workbook for details).
- Go to Administration > Boot Order
- Under Server Boot Order, select and highlight the Embedded RAID 1: HPE Smart ArrayP408i-a SR Gen 10 and click up until it is moved under VMware ESXi or at the top.

- Click Apply to save the changes.

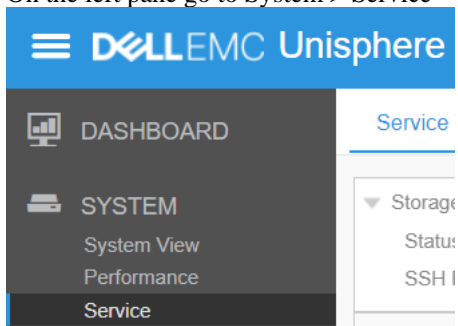
Workaround procedure to mitigate vulnerability CVE-2018-15473:

Note: Upgrade the VNXe3200 Storage Array to release 3.1.17 first before proceeding with the following workaround. At the time this version of the PSN was published, there is no permanent fix made available by our vendors.

1. From the MSC, open a web browser to the IP/FQDN of the array and log in with the admin credentials. See the customer workbook for login details.
2. On the left pane go to System > Service
