# Product Support Notice

PSN # PSN020578u

Name of problem PSN020578u - Avaya Aura® Communication Manager Centralized Licensing changes.

Avaya Aura® Communication Manager (CM) 6.3.x, 7.x, 8.x, 10.1.x

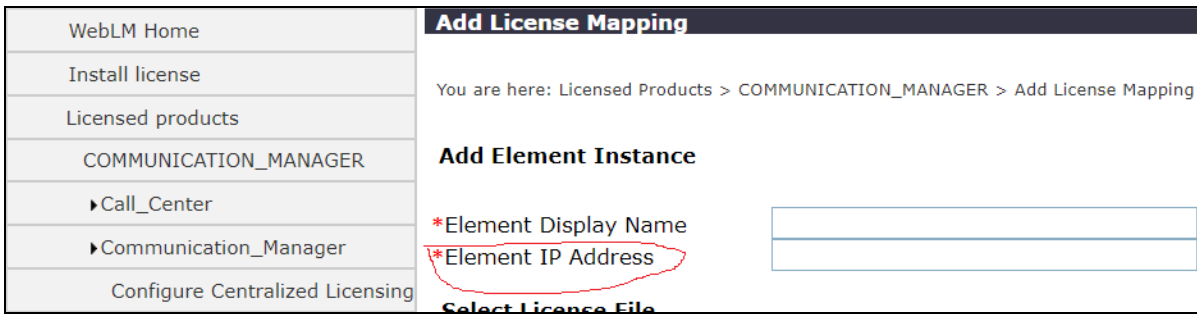
Example screen shot from SMGR 8.1.3.x WebLM with CM 8.1.3.x:

- Field Name
  - “*Element IP Address*”
- Field Content
  - In case of Simplex/Duplex use CM physical IP address  
<IP Address of CM>

**NOTE:** For CM duplex, an entry for **both** active and standby using the physical IP address must be created and it should be mapped to the same license file. CM cluster architecture was not supported in CM 8.x or earlier.

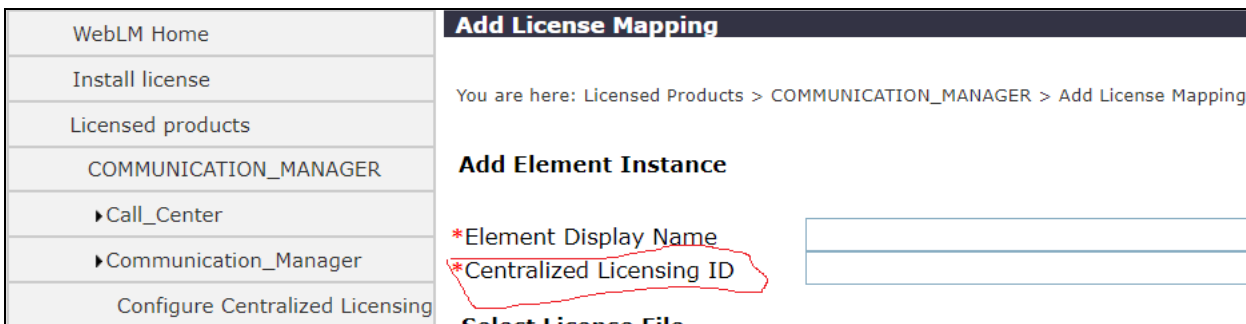
Example screen shot from SMGR WebLM 10.1.x with CM 10.1.x:

- New Field Name
  - *“Centralized Licensing ID”*
- New Field Content Format
  - In case of Simplex/Duplex use CM physical IP address  
CM @ <IP Address of CM>
  - In case of Cluster CM  
CM @ <CLUSTER-ID>

- There is a required space before and after the “@” in the field content above.
- For CM duplex, an entry for **both** active and standby using the **physical** IP address must be created and it should be mapped to the same license file. Do not use the virtual/alias IP.
- If Out of Band Management (OOBM) is enabled on CM, the IP address used for Centralized Licensing is the CM application IP address, not the OOBM IP address.
- If the license cannot be acquired, always verify that the values were entered properly and adhere to the rules mentioned above.
- These changes will now be implemented for any CM license (regardless of license version) generated from PLDS starting June 22, 2023.
