PSN # PSN028007u

Original publication date: 21-Dec-2022. This is Issue #08, published date: 01-Sept-2023. Severity/risk level Medium Urgency When Convenient

New Infrastructure Security Service Pack available for the ASP 4200 5.0 release.

Avaya Solutions Platform 4200 5.0, ASP 4200 5.0

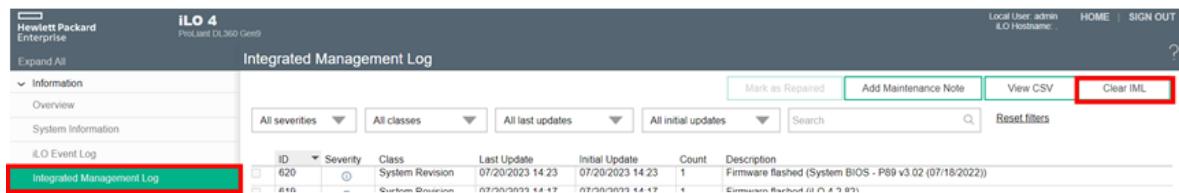
- ****NEW**** On the Gen10v1/v2 servers after the SPP firmware upgrade, the server may power off and not power back on automatically as expected. If this occurs, log into the server iLO and power it on. Once powered back on it may reboot once or twice to finish the firmware upgrades before booting into ESXi.
- ****NEW**** When running the Gen9 B3 firmware upgrade some of the firmware may not install and will require rerunning the SPP a second time in order to upgrade. If the firmware still does not install after rerunning the SPP, please reach out to Avaya Support for assistance with a manual mode install. See additional high-level checks below.

- Ensure latest Windows Server 2019 MSC from R5.0 is installed.
- Clear IML and iLO event Logs (From iLO Interface)

- Reset iLO interface (From iLO interface)

- Conduct a full power cycle to the server, allowing 5 minutes before plugging back the power cords.

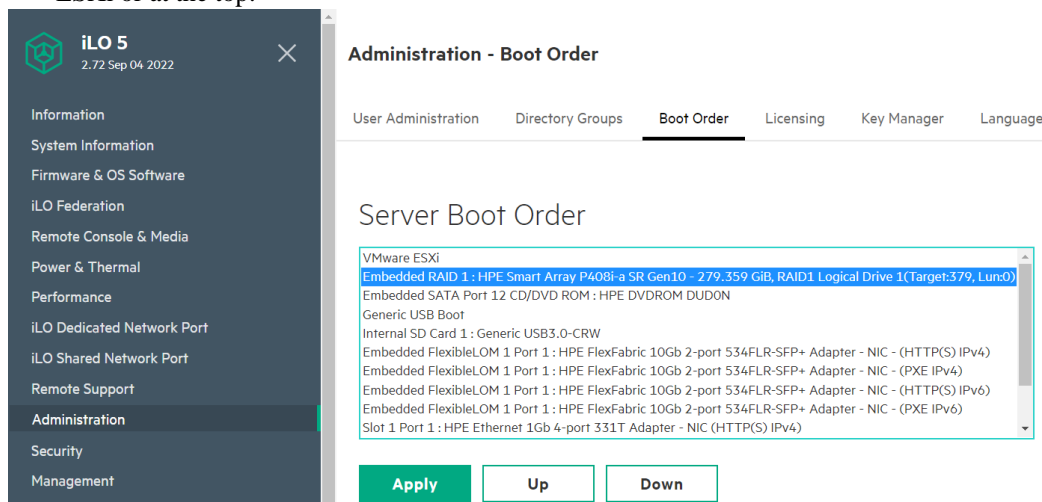
- On the Gen10v1/v2 servers after the SPP firmware upgrade, the boot order may get changed moving the Embedded RAID 1 Logical drive (HPE Smart Array) to the bottom of the boot order. If this occurs, then when the server reboots it will try to boot from the server's NICs first and timeouts will occur increasing server boot-up time. The server will boot from the Embedded RAID 1 controller after the NIC boot timeouts, but an increased boot-up time of 5 -10 minutes will result. This was further discussed with HPE, and this is expected behavior as designed.

Embedded RAID 1: HPE Smart Array is moved to the bottom of the boot order.

Note: This doesn't impact the overall ASP4200 solution, but if changes are not made, server boot-up could be delayed for 5 - 10 minutes until the server boot sequence gets to the Embedded RAID 1: HPE Smart Array.

- Open a web browser and go to the IP or FQDN of the host iLO.
- Log in with the administrative credentials (See the customer workbook for details).
- Go to Administration > Boot Order
- Under Server Boot Order, select and highlight the Embedded RAID 1: HPE Smart ArrayP408i-a SR Gen 10 and click up until it is moved under VMware ESXi or at the top.

- Click Apply to save the changes.

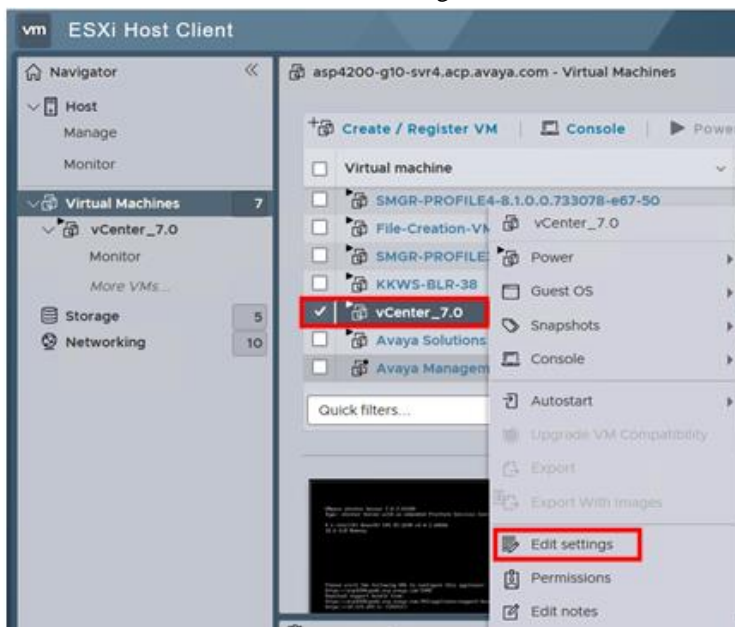
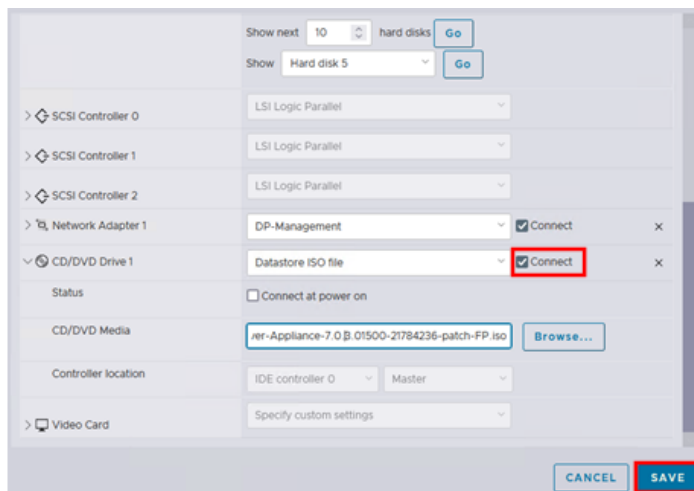
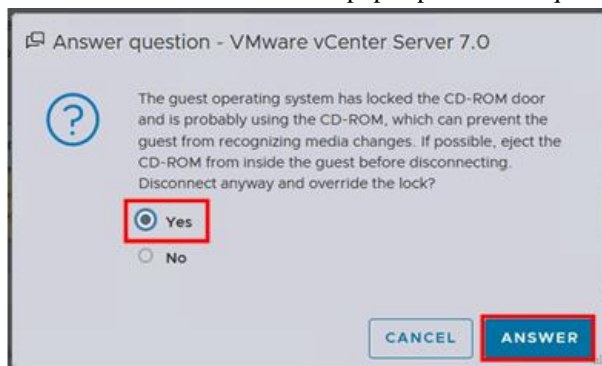
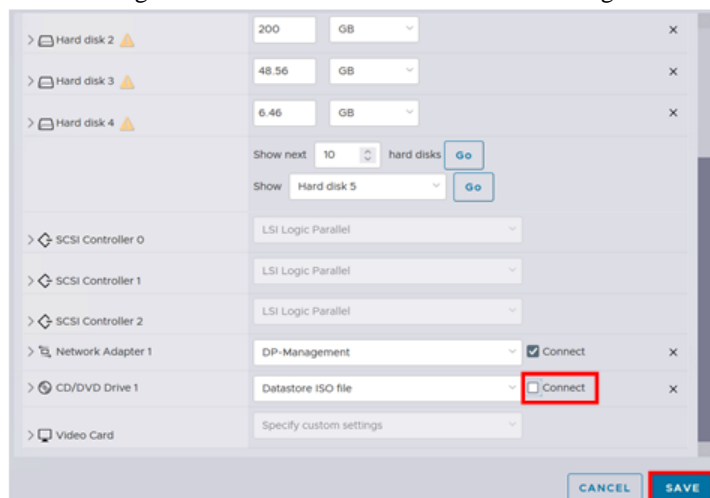
- ****NEW**** When mounting the patch ISO to the vCenter Server VM CD-ROM to conduct the update, the

vCenter connection gets dropped after a few minutes and is offline for up to 10 minutes. After further discussions with our vendor, anytime that a file is mounted or there is a change with the vCenter VM CD-ROM there is a question that the user must answer in order to override the lock on the CD-ROM.

11. From the CD/DVD drive 1 option, select datastore ISO from the dropdown menu.
12. If not already, expand the CD/DVD drive 1 view and click browse.
13. Navigate to and select the VCSA update patch ISO file uploaded during step 6 and click Select to mount it to the vCenter VM CD/DVD drive.
14. Ensure that the CD/DVD drive 1 is connected and click Save.

15. Once Save is clicked a window pops up to answer question. Select Yes and click Answer.

16. After answering the question, the CD/DVD drive 1 gets disconnected. Go back to Virtual Machines and select and right click the vCenter VM. Go to Edit Settings.

17. Check Connect to reconnect the CD/DVD drive 1 and click Save.
18. Open a new browser tab and go to the VCSA appliance management interface with the URL: https://vcenter_ip:5480. Log in with the root credentials.
19. Click Update in the left column.
20. Click Check Updates and select check CD ROM. The patch ISO file mounted during step 13 should now be visible under Available updates (7.0.3.01500).
21. Click Stage and Install.
22. Accept the license agreement and click Next.
23. Check that a back up of the VCSA has been completed. Click Finish to start the update.
24. Once the update completes click OK.
