**Bulletin Number: P-2009-0028-Global-Rev2**

## **Nortel Communication Server 1000 Telephony Manager Release 4.0**

This document provides an overview of enhancements and advisements to the Communication Server 1000 Telephony Manager 4.0.

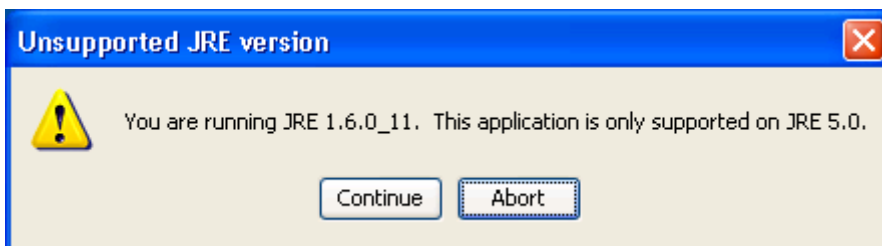
Figure 1: Error - Unsupported JRE version

With JRE 1.6 installed, if CND Manager is launched through *Start -> Programs -> Nortel -> Common Network Directory -> CND Manager*, an error message of “Unsupported JRE version” as shown in **Figure 1** is displayed. However, CND functionalities are NOT affected by JRE 1.6 and are compatible with it. User can just click on the ‘Continue’ button to proceed.

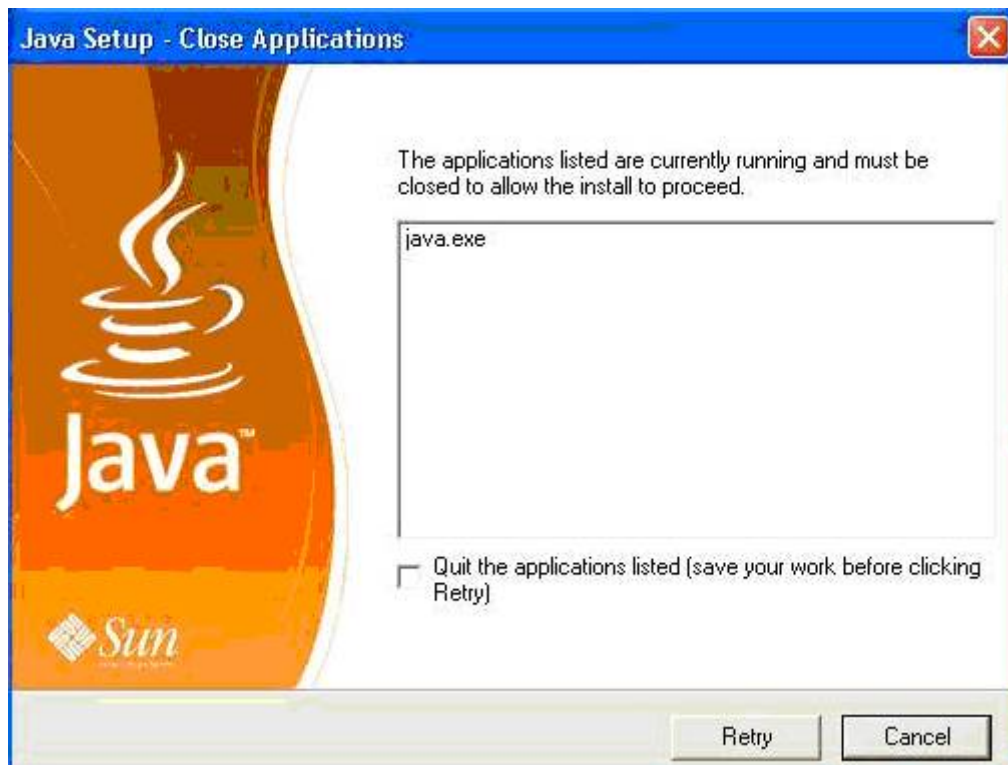
Figure 2: Java Setup Window

If you perform a Repair with java.exe task running in the Task Manager, then you will receive a pop up message as in the **Figure 2**. Select the **“Quit the applications listed (save your work before clicking Retry)”** check box and click on **Retry** to continue with the Telephony Manager 4.0 Repair.

This message does NOT pop up if java.exe task is not running.

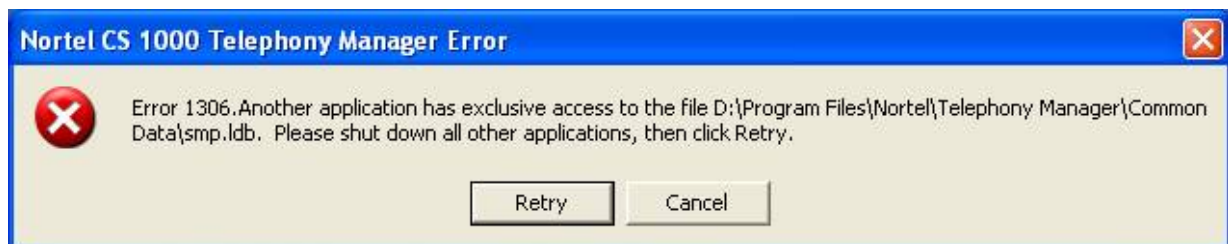
**Q02001319 TM 4.0 NTP: Missing upgrade steps for Direct upgrade (TM 3.2 to TM 4.0).**

If all TM applications are not terminated before performing upgrade then the following error message will be displayed during upgrade operation. User must click on 'Cancel' button on the error message, reboot the machine and then perform upgrade again.
