Product Support Notice

PSN # PSN020151u

Name of problem Issues to be aware of when running CM in a Virtualized Environment (VE) or on AVP.

Avaya Aura® Communication Manager (CM), Releases 6.2 and higher

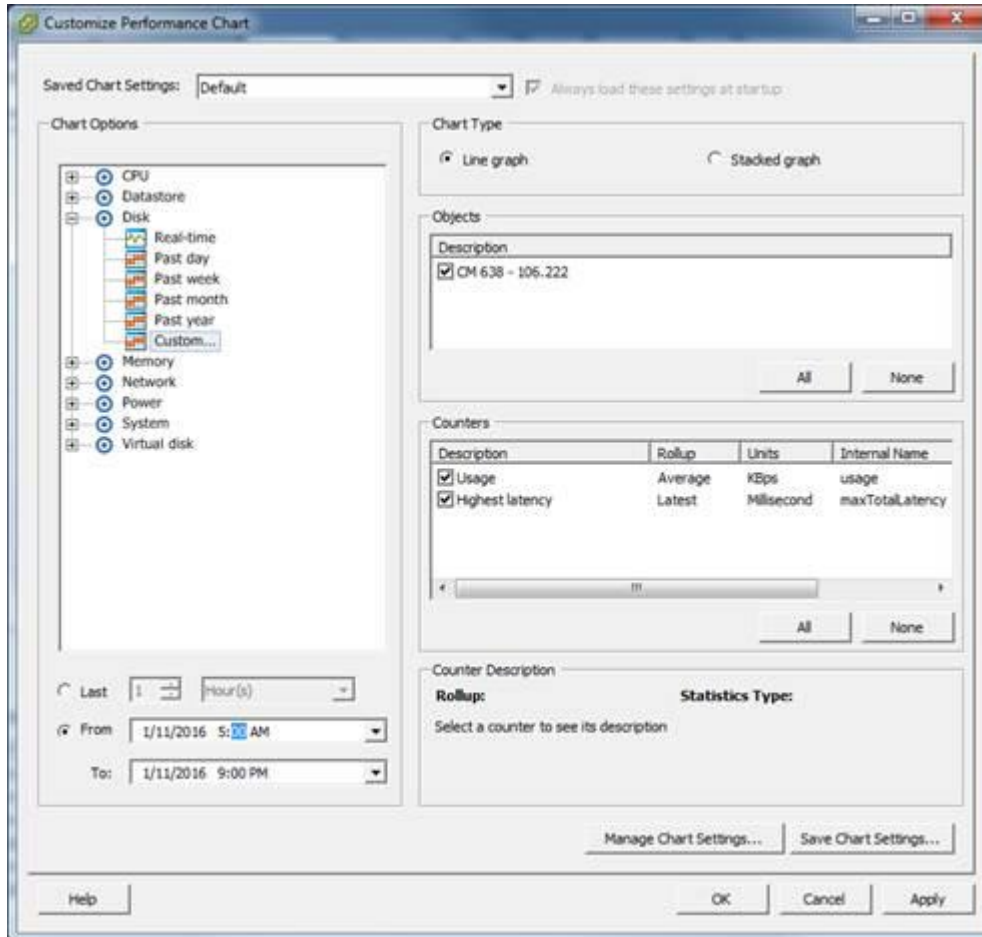
Collect the disk performance chart. Select *Disk* in *Chart Options* with *Custom Date/time*, and select the timeframe described in the above bullet. Make sure *Usage* and *Highest Latency* are selected. Example:

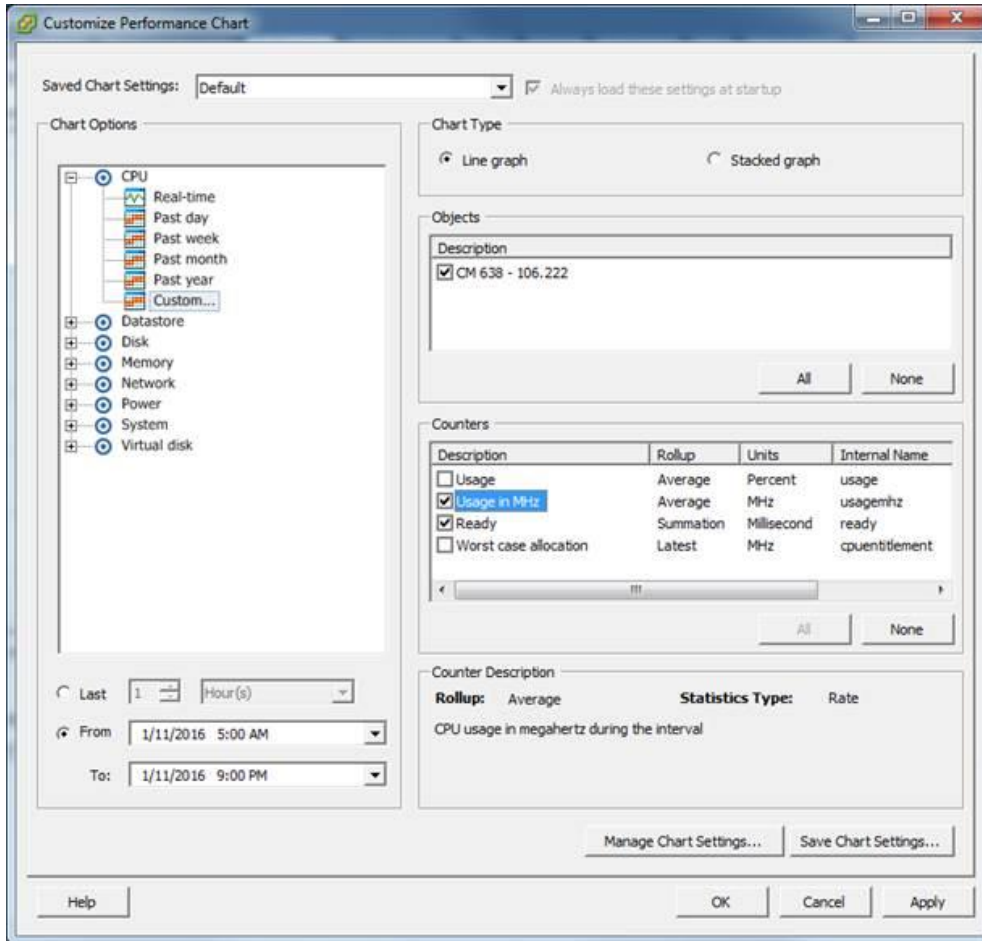
Collect the CPU usage chart for the two CM VMs for the same timeframe with *Usage in MHz* and *Ready* time selected.
Example:
