Maintenance Alarms for Avaya Communication Manager 2.2, Media Gateways and Servers

03-300190
Issue 3
January 2005

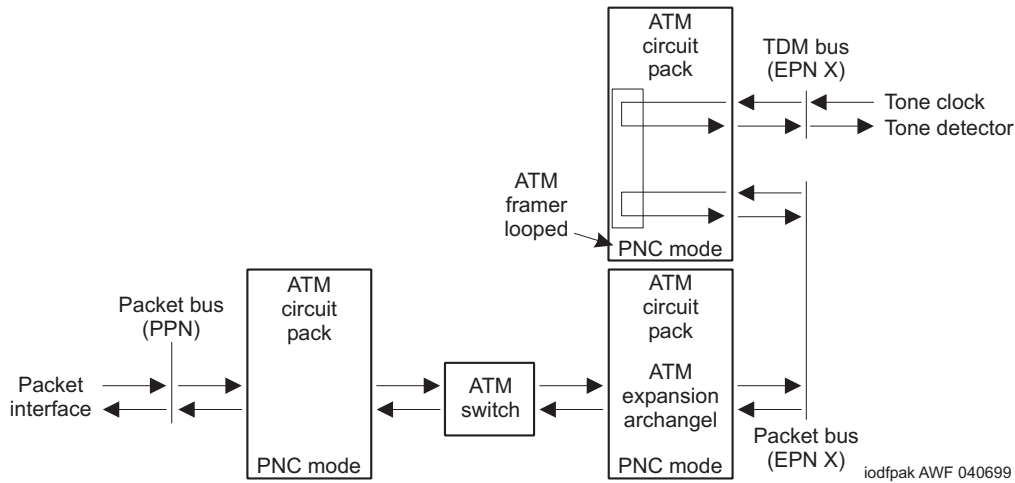
Figure 28: ATM Board Framer Loop-Around Test (#1260) (non-EAA, Packet Path)

- **Packet path:** the Packet Interface circuit pack sends packet data to the ATM framer interface, where it is mapped into ATM cells and then looped around internally. The cells are converted back to packet data after it has been looped. This portion of the test verifies correct operation of the ATM-EI's packet-bus interface and a large portion of the ATM-EI's packet paths. [Figure 28: ATM Board Framer Loop-Around Test \(#1260\) \(non-EAA, Packet Path\)](#) on page 543 shows the packet switched signal path for the ATM circuit pack.

- This test verifies the operation of a large portion of the ATM-EI circuit and packet paths, but does not verify the optical portion of the lightwave transceiver. If this test passes, the ATM-EI circuit pack is functioning correctly, but faults can exist in the lightwave transceiver. If the test fails, the fault can be on the board. After the test results are reported, the ATM framer is taken out of loopback.

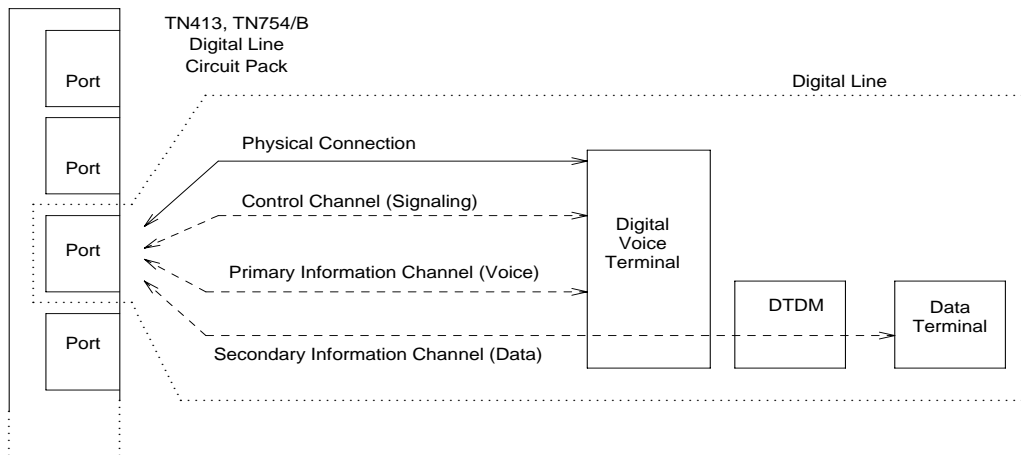
Figure 45: Digital Line Connectivity

Each digital line port supports two 64 kbps information channels (primary and secondary) and one 8kbps signaling channel. Digital voice terminals always use the primary information channel, and only one voice terminal can be connected to each port. The secondary information channel can be used to connect a data terminal via a Digital Terminal Data Module (DTDM) or a Data Adaptor (DA). All other devices currently supported by Digital Line circuit packs communicate on the primary information channel. [Figure 45: Digital Line Connectivity](#) on page 900 shows examples of digital line connectivity.

The TN2181 and TN2224B/CP support both modes as shown in [Figure 45: Digital Line Connectivity](#) on page 900 and [Figure 46: Digital Line Connections](#) on page 901.

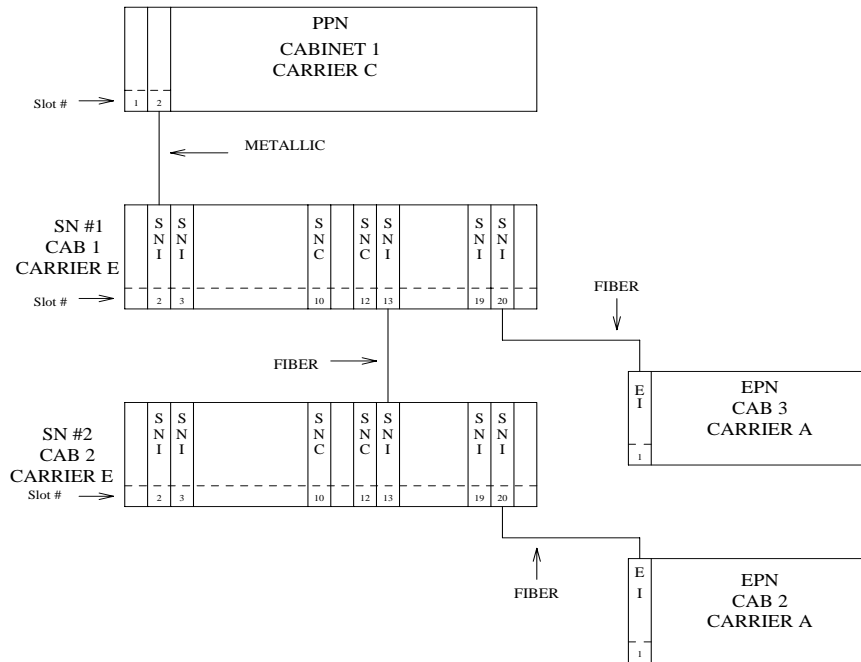
Figure 62: Center Stage Switch Configuration with Unduplicated PNC

[Figure 62: Center Stage Switch Configuration with Unduplicated PNC](#) on page 1146 shows the location of EIs in a typical center stage switch configuration with unduplicated PNC.

For an unduplicated center stage switch configuration, only one EI is needed in each PN. Notice that there is no direct connection between the PNs, rather every inter-PN connection is made through the center stage switch. Each SNI in the switch node carriers can be connected to a PN through an EI circuit pack.

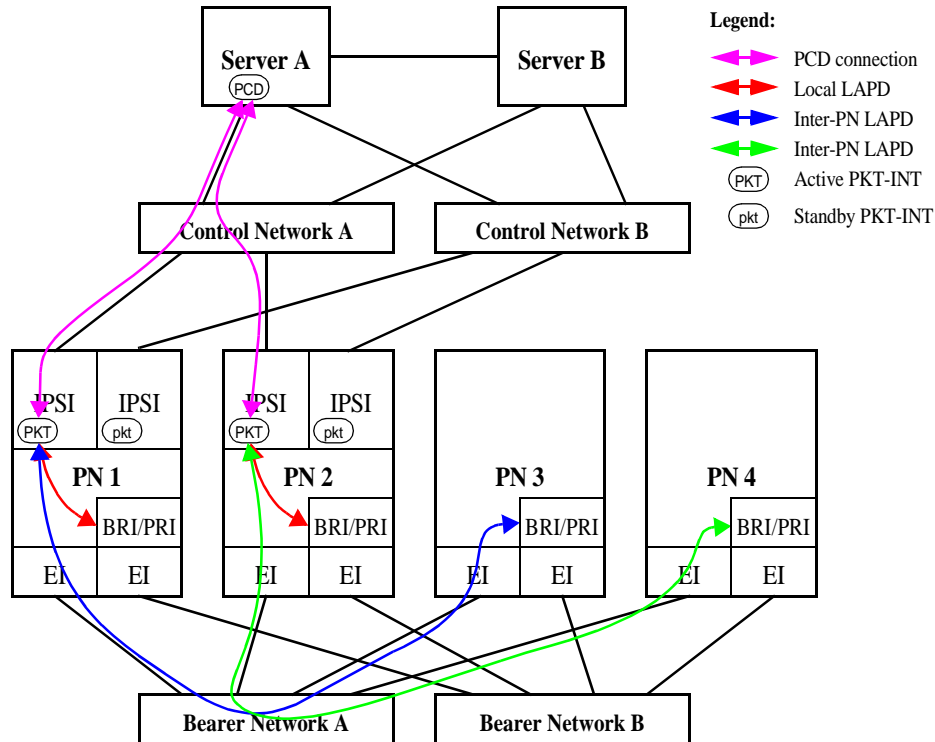
Figure 111: Distributed PKT-INTs

S8700 MC: As shown in [Figure 111: Distributed PKT-INTs](#) on page 1759, PNs 1 and 2 have IPSIs that terminate LAPD links. PNs 3 and 4 do not have local IPSIs, so their LAPD links are terminated by IPSIs in PNs 1 and 2.

The Packet Interface module is a single point of failure in a standard- or duplex-reliability system, with unduplicated IPSIs. If not acceptable, an S8700 customer can upgrade to a high- or critical-reliability system with duplicated IPSIs. [Figure 111: Distributed PKT-INTs](#) on page 1759 shows an S8700 Multi-Connect configuration with duplicated IPSIs. The following concepts apply to duplicated IPSIs:

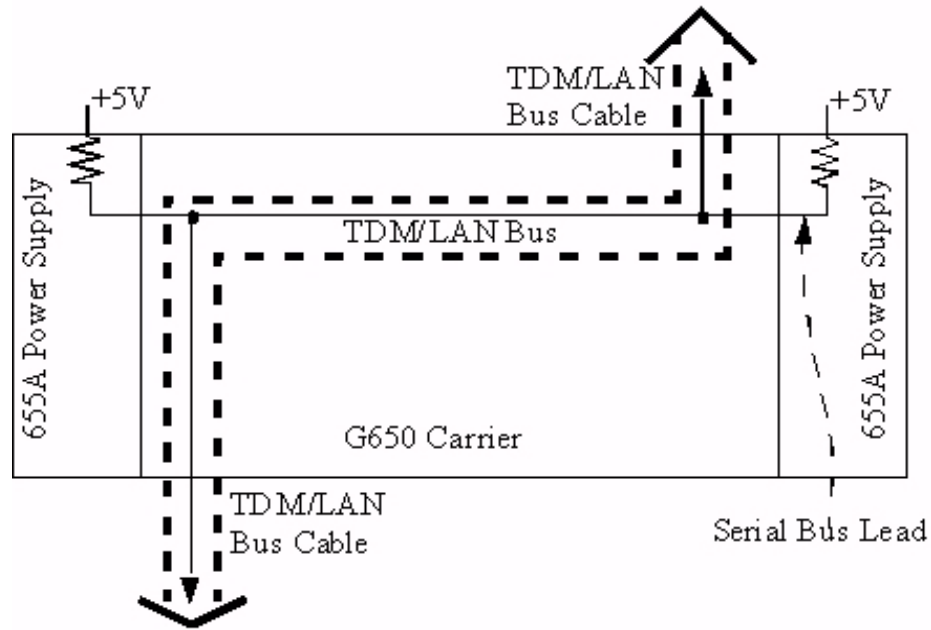
Figure 121: Wiring diagram for serial bus data and clock leads

The TN2312BP IPSI in the A carrier will act as master of the serial bus and poll each of the power supplies based on their board address. Only a TN2312BP IPSI in the A carrier can be a bus master, even if a TN2312BP in carrier B is used for port network connectivity. Therefore, setting the TN2312BP in the A carrier or B carrier to be active will not clear a problem if the TN2312BP itself is the reason for the failure. The power supply's board address is derived from 4 board address leads in the power slot of the backplane. The G650 carrier addressing paddle card sets 3 of these 4 address leads for the power slot. A G650 can have a maximum of ten 655A power supplies on the serial bus (See [Figure 121: Wiring diagram for serial bus data and clock leads](#) on page 1915).

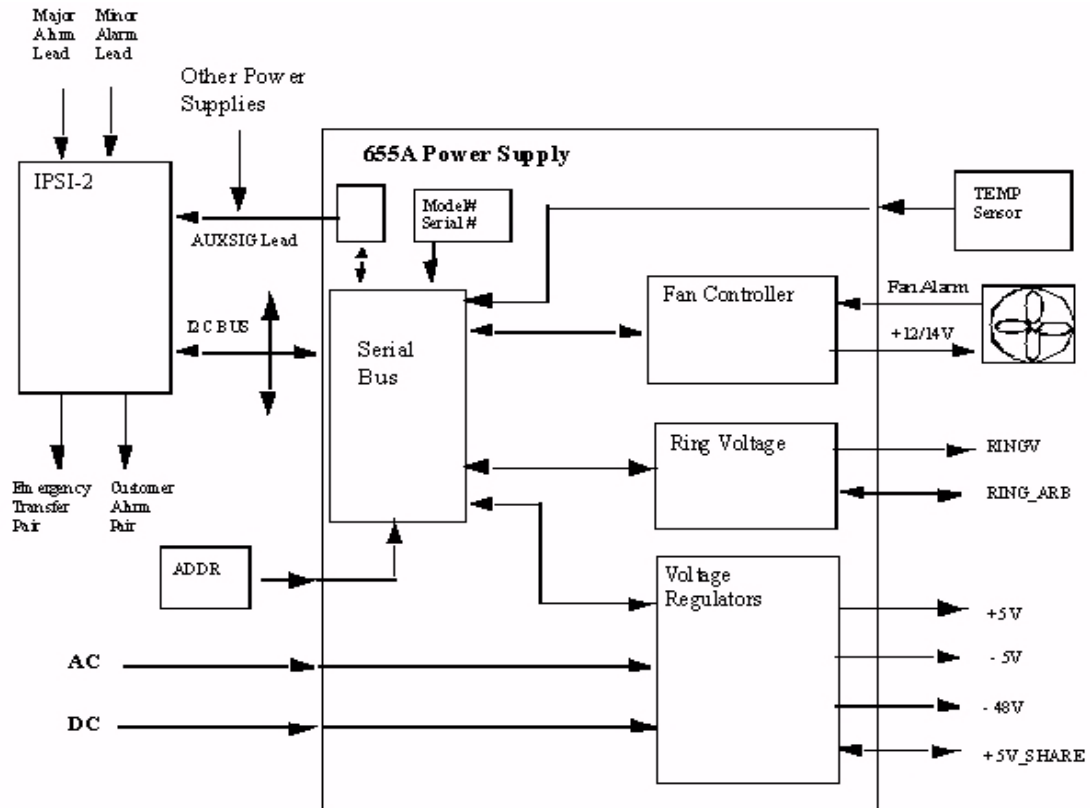
Figure 122: G650 Cabinet Environmental Hardware Components

[Figure 122: G650 Cabinet Environmental Hardware Components](#) on page 1916 illustrates these components.

- Inlet temperature - 655A power supply sensor
- Exhaust temperature - G650 carrier exhaust air sensor
- Hot Spot temperature - 655A power supply sensor
 - The system generates a warning at 176° Fahrenheit (80° Celsius).
 - The power supply shuts down at 194° Fahrenheit (90° Celsius).
- Power supply output voltage measurements, +5VDC, -5VDC, and -48VDC
- Fan Control - The speed of the fans, either mid (normal) or high (fan failure or hot spot temperature limit exceeded).
- Fan Alarm - Detection of a blocked or failed fan
- Ring Status - OK, overload, shorted, or failed
- Ring Control - Active, standby, disabled, off (shorted or failed)
- Ringer Setting - 20Hz, 25Hz, or other
- Ring Detection - Reports if power supply detects ring on the backplane ring leads

Refer to [Figure 122: G650 Cabinet Environmental Hardware Components](#) on page 1916 for further information.

A TN2312BP IPSI, in a G650 with a carrier address set to A, has two alarm ports that connect to external devices. An example of an external device is an uninterruptible power supply (UPS). Refer to [Figure 122: G650 Cabinet Environmental Hardware Components](#) on page 1916 for further information.

There is one instance of this MO for each 655A power supply equipped in a G650 stack. Refer to [Figure 122: G650 Cabinet Environmental Hardware Components](#) on page 1916 for further information.
