Maintenance Alarms for Avaya Communication Manager 3.0, Media Gateways and Servers

03-300430
Issue 1
June 2005

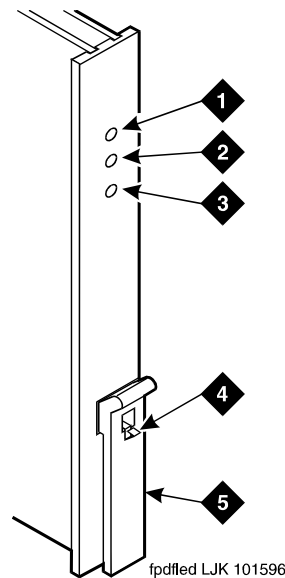
Figure 1: TN775 circuit pack LEDs on faceplate

These LEDs are illustrated [Figure 1: TN775 circuit pack LEDs on faceplate](#) on page 261.

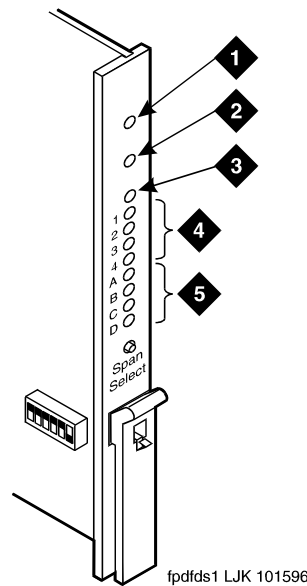
Figure 2: TN574 DS1 Converter circuit pack LEDs

Below the three standard LEDs on the DS1C circuit pack are four green LEDs that indicate whether a receive signal is present for each of the four DS1 facilities. [Figure 2: TN574 DS1 Converter circuit pack LEDs](#) on page 263 shows which facility (A, B, C, or D) corresponds to each LED. If a green LED is off, there is a Loss of Signal condition on the DS1 facility associated with that LED. The presence of a signal does not guarantee that the signal is using the correct framing format or line coding; an Alarm Indication Signal indicating that the opposite end of the DS1C complex is out of service may be present.

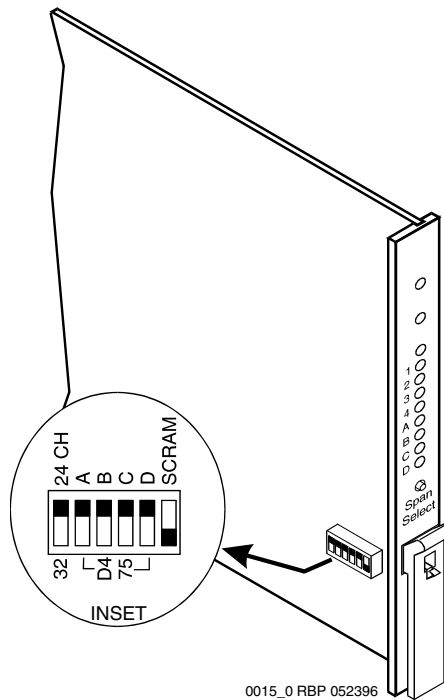
Figure 3: TN1654 DS1CONV circuit pack

The bottom four LEDs on the TN1654 board are labeled SPAN LEDs. These LEDs are under firmware control. If the facility is not administered, then the LED is not lit. The LED is lit amber if the facility is running alarm free. If the facility is detecting either a red alarm (loss-of-signal or loss-of-frame), a yellow alarm (remote frame alarm) or a blue alarm (AIS signal) then the LED is lit red. The SPAN SELECT switch on the TN1654 faceplate is for future use. Pushing the switch will have no effect on the board. See [Figure 3: TN1654 DS1CONV circuit pack](#) on page 265 for a view of the faceplate on the TN1654 DS1CONV circuit pack.

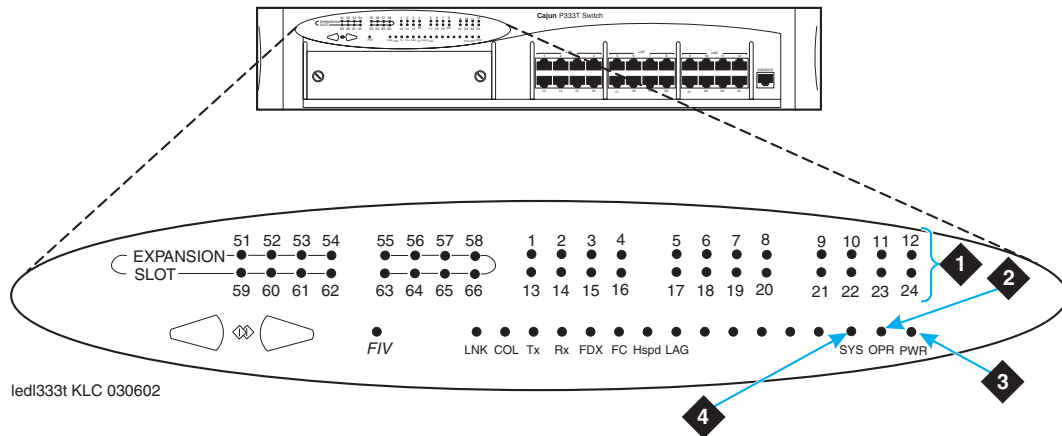
Figure 4: Avaya Ethernet switch LEDs

The Avaya Ethernet switch's LEDs are shown in [Figure 4: Avaya Ethernet switch LEDs](#) on page 268.

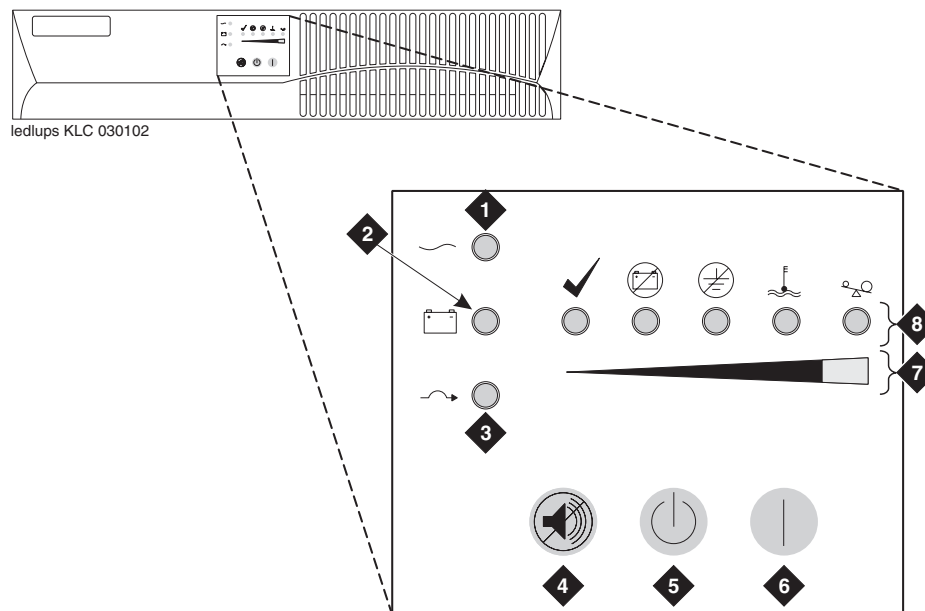
Figure 5: UPS LEDs

The Powerware front panel has the LEDs shown in [Figure 5: UPS LEDs](#) on page 269.

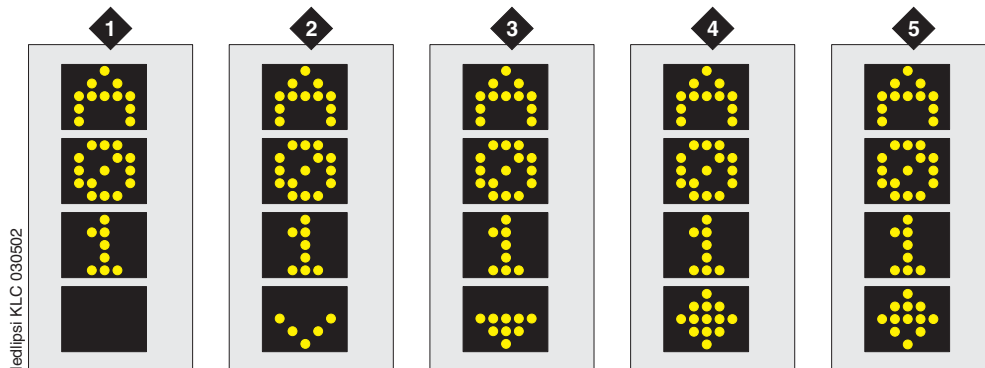
Figure 6: IPSI display showing connectivity status

There are four LEDs on the TN2312AP IPSI faceplate, and five LEDs on the TN2312BP IPSI faceplate. The top three LEDs are the standard ones found on most TN circuit packs. The fourth LED imitates the TN2182B Tone-Clock's amber LED. The archangel flashes the yellow LED when active, 2 seconds on and 200 msec off. In addition, the TN2312BP has a fifth LED that shows the emergency transfer control status.

Connectivity status	1	2	3	4	5
IPSI is connected to Avaya Ethernet switch	no	yes	yes	yes	yes
IPSI has an IP address	no	no	yes	yes	no
Laptop computer is connected to IPSI services port	no	no	no	yes	yes

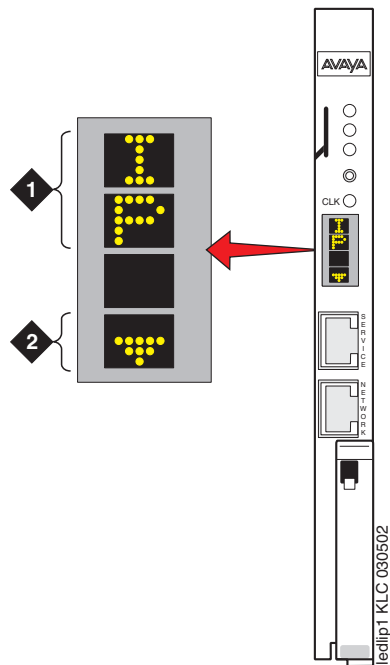
Figure 7: S8700 IP-Connect IPSI display

- 1 IPSI using DHCP
- 2 IPSI has connectivity and an IP address

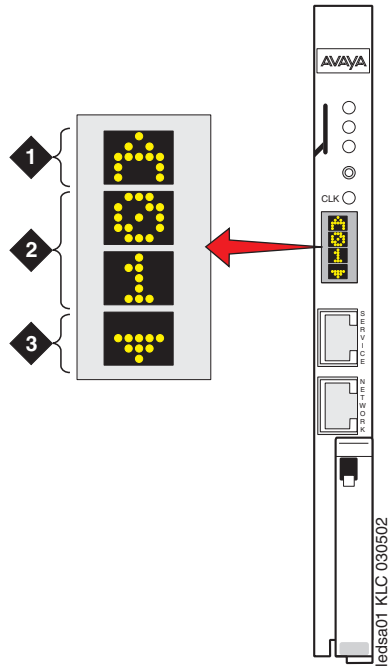
Figure 8: S8700 Multi-Connect IPSI Board Display

- 1 Switch identifier
- 2 Cabinet
- 3 IPSI has connectivity and an IP address

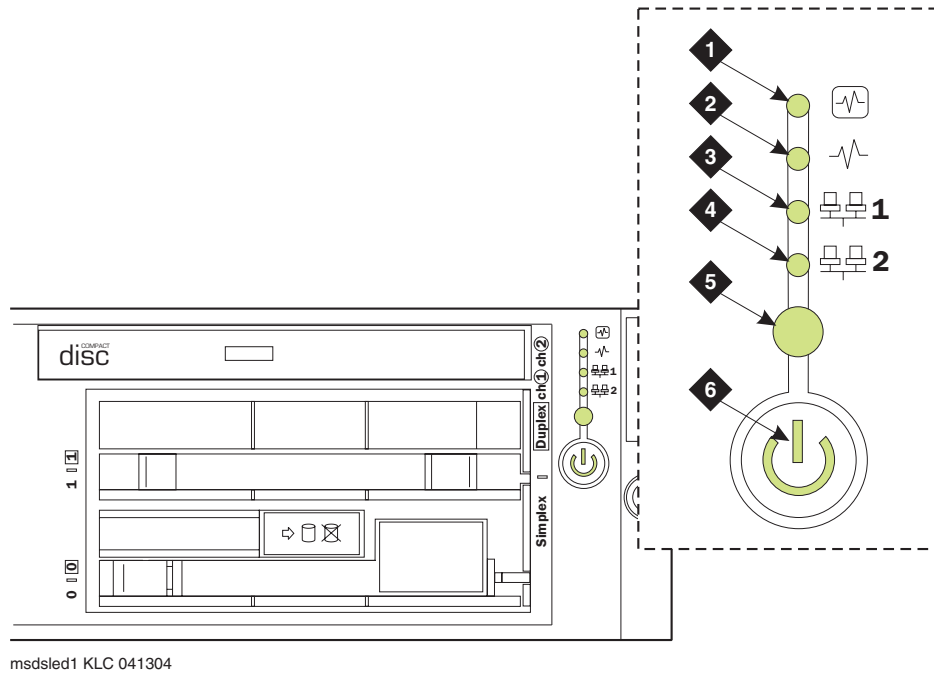
Figure 9: LEDs on front panel of S8710 Media Server

Number	Description	Status
1	Internal health	GREEN: normal AMBER: system degraded. See system board LEDs to identify component in degraded state. RED: system critical. See system board LEDs to identify component in critical state.
2	Power supply	GREEN: normal AMBER: power redundancy failure RED: Critical power supply failure
3	NIC 1 (Eth0) link/activity (GREEN)	STEADY ON: network link FLASHING: network link and activity Off: No link to network
4	NIC 2 (Eth1) link/activity (GREEN)	STEADY ON: network link FLASHING: network link and activity OFF: No link to network
5	Active/Standby mode (BLUE)	STEADY ON: in active mode FLASHING: in standby mode OFF: deactivated NOTE: If pressed, the LED is deactivated; wait 10 seconds and the LED comes back on.
6	Power on/ Standby button/ System power	GREEN: system on AMBER: system shut down but power still applied OFF: power supply failure

S8710 location	Diagram	LED interpretation
Front panel	Figure 9	Table 74: S8710 front panel LED interpretation on page 277
Back panel	Figure 10	Figure notes: S8710 rear panel LED interpretation on page 278

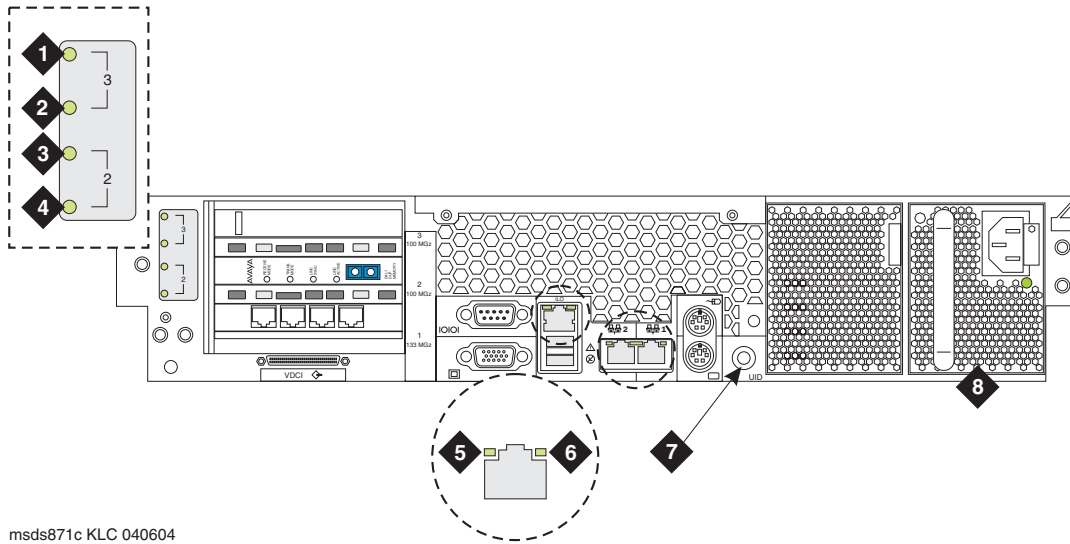
Figure 10: LEDs on back panel of S8710 Media Server

Number	Description	Status
1	Not used	ON: expansion board failed. OFF: normal
2	Not used	STEADY ON: slot has power FLASHING: power is cycling OFF: no power
3	Quad-NIC fault (slot 2) (AMBER)	ON: expansion board failed. OFF: normal
4	Quad-NIC power (slot 2) (GREEN)	STEADY ON: slot has power FLASHING: power is cycling OFF: no power
5	RJ45 link (GREEN)	ON: linked to network OFF: not linked to network
6	RJ45 link (GREEN)	STEADY ON: network activity FLASHING: network activity OFF: no network activity
7	Active/standby mode (BLUE)	STEADY ON: in active mode FLASHING: in standby mode Off: deactivated NOTE: If pressed, the LED is deactivated; wait 10 seconds and the LED comes back on.

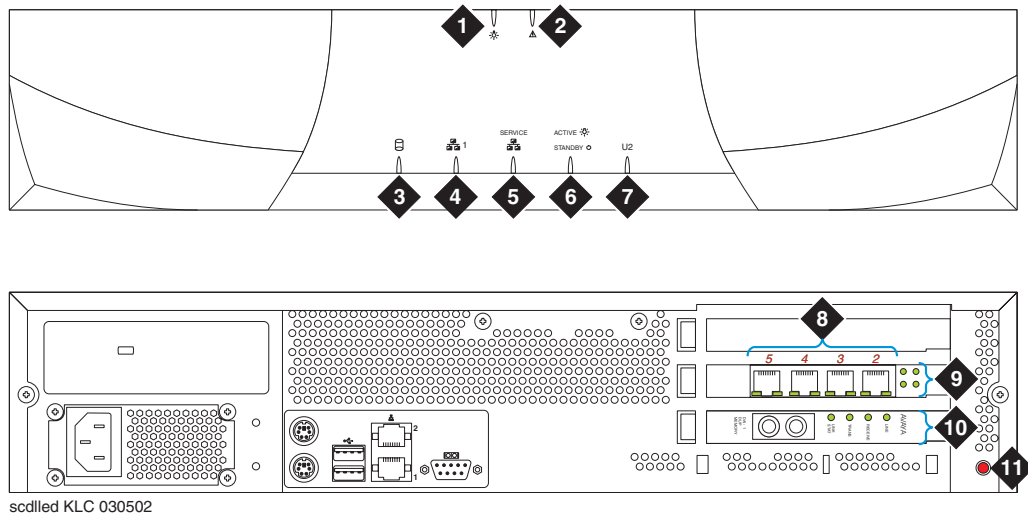
Figure 11: S8700 Media Server LEDs—Front and Back

The S8700 Media Server has an LED called Active/Standby that indicates whether the server is the active server or the standby server. The Active/Standby LED in the “on” state implies active and in the “flashing” state implies standby. It flashes at the rate of 400 ms “on” and 600 ms “off” when in standby mode.

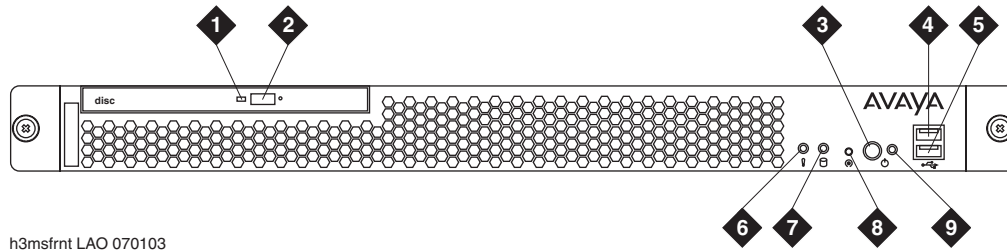
Figure 12: S8500 front panel

- Five (5) LEDs on the front panel ([Figure 12: S8500 front panel](#) on page 282)
- Four (4) LEDs on the back ([Figure 13: S8500 rear panel](#) on page 283)

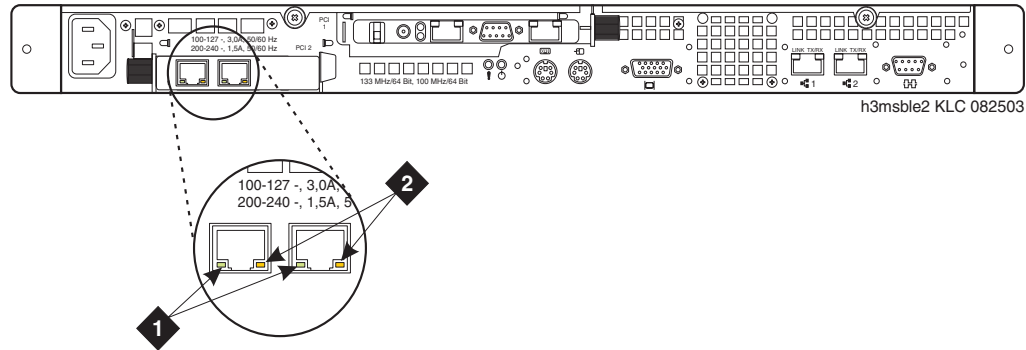
Figure 13: S8500 rear panel

The four LEDs on the S8500 back panel are shown in [Figure 13: S8500 rear panel](#) on page 283.

- 1 Activity 2 Connection speed
- LED is off: there is a 10 BASE-T active link.
 - LED is green: there is a 100 BASE-T active link.
 - LED is orange: there is a 1000 BASE-T active link.

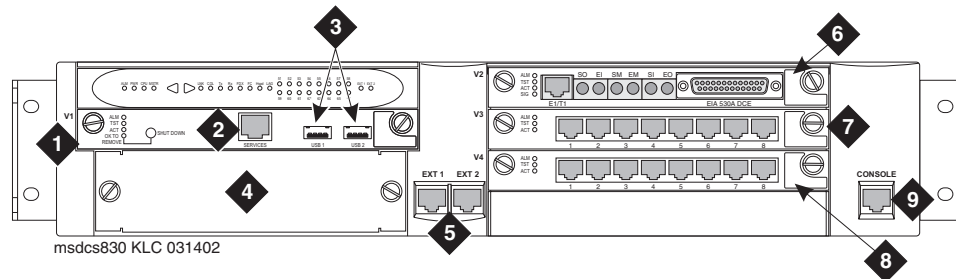
Figure 15: G700 LED Panel Location

As shown in [Figure 15: G700 LED Panel Location](#) on page 289, the LED panel is located on the top left corner of the G700. Directly below the LED panel is Media Module slot V1, which can be occupied by any type of Media Module. However, the S8300 Media Server can reside only in this particular slot because of height restrictions (for a specific discussion of the S8300 LEDs, see [S8300 Media Server LEDs](#) on page 283).

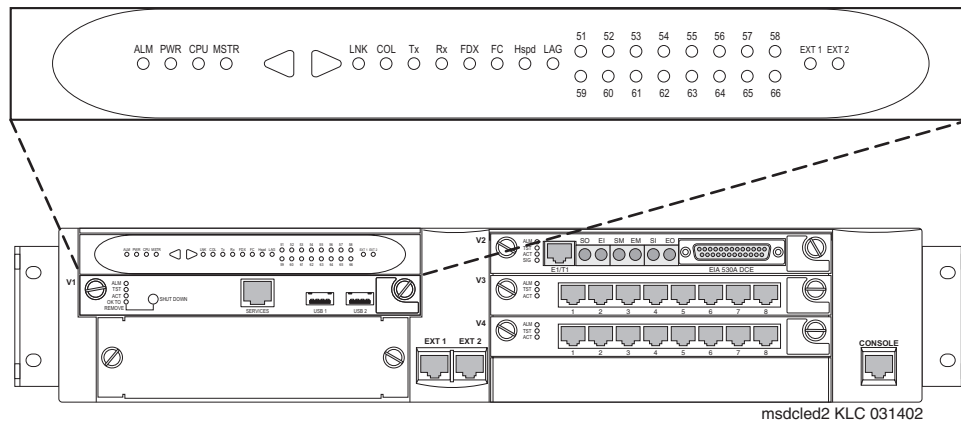
Figure 16: G700 LED Panel

[Figure 16: G700 LED Panel](#) on page 290 shows an expanded view of the G700 LED panel.

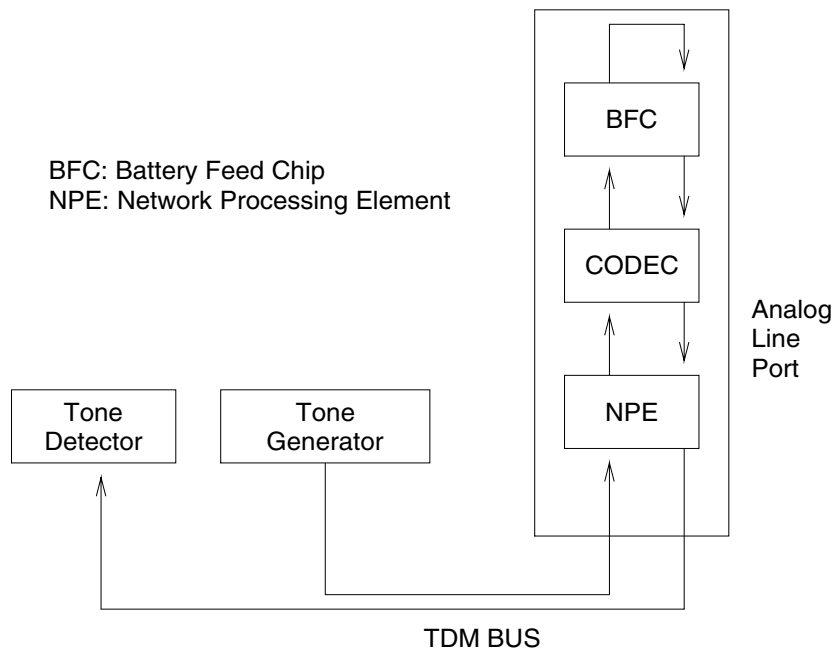
Figure 22: Analog Looparound and Conference Test

This test is designed to check the on-board transmission capabilities of the NPE, the codec, and the battery feed chip of the Analog port. A Tone Detector and a Tone Generator talk and listen on the same pair of time slots as the Analog port. The Analog port is then instructed to go into loop around mode (see [Figure 22: Analog Looparound and Conference Test](#) on page 417). The test passes if the signal measured by the Tone Detector is within acceptable limits.

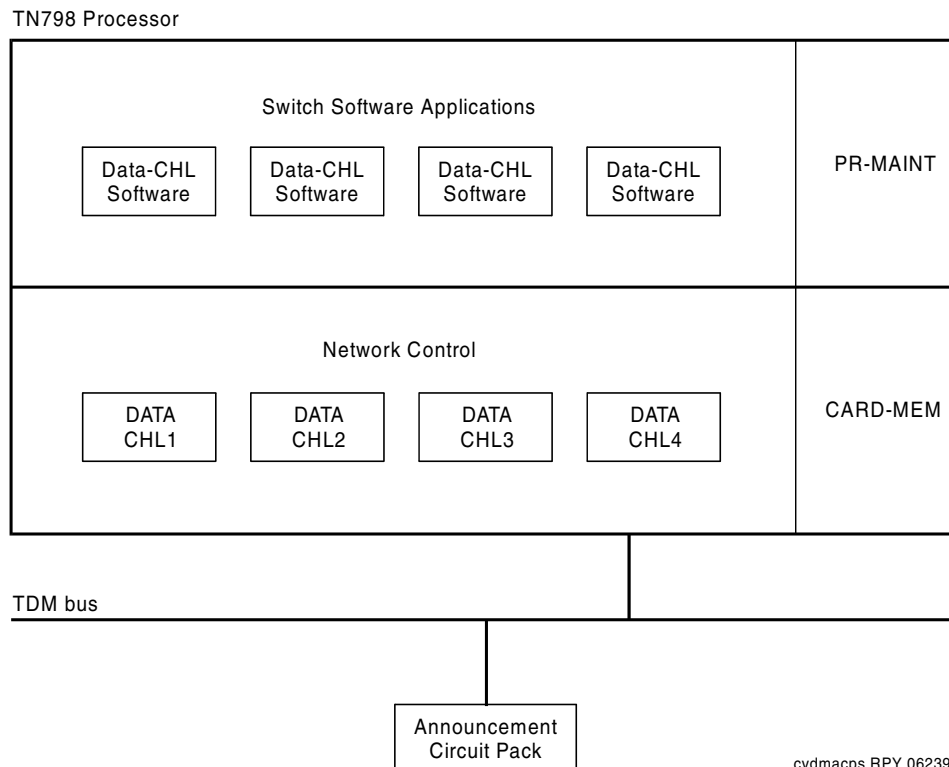
Figure 23: Connection of announcement circuit pack to the system

[Figure 23: Connection of announcement circuit pack to the system](#) on page 477 shows the connection of the Announcement Circuit Pack to the system. To save or restore announcements, an ANNOUNCEMENT Data Extension must be administered, and at least one DATA-CHL (Network Control Data Channel) must be in the in-service/idle state.

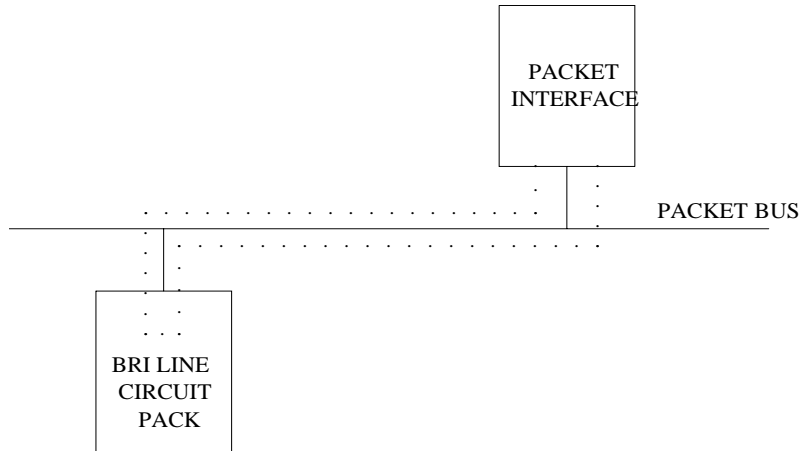
Figure 24: BRI Port Local LAN Loop-Around Path

The dotted lines in [Figure 24: BRI Port Local LAN Loop-Around Path](#) on page 498 show how a loop-around test is performed across the packet bus for the D channel.

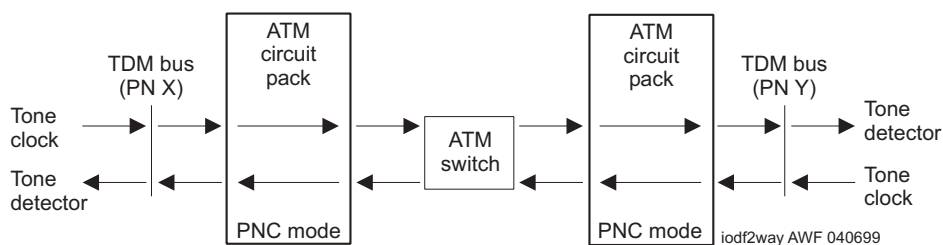
Figure 25: Expansion Interface 2-Way Transmit Test #241
PN X and PN Y represent any of 44 possible PNs.

The test results indicate if the test failed in one or both directions. The test aborts if the ATM-EIs do not exist on both ends (for example, the EIs are not administered correctly). If the test passes, the TDM and ATM framer interfaces of both ATM-EIs are functioning properly. If the test fails, a series of tests are run on the board. [Figure 25: Expansion Interface 2-Way Transmit Test #241 PN X and PN Y represent any of 44 possible PNs.](#) on page 545 shows a schematic of this test.

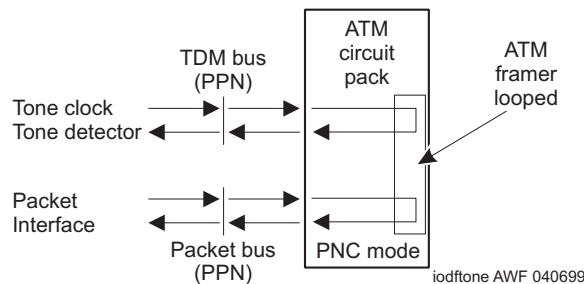
Figure 27: ATM Board Framer Loop-Around Test (#1260)

- **The circuit (TDM) path:** one of the Tone Generators sends a bit pattern through a TDM bus time slot to the ATM framer. The pattern is converted into ATM cells and looped back to the ATM-EI board, which converts the cell back into the bit pattern and puts it on a pre-determined time slot. A Tone Detector tests for the bit pattern and reports the test result. This test verifies that a large portion of the ATM-EIs circuit paths are functioning correctly. [Figure 27: ATM Board Framer Loop-Around Test \(#1260\)](#) on page 560 shows a diagram of the test.

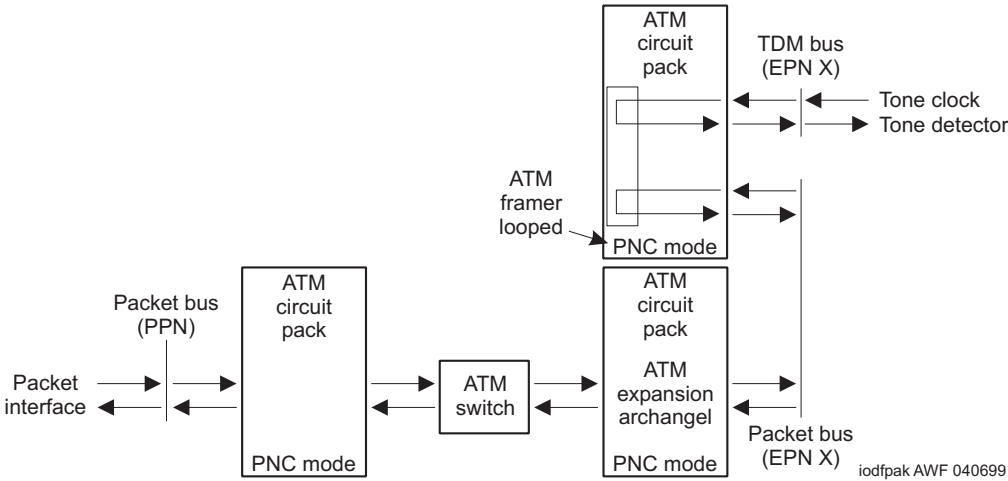
Figure 28: ATM Board Framer Loop-Around Test (#1260) (non-EAA, Packet Path)

- **Packet path:** the Packet Interface circuit pack sends packet data to the ATM framer interface, where it is mapped into ATM cells and then looped around internally. The cells are converted back to packet data after it has been looped. This portion of the test verifies correct operation of the ATM-EI's packet-bus interface and a large portion of the ATM-EI's packet paths. [Figure 28: ATM Board Framer Loop-Around Test \(#1260\) \(non-EAA, Packet Path\)](#) on page 561 shows the packet switched signal path for the ATM circuit pack.

- This test verifies the operation of a large portion of the ATM-EI circuit and packet paths, but does not verify the optical portion of the lightwave transceiver. If this test passes, the ATM-EI circuit pack is functioning correctly, but faults can exist in the lightwave transceiver. If the test fails, the fault can be on the board. After the test results are reported, the ATM framer is taken out of loopback.

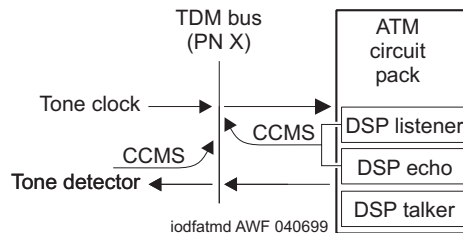
Figure 30: ATM Board DSP Test (#1293)

This test applies to TN2305 and TN2306 ATM-ElIs, both active and standby, and is run as part of craft short and long testing, periodic, scheduled, initialization, and error analysis testing. Refer to [Figure 30: ATM Board DSP Test \(#1293\)](#) on page 570 for a diagram of this loop-around test.

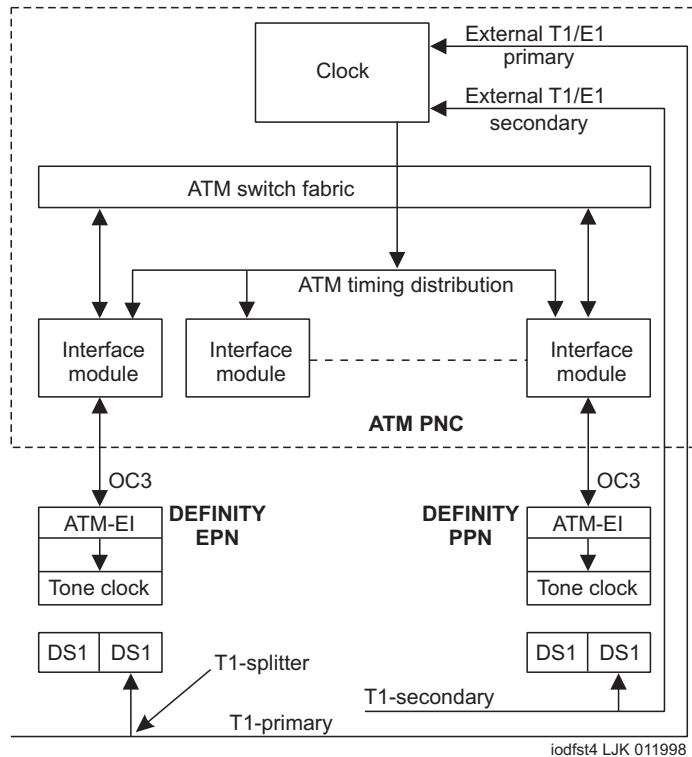
Figure 32: Stratum-4 Synchronization with Unduplicated ATM PNC

If the primary synchronization reference in [Figure 32: Stratum-4 Synchronization with Unduplicated ATM PNC](#) on page 612 is providing a valid timing signal, then the flow of system synchronization would travel from the DS1 interface circuit pack in the PN to the ATM switch. The primary DS1 interface circuit pack provides a timing signal for the ATM switch clock circuitry. This synchronization source is then distributed to all of its OC3 Interface Modules. Each ATM Expansion Interface circuit pack uses the received data stream from the ATM switch to generate a timing signal. The Tone-Clock circuits in the PNs use this signal to generate timing for every circuit pack in their respective PNs. All PNs, in the above mentioned scenario are designated the *slave* PNs. The ATM switch is the *master* that contains the system synchronization source. If the primary synchronization reference does not provide a valid timing signal, ATM synchronization maintenance infers a switch to the secondary reference.

[Figure 32](#) depicts a simplex ATM PNC with T1/OC3 synchronization reference into the ATM switch.

The TN722 DS1 Interface circuit pack does not provide a synchronization reference as reliably as the TN767 or TN464 circuit packs. Therefore, administer the TN767 or TN464 circuit packs as the primary or secondary sources.

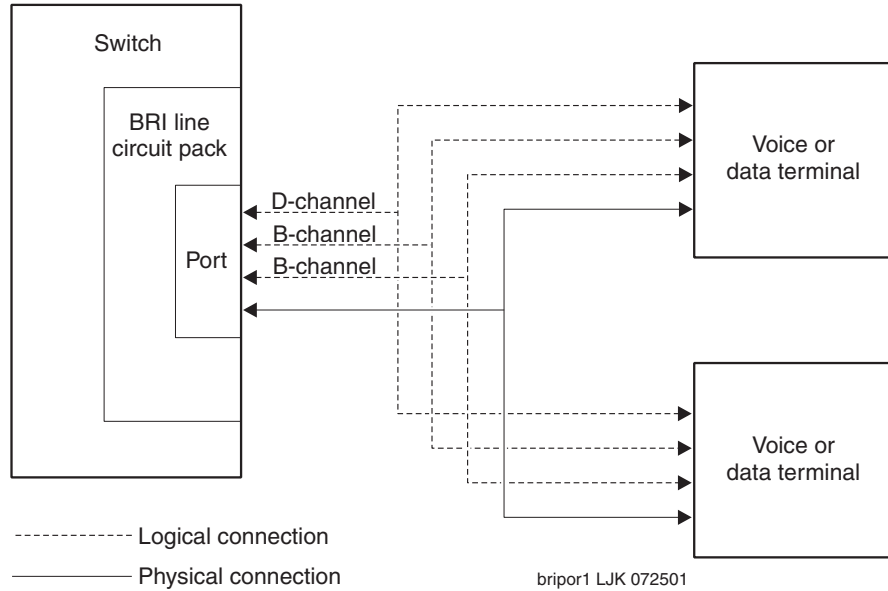
Figure 33: ISDN-BRI Port Interactions

[Figure 33: ISDN-BRI Port Interactions](#) on page 687 illustrates the physical connection (solid line) between an ISDN-BRI port and its associated ISDN-BRI set(s). Each physical connection allows for two B channels and one D channel. Each ISDN-BRI circuit pack can support up to 12 of these *physical* connections to different voice and voice/data sets or ASAI or Avaya adjuncts. On a TN2198 each ISDN-BRI circuit pack can support up to 12 *physical* connections to a NT1 which in turn connects to 2 terminals.

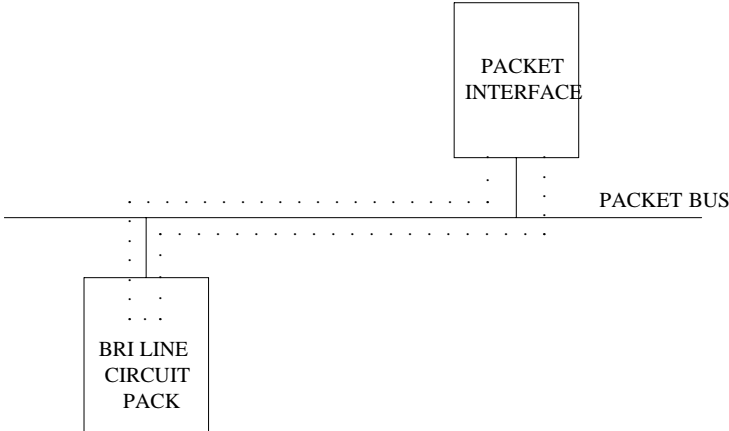
Figure 34: Path of the BRI Port Local LAN Loop Around

The dotted lines in [Figure 34: Path of the BRI Port Local LAN Loop Around](#) on page 693 show how a Loop Around test is performed across the packet bus for the D channel.

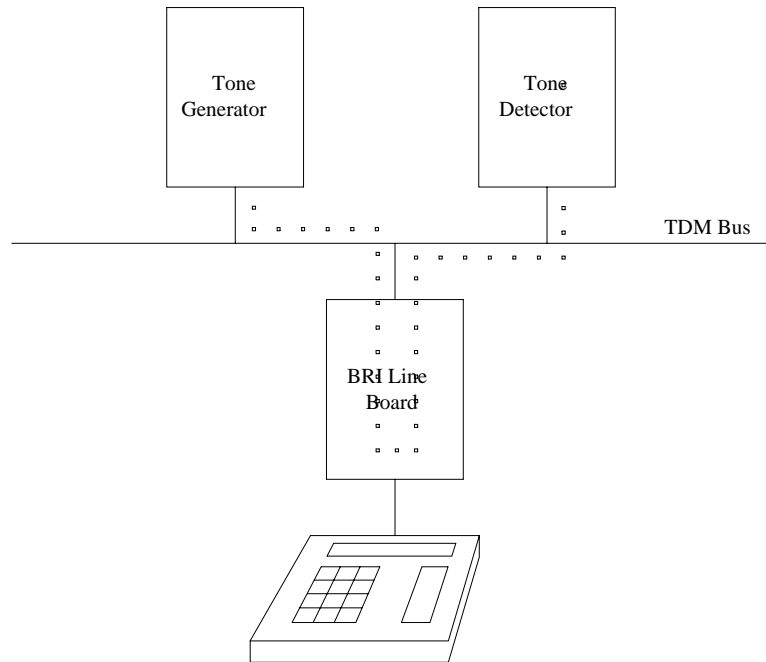
Figure 35: Path of the BRI Port Local TDM Loop Around

The dotted lines in [Figure 35: Path of the BRI Port Local TDM Loop Around](#) on page 696 show how a Loop Around test is performed for the B channels. The figure shows a terminal connected to a BRI line board using a TN556. If a TN2198 is used the terminal would be connected to a NT1, and the NT1 to the BRI board.

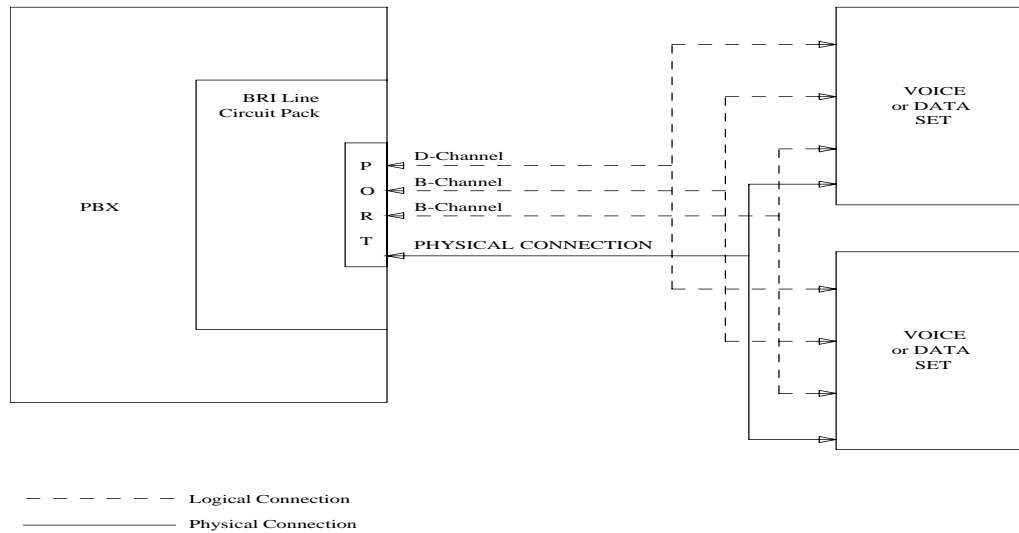
[Figure 36: ISDN-BRI Set Interactions](#) on page 710 illustrates the physical connection (solid line) between an ISDN-BRI circuit pack and a voice or voice/data set. Each physical connection allows for two B channels, as stated above, plus one D channel. Each ISDN-BRI circuit pack can support up to 12 of these PHYSICAL connections to different voice and voice/data sets or ASAI and Avaya adjuncts.

Figure 36: ISDN-BRI Set Interactions

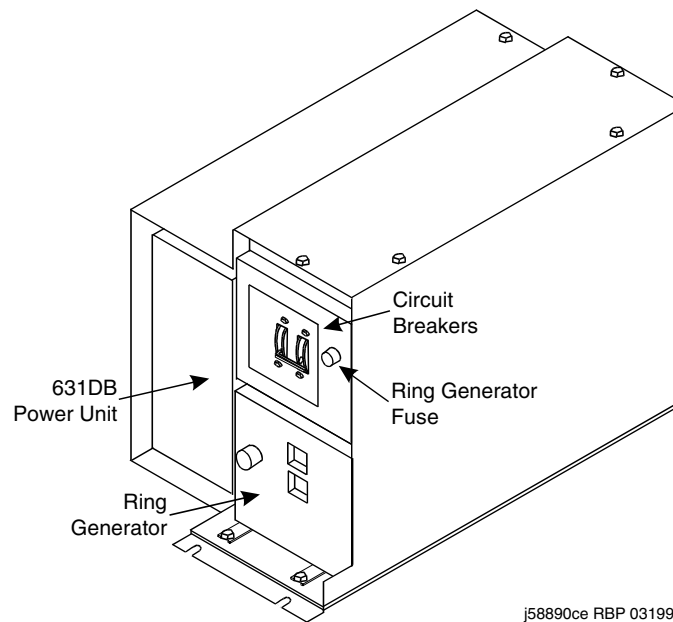
[Figure 37: AC Power-Distribution Unit \(J58890CE-2\): Front](#) on page 772 shows an AC power-distribution unit (List 9 or List 10). This unit sits at the bottom of some multicarrier cabinets.

Figure 37: AC Power-Distribution Unit (J58890CE-2): Front

The AC power-distribution unit contains the following components:

- Circuit breaker
- Electromagnetic Interference (EMI) filter
- Ring generator
- AC input fuse
- 20-Amp fuses
- Signal connector
- -48 VDC fan power

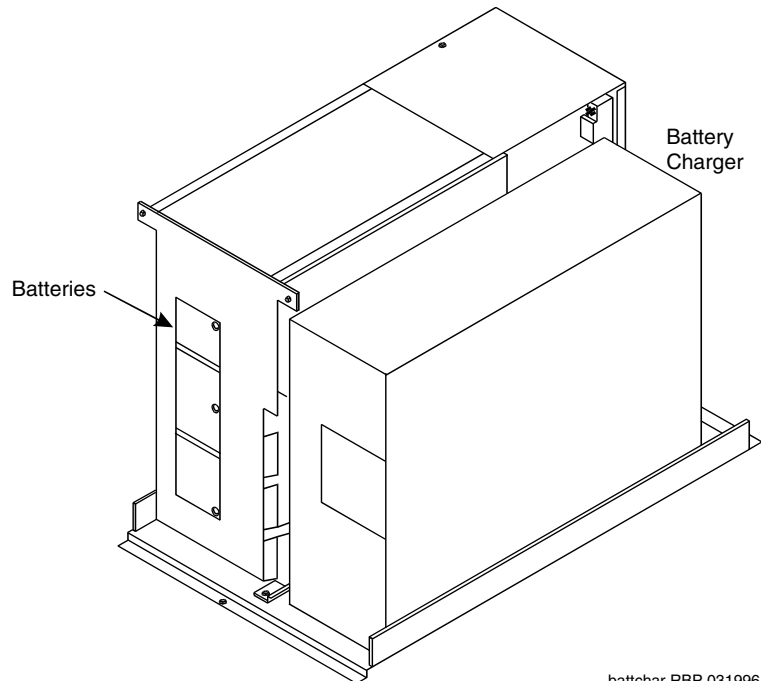
The optional battery charger (List 11) sits at the bottom of some multicarrier cabinets. See [Figure 38: Battery Charger \(Optional Part of J58890CE-2\): Front](#) on page 773.

Figure 38: Battery Charger (Optional Part of J58890CE-2): Front

The charger is used only without an uninterruptible power supply (UPS). The charger contains:

- Three 48 VDC batteries for backup power to the cabinet
- A DC power relay to automatically switch the batteries into the power circuit if a main power failure is detected

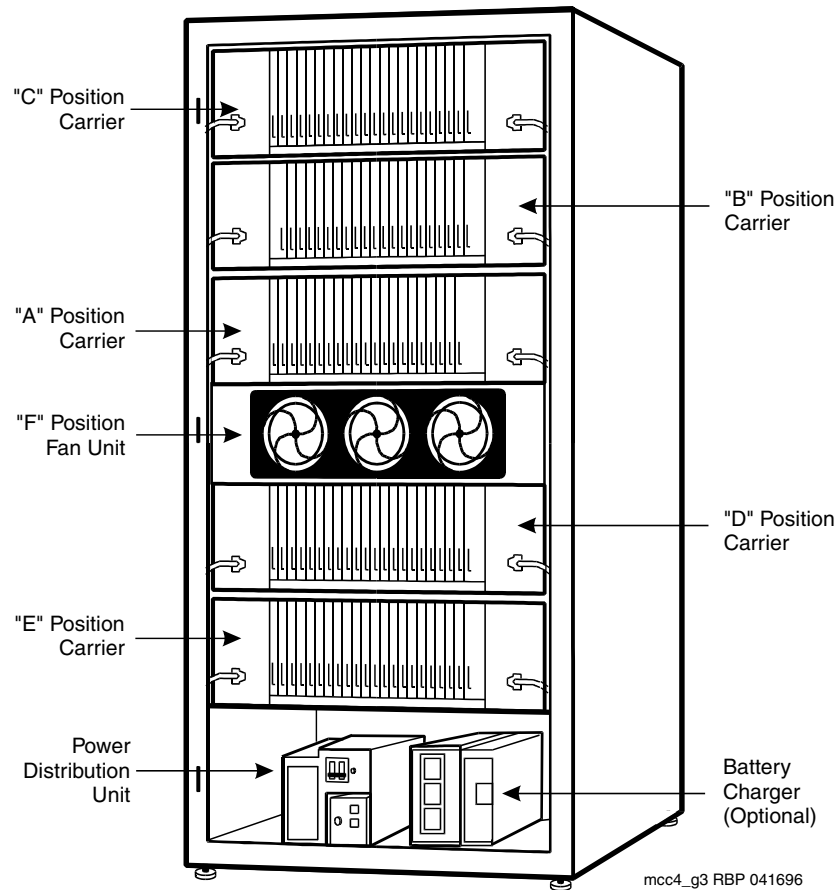
[Figure 39: AC Power Distribution in Multicarrier Cabinets](#) on page 774 shows AC power distribution in some multicarrier cabinets. The DC power-distribution cables are on both sides of the cabinet. **These cables supply power to each of the carriers.** The optional battery charger is at the right side of the power-distribution unit.

Figure 39: AC Power Distribution in Multicarrier Cabinets

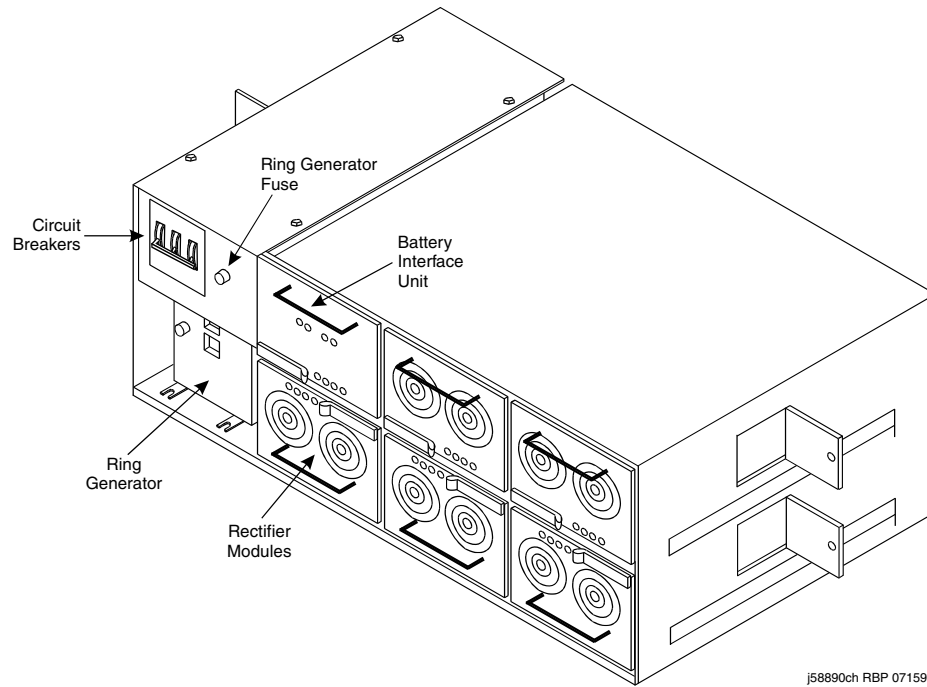
In AC-powered cabinets, the power-distribution unit (J58890CH-1), distributes 170 to 264 VAC from a wall outlet to a set of BU3200A Battery Interface Units (BIU). See [Figure 40: AC Power-Distribution Unit \(J58890CH-1\): Front](#) on page 775 and [Figure 41: Power-Distribution Unit \(J58890CH-1\)](#) on page 776.

Figure 40: AC Power-Distribution Unit (J58890CH-1): Front

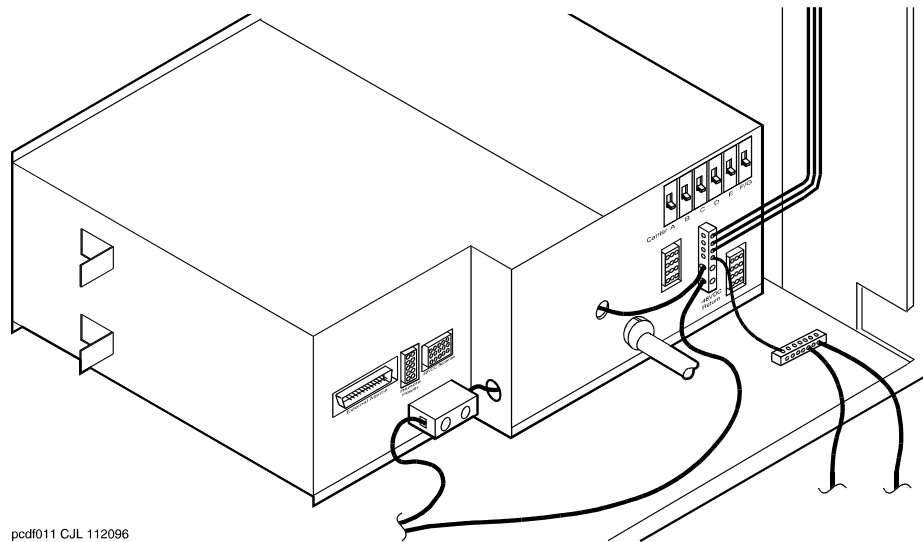
Figure 41: Power-Distribution Unit (J58890CH-1)

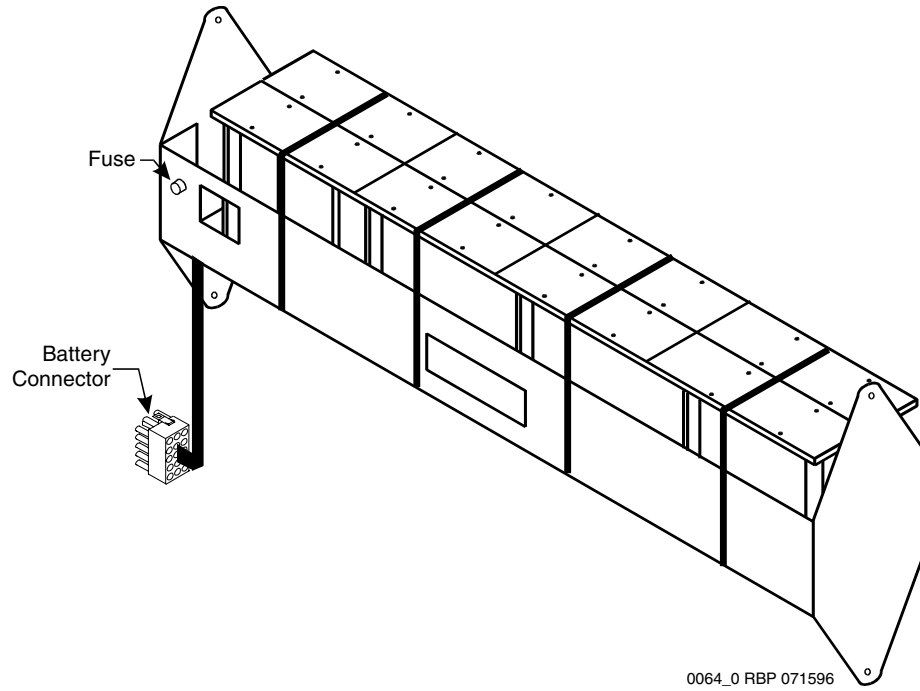
[Figure 42: Small Battery Assembly](#) on page 777 shows the small battery assembly.

Figure 42: Small Battery Assembly

The small battery is at the center rear of the multicarrier cabinet. This 8-AH (Amp Hour) battery is fused for short circuit protection and is charged by the J58890CH-1. The batteries also contain a thermal sensor that changes the charging voltage depending on battery temperature.

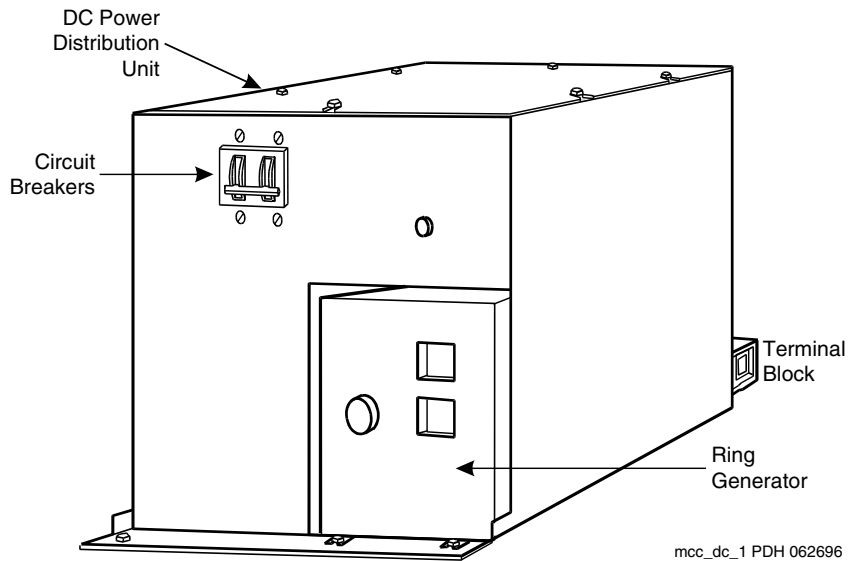
[Figure 43: DC Power-Distribution Unit \(J58890CF-2\): Front](#) on page 778 shows a power-distribution unit in some DC-powered multicarrier cabinets. The unit sits at the bottom of the cabinet and contains the ring generator, 20-Amp circuit breakers, terminal blocks, and system fan power.

Figure 43: DC Power-Distribution Unit (J58890CF-2): Front

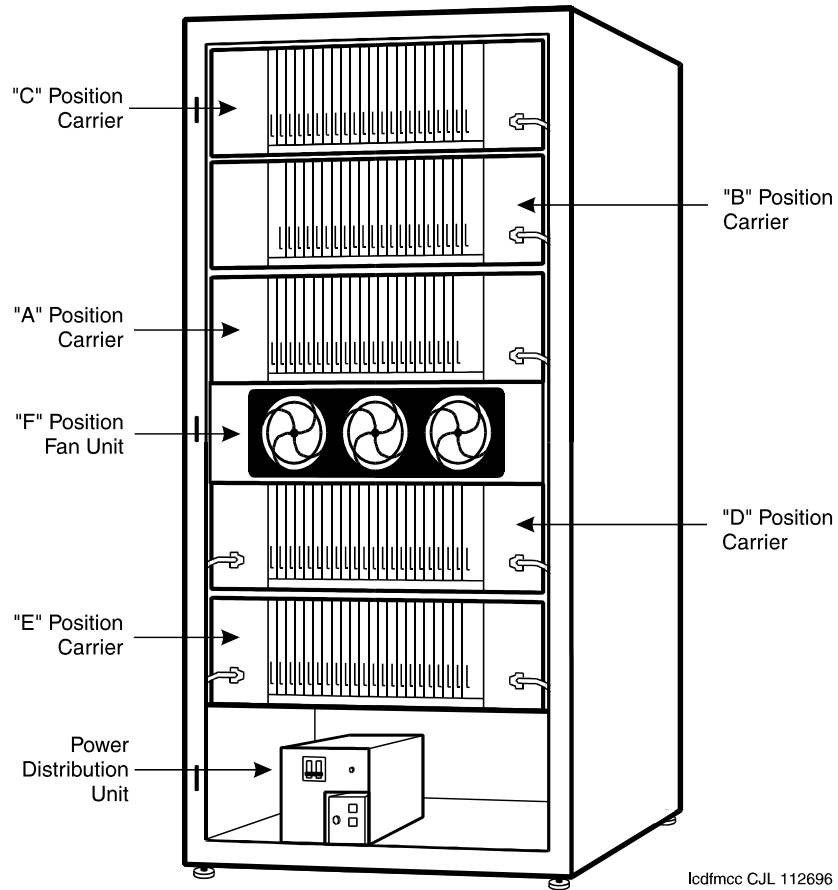
Some carriers may contain two power supplies, the 644A and the 645B, that together supply the required voltages to the carrier. Other carriers may contain one 649A power supply located on the right side of the carrier. In these systems, an additional 649A is located on the right of the optional switch node carriers.

[Figure 44: Typical Multicarrier Cabinet with 649A Power Units](#) on page 779 shows a typical AC-powered multicarrier cabinet.

Figure 44: Typical Multicarrier Cabinet with 649A Power Units

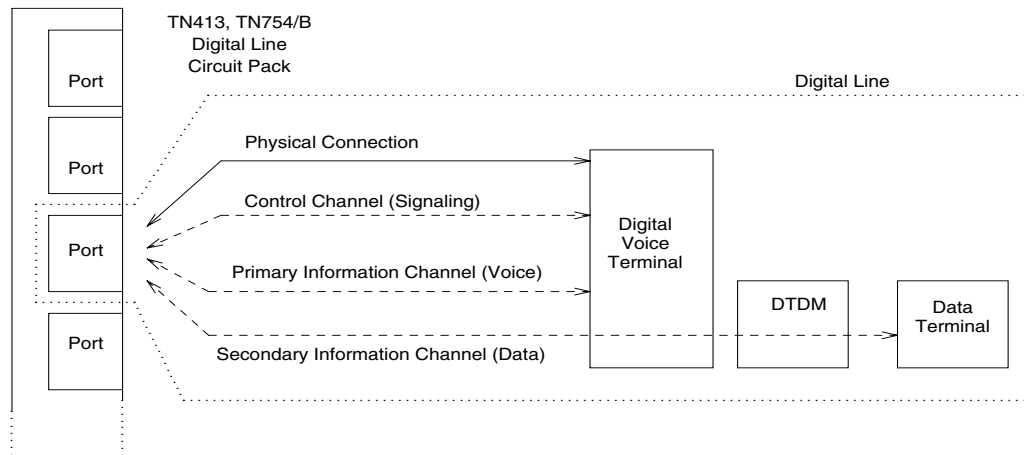
Figure 45: Digital Line Connectivity

Each digital line port supports two 64 kbps information channels (primary and secondary) and one 8kbps signaling channel. Digital voice terminals always use the primary information channel, and only one voice terminal can be connected to each port. The secondary information channel can be used to connect a data terminal via a Digital Terminal Data Module (DTDM) or a Data Adaptor (DA). All other devices currently supported by Digital Line circuit packs communicate on the primary information channel. [Figure 45: Digital Line Connectivity](#) on page 925 shows examples of digital line connectivity.

The TN2181 and TN2224B/CP support both modes as shown in [Figure 45: Digital Line Connectivity](#) on page 925 and [Figure 46: Digital Line Connections](#) on page 926.

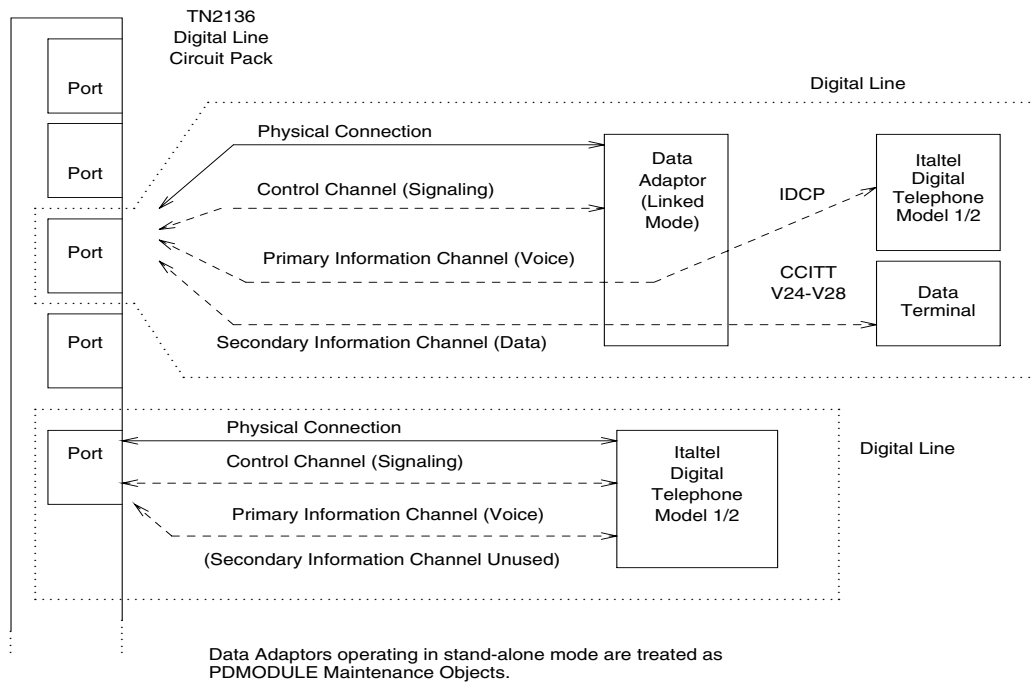
Figure 46: Digital Line Connections

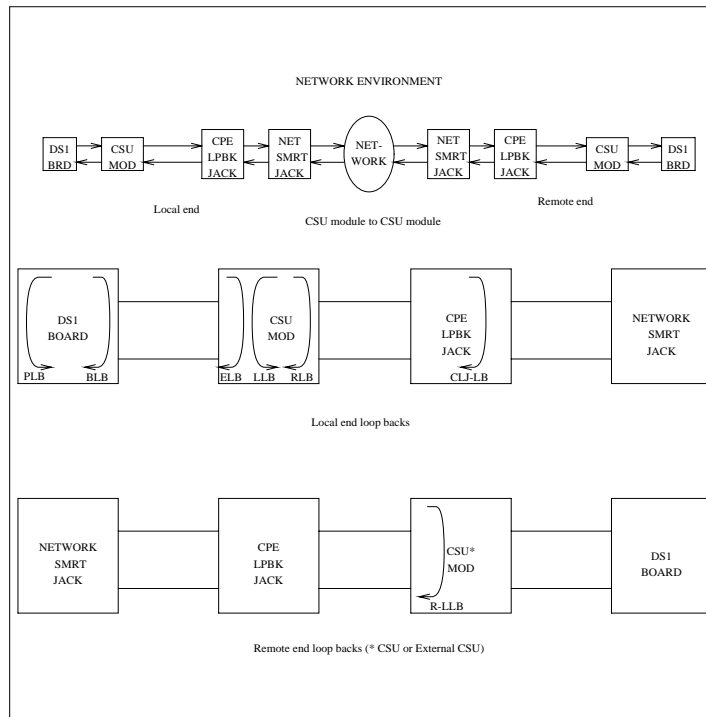
Figure 49: High-Level Overview Of Loop-Back Points

These loop-back tests are explained in detail later in this DS1-BD section, but [Figure 49: High-Level Overview Of Loop-Back Points](#) on page 980 gives a high-level overview of the loop-back points.

The following list of acronym definitions are for [Figure 49: High-Level Overview Of Loop-Back Points](#) on page 980:

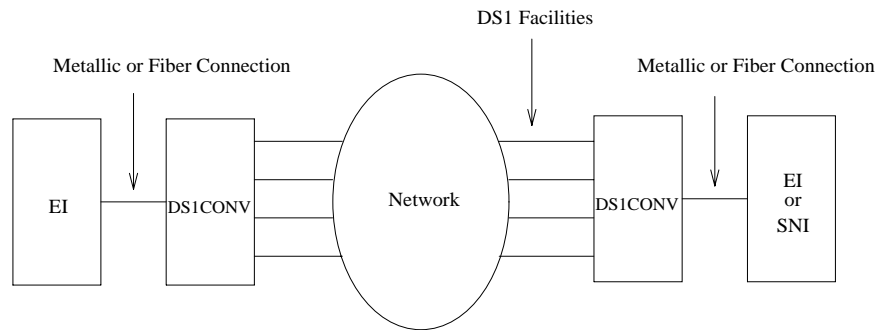
DS1 converter circuit packs are connected to the Expansion Interface (EI) circuit packs (TN570) and the Switch Node Interface (SNI) circuit packs (TN573) as shown in [Figure 50: DS1 Converter Complex and the DS1 Facilities](#) on page 1054.

Figure 50: DS1 Converter Complex and the DS1 Facilities

The DS1 converter complex can replace fiber links between two EIs and fiber links between an PN's EI and an SNI. Fiber links between two SNIs and fiber links between the and the Center Stage Switch (CSS) cannot be replaced by a DS1 converter complex.
