Maintenance Alarms for Avaya Communication Manager 3.0, Media Gateways and Servers

03-300430
Issue 1
June 2005

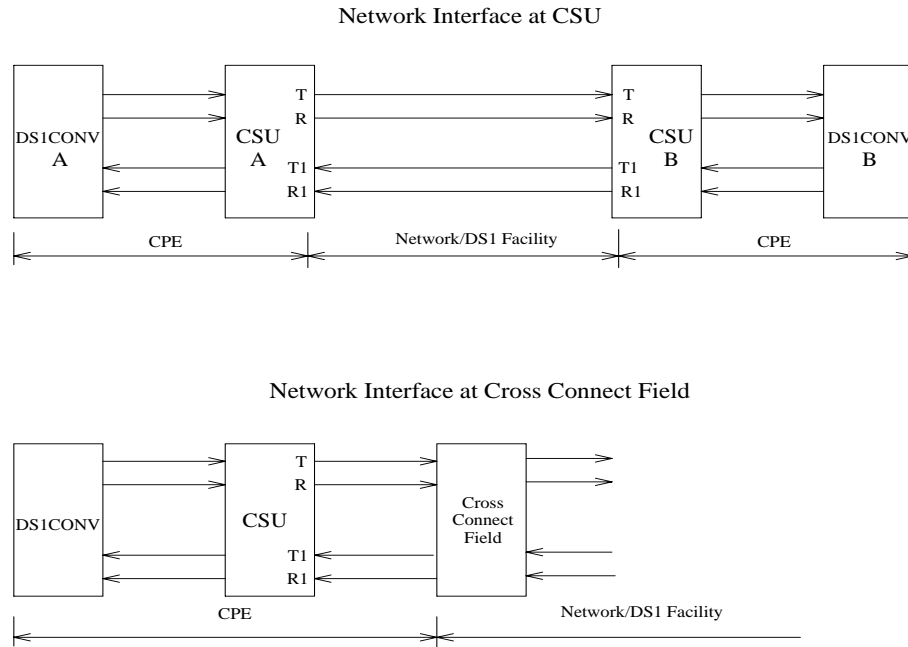
Figure 51: DS1 Facility Connections

For the following repair procedure, see to [Figure 51: DS1 Facility Connections](#) on page 1068 and the diagrams in the related test descriptions.

For the following repair procedure, see [Figure 51: DS1 Facility Connections](#) on page 1068 and the diagrams in the related test descriptions.

1. Check the loop-back LEDs on both CSU A and CSU B as shown in [Figure 51: DS1 Facility Connections](#) on page 1068 to see if a CSU is in a loop-back mode. Also check to see if the CSUs have been manually hard-wired into a loop-back mode. Remove detected loop backs.

To isolate a problem, set the loop back first at the loop-back point LB 1, and then at the loop-back point LB 2, see [Figure 54: Loopback Points for Test #799](#) on page 1074 and [Figure 51: DS1 Facility Connections](#) on page 1068. Place the loop backs at as many points as your CSU capabilities will allow. Hard-wired loop backs at the far end are not desirable, because the equalization-level adjustments may cause problems.

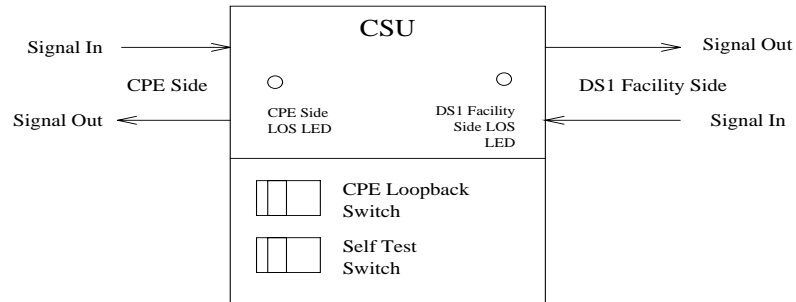
Figure 52: Typical CSU Maintenance Capabilities

Fault isolation for this problem may be different depending on the capabilities of the CSU device that is being used. Typically, CSUs provides an LED that is useful for fault isolation (see [Figure 52: Typical CSU Maintenance Capabilities](#) on page 1068). This is the “16 Zeros” LED. This LED is momentarily lit when a string of 16 consecutive zeros is detected in the DS1 signal from the DS1 converter. Zeros on a DS1 link are represented by an absence of a pulse. Thus, an active 16 Zeros LED indicates a LOS alarm from the DS1 converter.

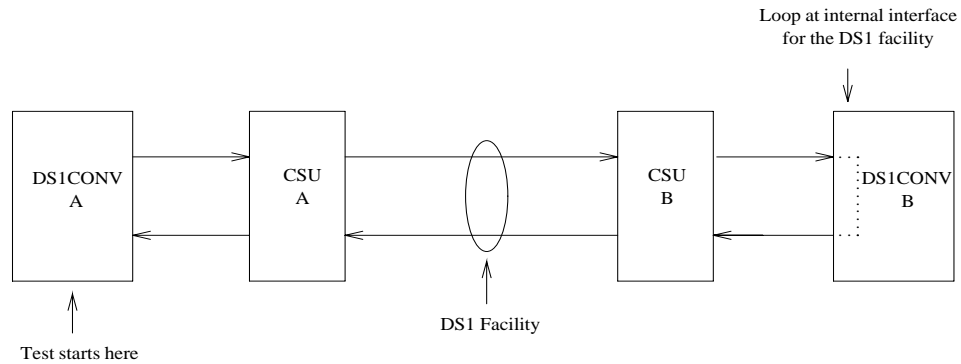
Figure 53: Far-End Internal Loop-Back Test (#797)

If the test passes on a TN1654 DS1 facility, the *round trip delay time* appears in milliseconds in the `Error Code` field. The round trip delay time is the length of time in milliseconds it takes for the firmware to receive the test pattern after it has been sent.

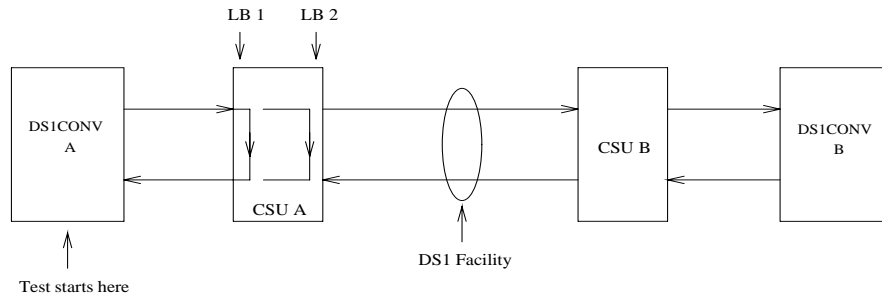
Figure 54: Loopback Points for Test #799

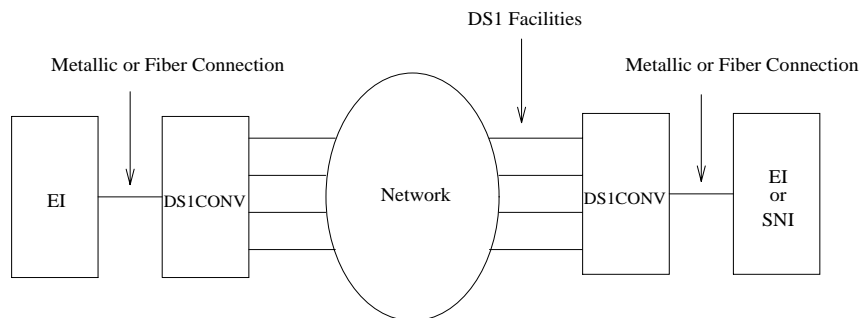
Figure 55: DS1 converter connection to EIs and SNIs

DS1 converter circuit packs connect to TN570 Expansion Interface (EI) circuit packs and TN573 Switch Node Interface (SNI) circuit packs via metallic cables as shown in [Figure 55: DS1 converter connection to EIs and SNIs](#) on page 1078. A fiber link cable can be used instead of the metallic cable if it is necessary to locate the DS1 converter far from the connected EI or SNI circuit pack, for example, in an adjacent cabinet.

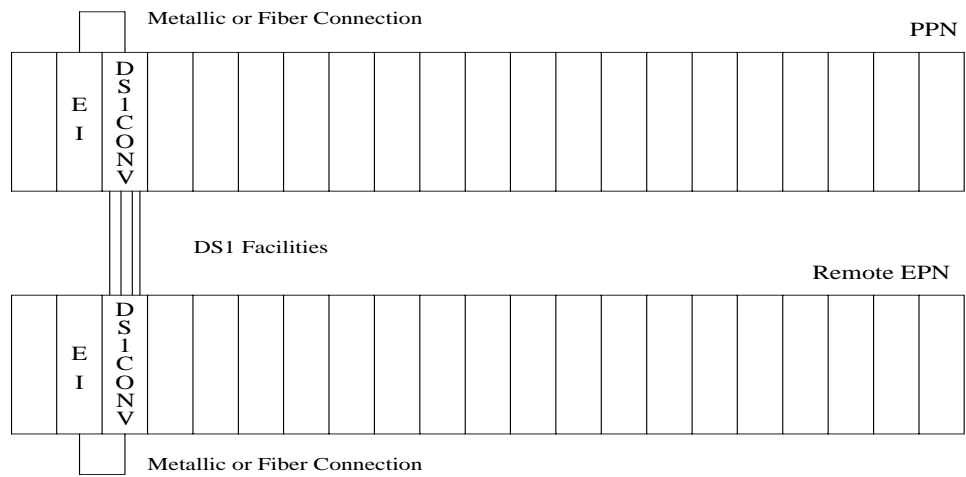
Figure 56: DS1 converter Complex in Direct Connect PNC

[Figure 56: DS1 converter Complex in Direct Connect PNC](#) on page 1079 and [Figure 57: DS1 Converter Complex in Duplicated PNC with 1 SN](#) on page 1080 show DS1 converter connections in a direct-connect PNC configuration and between the CSS and an PN in a critical-reliability system configuration (duplicated PNC).

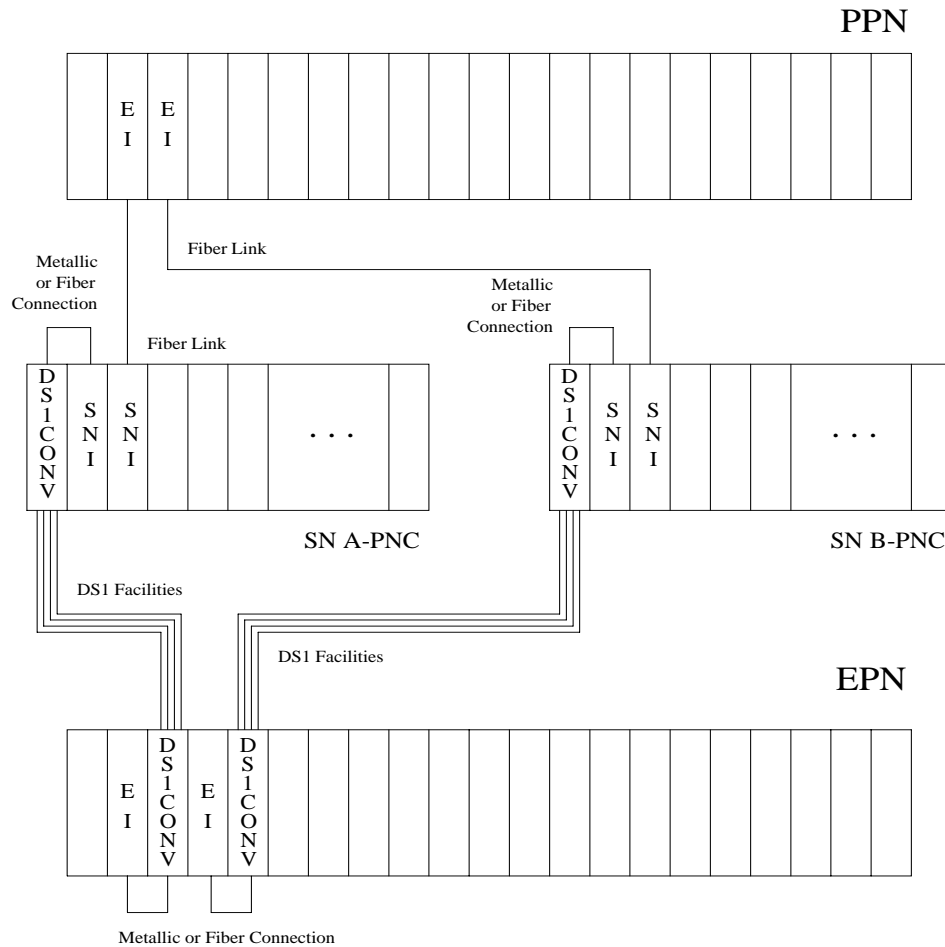
Figure 57: DS1 Converter Complex in Duplicated PNC with 1 SN

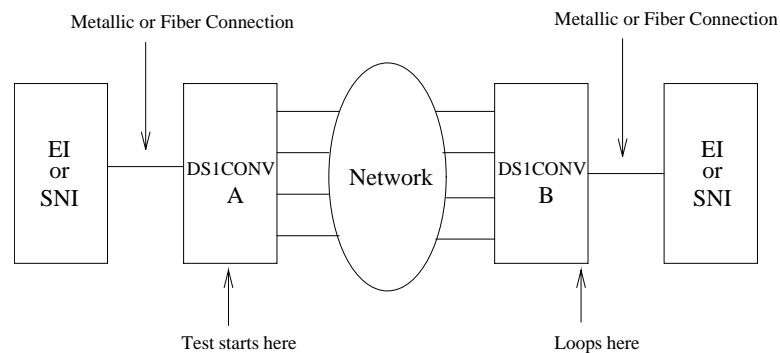
Figure 58: Far-End DS1 Converter Loop-Back Test (#788)

This test starts at the DS1 converter circuit pack whose equipment location was entered, and loops all fiber time slots at the far edge Fiber Optic Interface of the DS1 converter circuit pack at the other end of the DS1 converter complex. See [Figure 58: Far-End DS1 Converter Loop-Back Test \(#788\)](#) on page 1103.

For a standard-, duplex-, or high-reliability system (no PNC duplication), this test can only be executed at the endpoint that is closer to the media server relative to the neighbor DS1 converter circuit pack, because of its impacts on the system control links. The completion of the test is delayed in this configuration to wait for the recovery of the system control links. For a critical-reliability system (PNC duplication), test can be executed at any DS1 converter circuit pack.

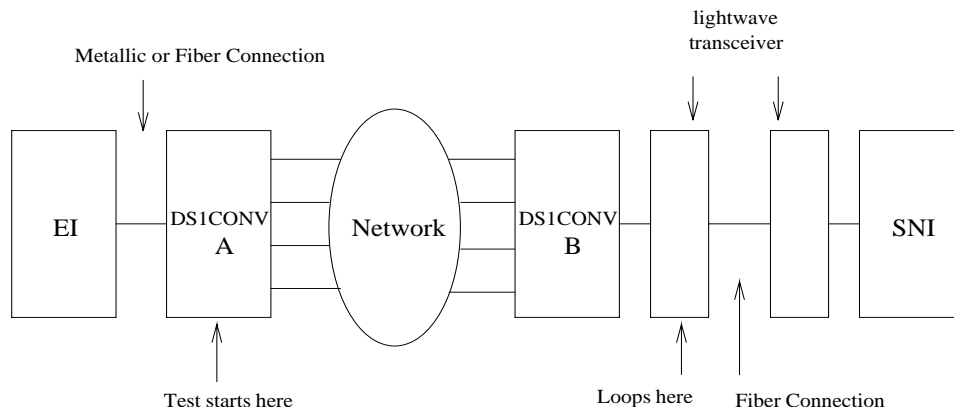
Figure 59: Far-End Lightwave Transceiver Loop-Back Test

For a standard-, duplex-, or high-reliability system (no PNC duplication), this test can only be executed at the endpoint that is closer to the media server relative to the neighbor DS1 converter circuit pack because of its impacts on the system control links, also the completion of the test will be delayed in this configuration to wait for the recovery of the system control links. For a critical-reliability system (PNC duplication), the test can be executed at any DS1 converter circuit pack.

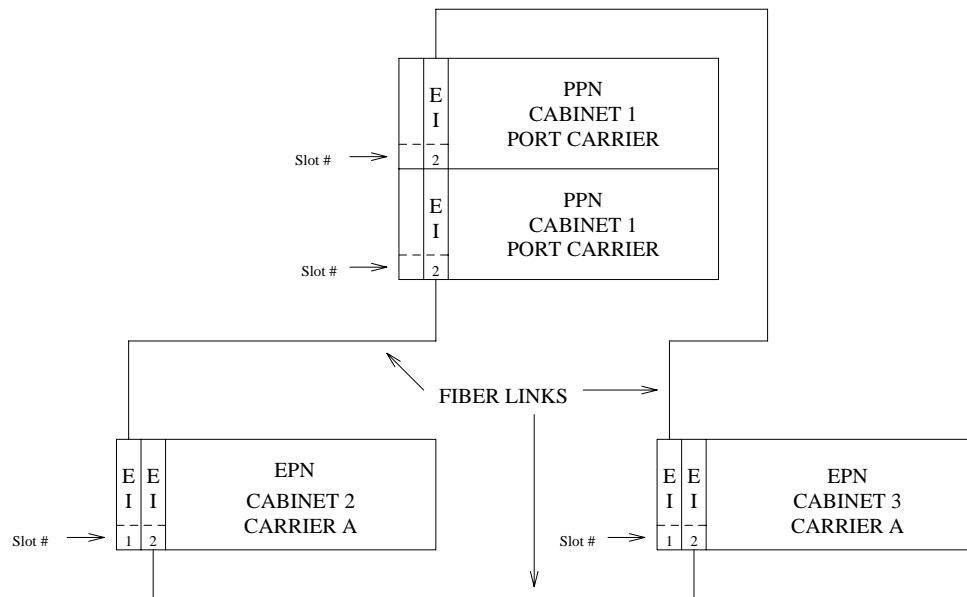
[Figure 61](#) shows the location of the EI circuit packs in a typical unduplicated PNC, direct connect configuration.

Figure 61: Direct Connect Configuration with Unduplicated PNC

Each PN in a direct-connect configuration must be connected to the other PNs through a fiber link. Each PN has one EI that functions as an Archangel. This EI must be connected with fiber to an EI. If an EI is functioning as an Archangel (bus master), its amber LED will be flashing at a rate of 2 seconds on and 200 ms off.

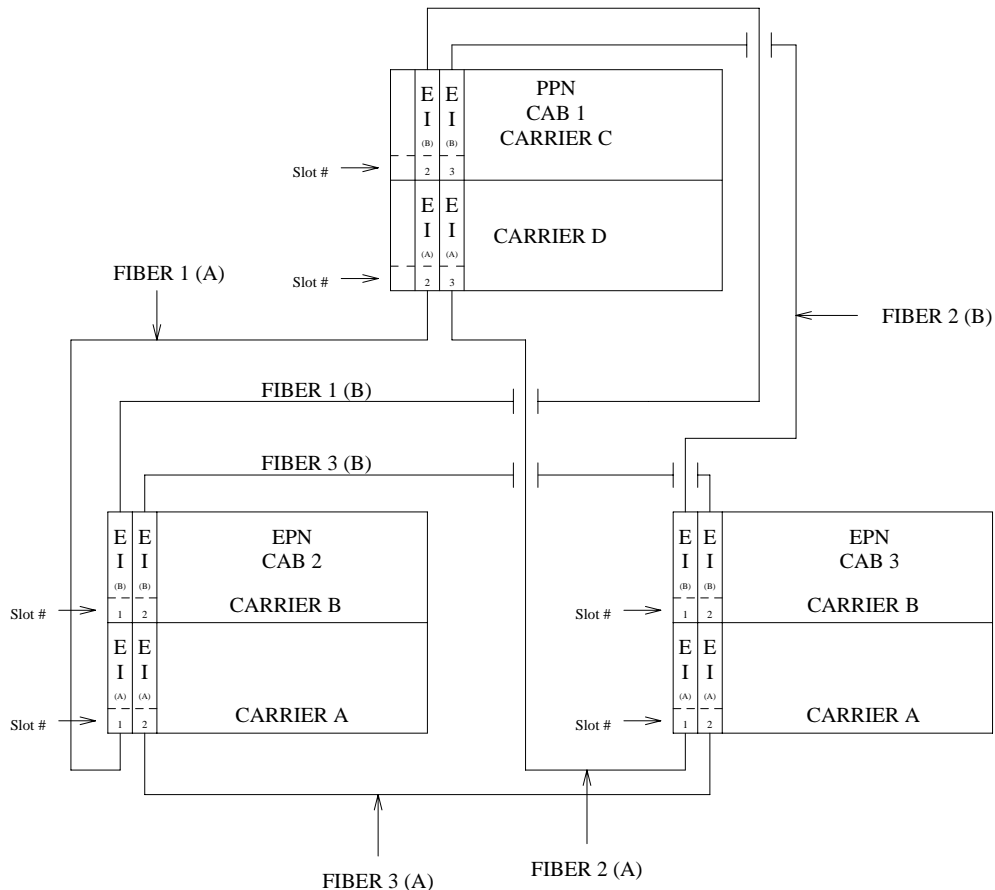
[Figure 62](#) shows the location of EI circuit packs in a typical duplicated PNC, direct-connect configuration.

Figure 62: Direct Connect Configuration with Duplicated PNC

In a duplicated PNC there is an A-side and a B-side PNC. Every EI in this diagram is labeled with an A or a B designating to which PNC it belongs. Note that a PNC's designation (A or B) does not relate directly to the carrier where its EIS reside. Again, only one of a PN's EIs can function as the Archangel (TDM-bus master). A PN's EI that is:

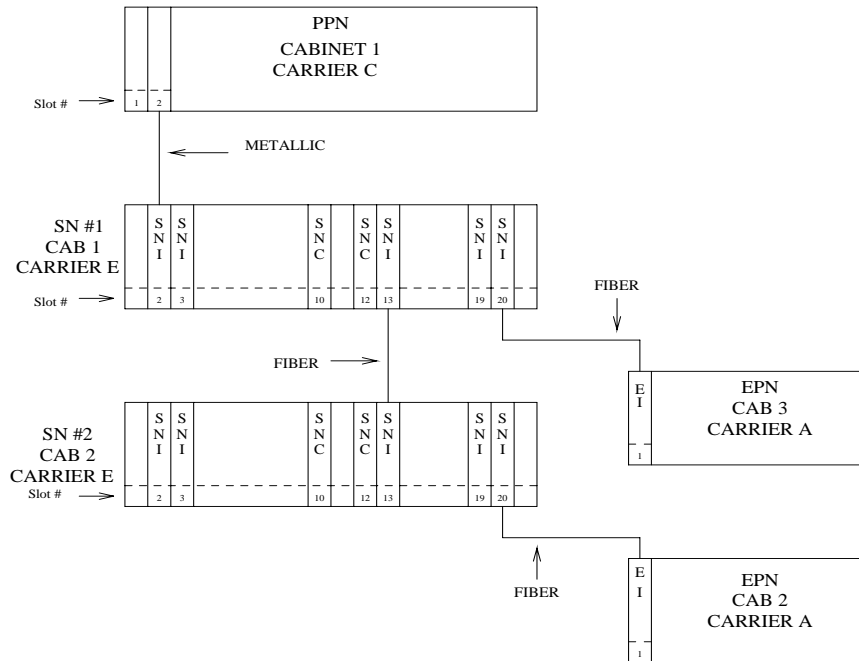
Figure 63 shows the location of EIs in a typical center stage switch configuration with unduplicated PNC.

Figure 63: Center Stage Switch Configuration with Unduplicated PNC

For an unduplicated center stage switch configuration, only one EI is needed in each PN. Notice that there is no direct connection between the PNs, rather every inter-PN connection is made through the center stage switch. Each SNI in the switch node carriers can be connected to a PN through an EI circuit pack.

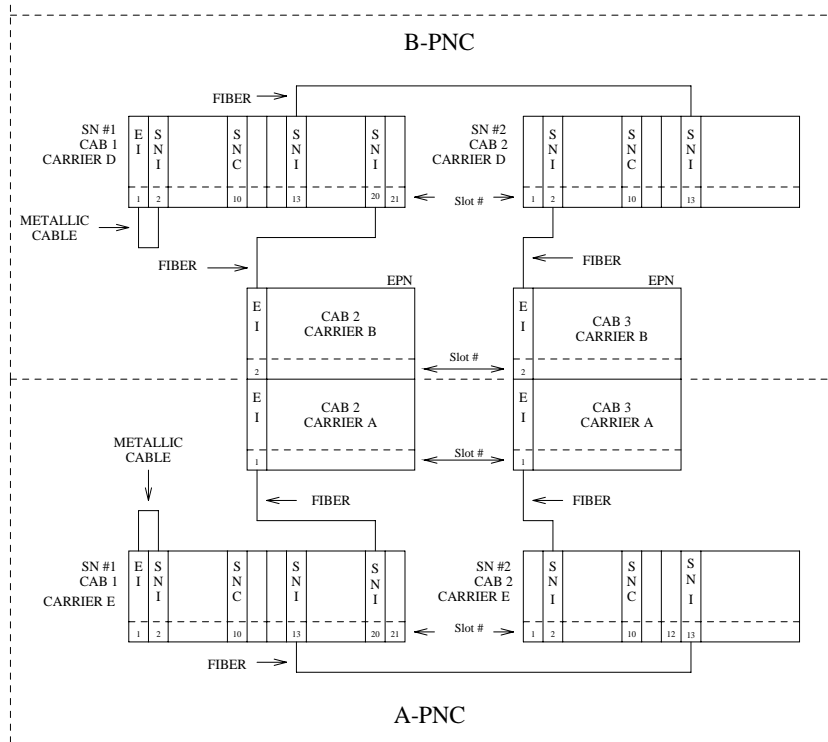
Figure 64: Center Stage Switch Configuration with Duplicated PNC

Figure 64: [Center Stage Switch Configuration with Duplicated PNC](#) on page 1180 shows the location of EIs in a typical two Switch Node Center Stage Switch configuration with duplicated PNC.

In a duplicated center stage switch configuration, two EIs are needed in each PN. One resides in the PNC's A side and one in the B side. Note that a PNC designation (A or B) does not directly designate the carrier where an EI resides. The active PNC's EI is the one acting as the PN's Archangel (TDM bus master). This EI's amber LED should be blinking at a rate of 2 seconds on and 200 ms off. Whereas, the amber LED on standby PNC's EI should be off.

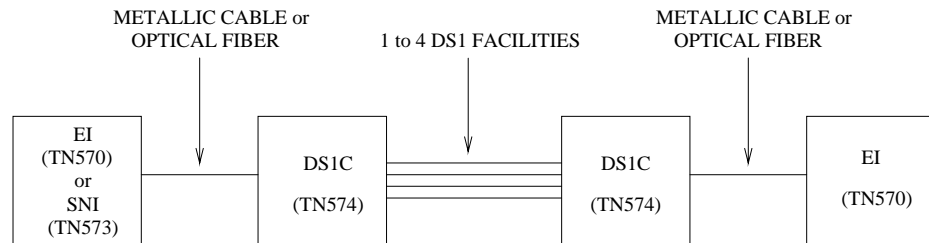
Figure 65: Fiber Link with DS1 Converter Complex

A PN (and thus, the EIs contained within it) can be remoted via a DS1 Converter complex. This requires that a fiber link (providing connectivity to the remoted PN) be administered with an associated DS1 Converter complex. This complex consists of two TN574 DS1 Converter (DS1C-BD) circuit packs connected by from 1 to 4 DS1 facilities. [Figure 65: Fiber Link with DS1 Converter Complex](#) on page 1181 shows where the DS1 converter complex fits into an EI-to-SNI or EI-to-EI fiber link. For more information, see [DS1C-BD](#) on page 1077.

A PN-to-PN connection can be extended through a DS1 converter complex. (See [Figure 65: Fiber Link with DS1 Converter Complex](#) on page 1181). When discussing problems that may be related to fiber links, the DS1 converter is considered part of the fiber link. If diagnosis of the problem points to fiber connectivity and a DS1 converter circuit pack is part of the connectivity, problems with the DS1 converter circuit pack should be investigated (see [DS1C-BD](#) on page 1077). The DS1 converter circuit pack enters into diagnostics for the EI circuit pack via such tests as the Neighbor Query test (#237), the Fiber Out-of-Frame test (#238), the Two-Way Transmission test (#241), and the Packet Transmission test (#589).

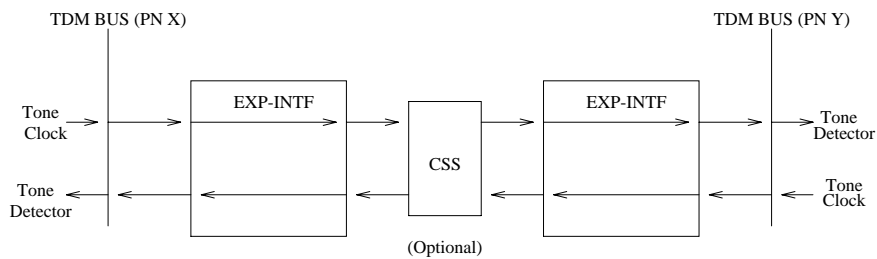
Figure 67: Two-Way Circuit Switch Transmission Test

The path used in this test is represented in [Figure 67: Two-Way Circuit Switch Transmission Test](#).

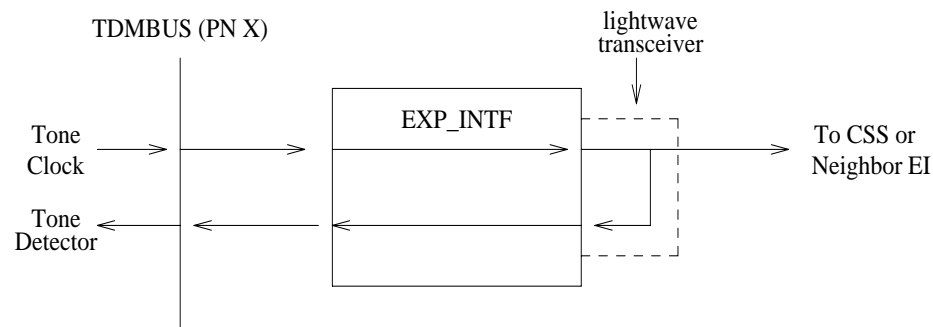
Figure 68: TDM BUS Lightwave Transceiver Looparound

This is a 2-part connectivity test. In the first part of the test, a digital count is transmitted from the cabinet of the EI circuit pack under test, through the EI circuit pack under test, out to its lightwave transceiver. The connection then loops back into the lightwave transceiver, through the same EI circuit pack again, and into the originating cabinet. If the test tone is detected by a tone detector, the first part of the test passes. The path used for this part of the test is represented in [Figure 68: TDM BUS Lightwave Transceiver Looparound](#) on page 1211.

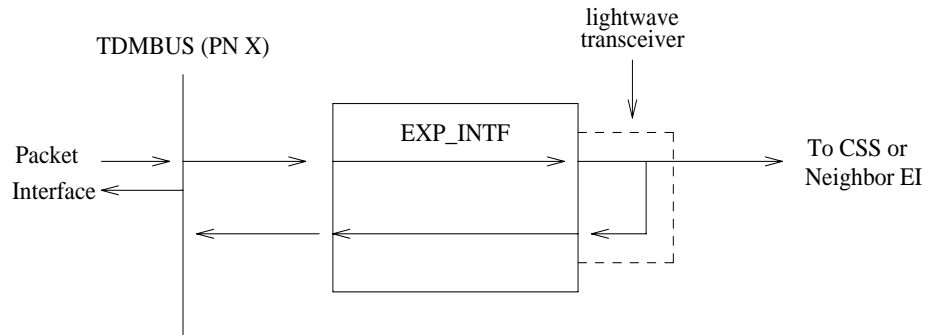
Figure 69: Packet Bus Lightwave Transceiver Looparound—PN only

In the second part of the test, a data packet is sent from the TN1655 Packet Interface circuit pack to the EI circuit pack under test, the packet is looped back through the lightwave transceiver and is sent back to the Packet Interface circuit pack. If the Packet Interface circuit pack receives the same packet it transmitted, the second part of the test passes. If the entire test has passed, the EI circuit pack, its backplane wiring, and the electrical portion of the lightwave transceiver are healthy. The path used for this test is represented in [Figure 69: Packet Bus Lightwave Transceiver Looparound—PN only](#) on page 1212. The path used for this test if the EI resides in a PN is represented in [Figure 70: Packet Bus Lightwave Transceiver Looparound—CSS and PN](#) on page 1212.

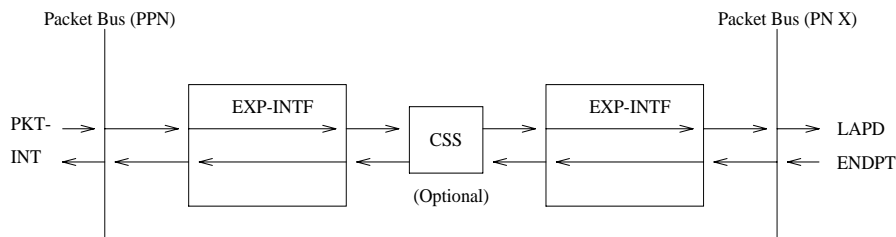
Figure 71: Expansion Interface Packet Interface Test—Packet Endpoint Loop

The path shown in [Figure 71: Expansion Interface Packet Interface Test—Packet Endpoint Loop](#) on page 1222 is used when testing a PN EI that is on the active PNC.

This test is nondestructive. This test attempts to send a data packet from the TN1655 Packet Interface circuit pack through any intervening EI circuit packs and/or SNI circuit packs and through the EI circuit pack to be tested. The path the data packet takes is dependent on the location of the EI circuit pack to be tested and whether the system has duplicated PNC. The following diagrams and short discussion of each describe the different paths the test uses.

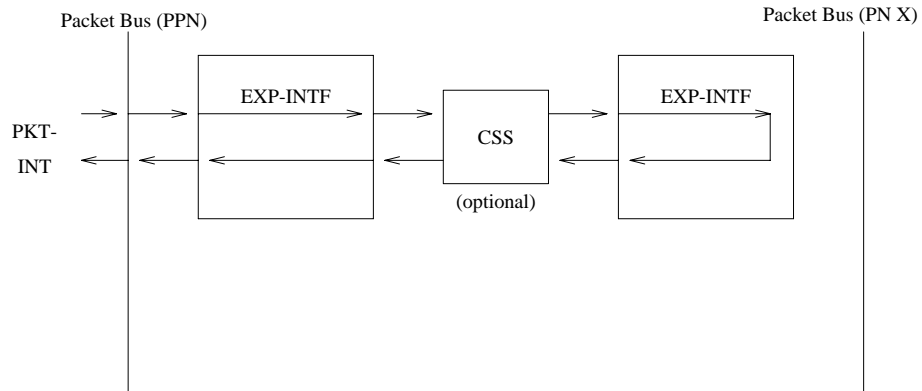
Figure 72: Expansion Interface Packet Interface Test, PN-to-PN loop

In a Center Stage configuration the path shown in [Figure 72: Expansion Interface Packet Interface Test, PN-to-PN loop](#) on page 1223 is used when testing a PN EI that is on the standby PNC. In a Direct Connect configuration, this path is used on any PN EI or on a PN EI that is on the standby PNC.

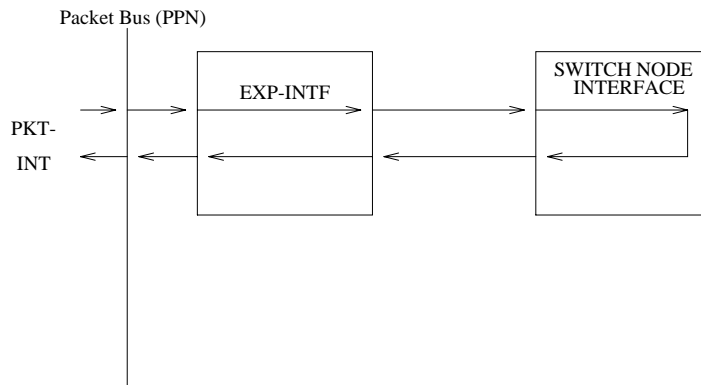
Figure 73: Expansion Interface Packet Interface Test—PN to CSS Loop

The path shown in [Figure 73: Expansion Interface Packet Interface Test—PN to CSS Loop](#) on page 1223 is used when running the test on a PN EI in a Center Stage configuration.

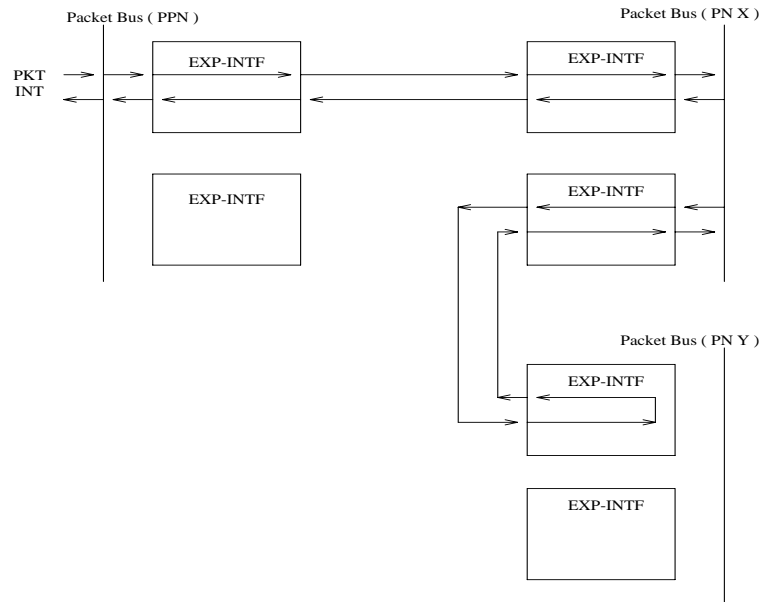
Figure 74: Expansion Interface Packet Interface Test, PN-to-PN link

The path shown in [Figure 74](#) is used when the EI under test is one that provides connectivity between the two PNs in a Direct Connect configuration.

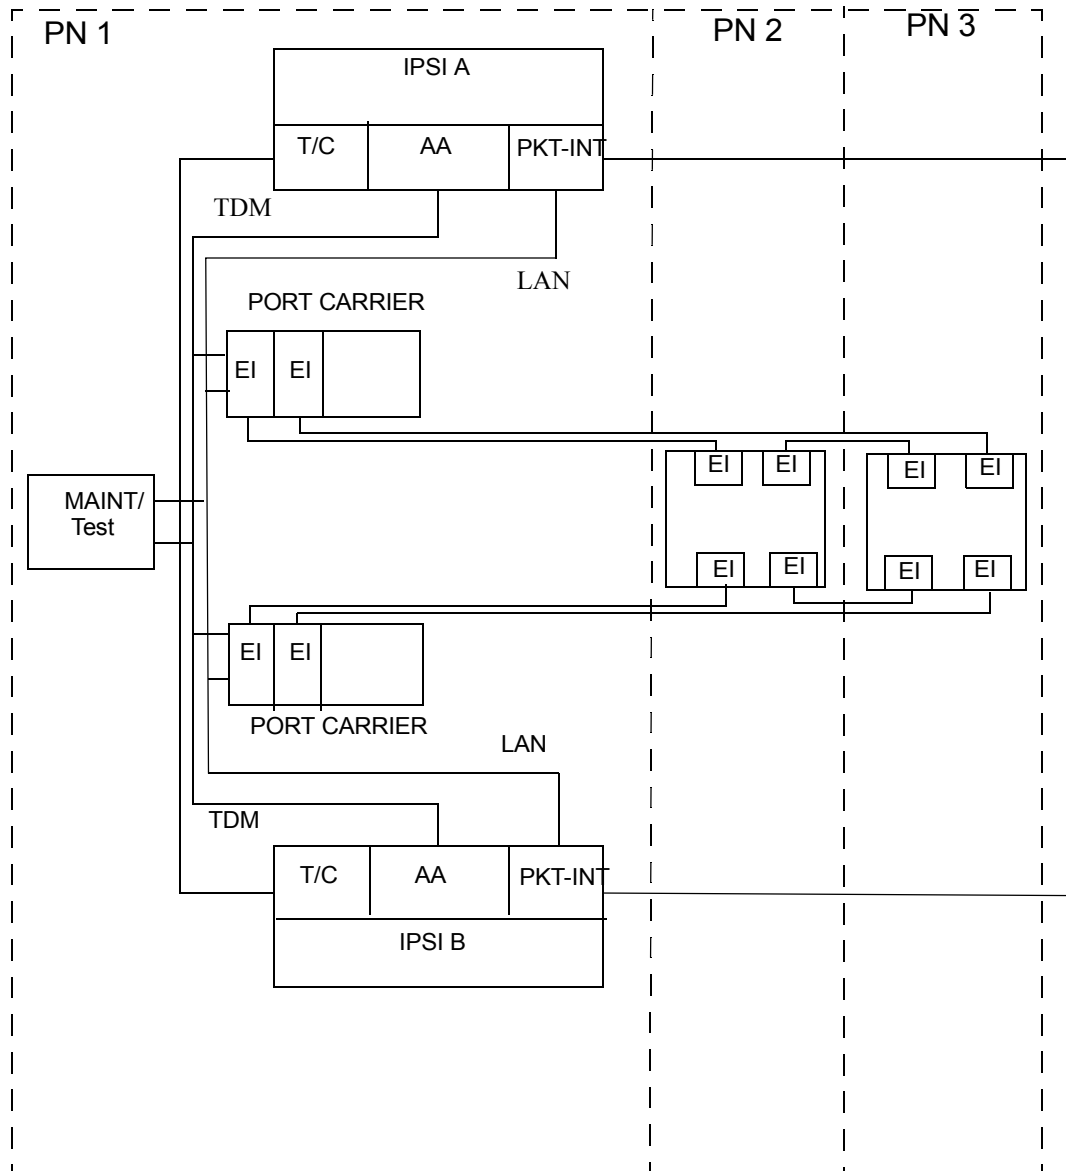
Figure 76: Duplicated IPSI Duplicated Direct Connect PNC Connectivity

[Figure 76](#) shows a critical-reliability system with duplicated IPSIs and directly connected PNCs.

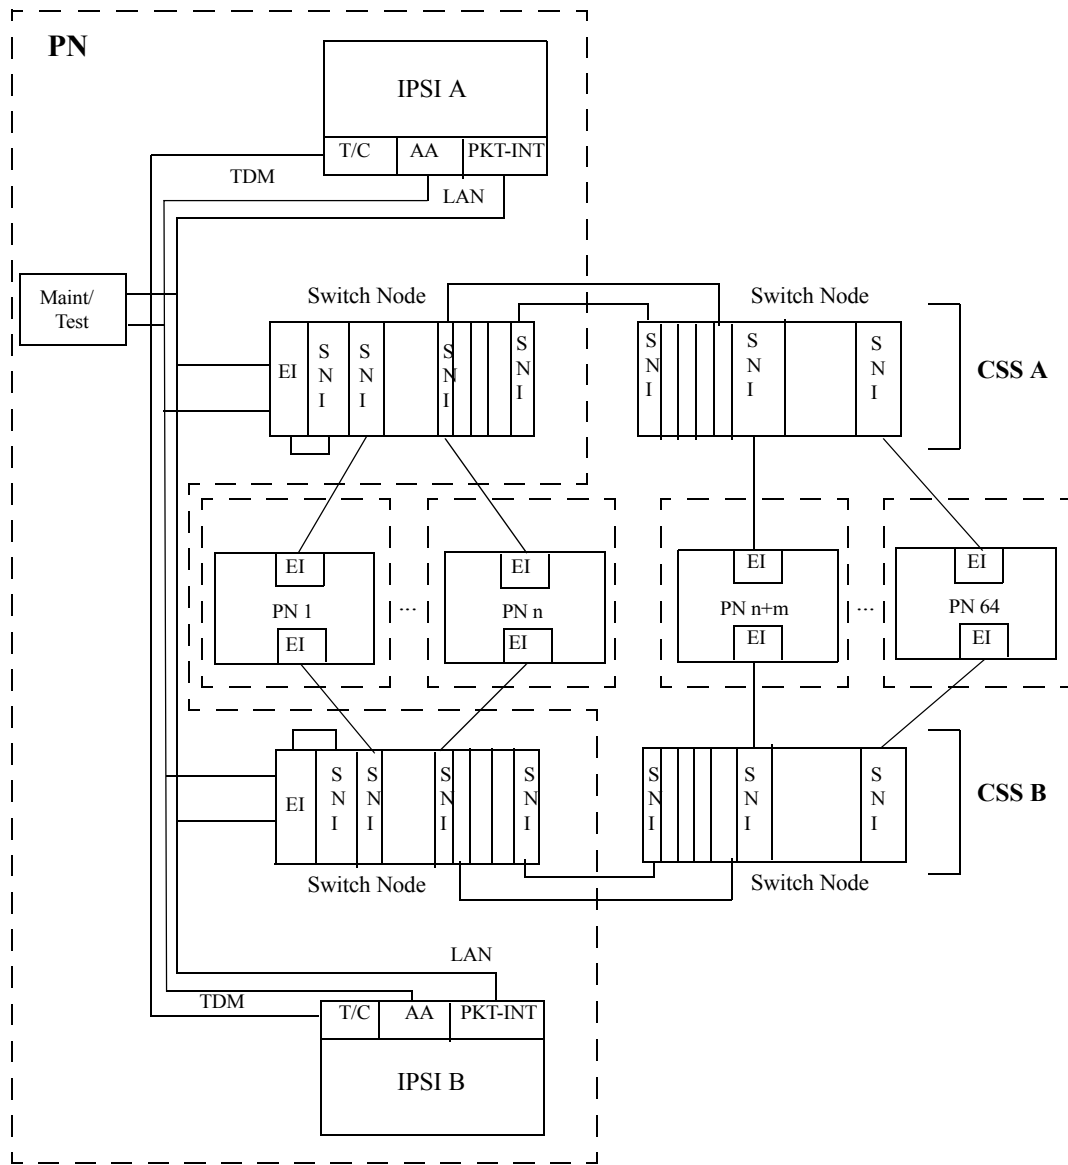
Figure 77: Duplicated IPSI Duplicated PNC with Center Stage Switch Connectivity

[Figure 77: Duplicated IPSI Duplicated PNC with Center Stage Switch Connectivity](#) on page 1409 shows a critical-reliability system with duplicated IPSIs and CSS-connected PNCs.

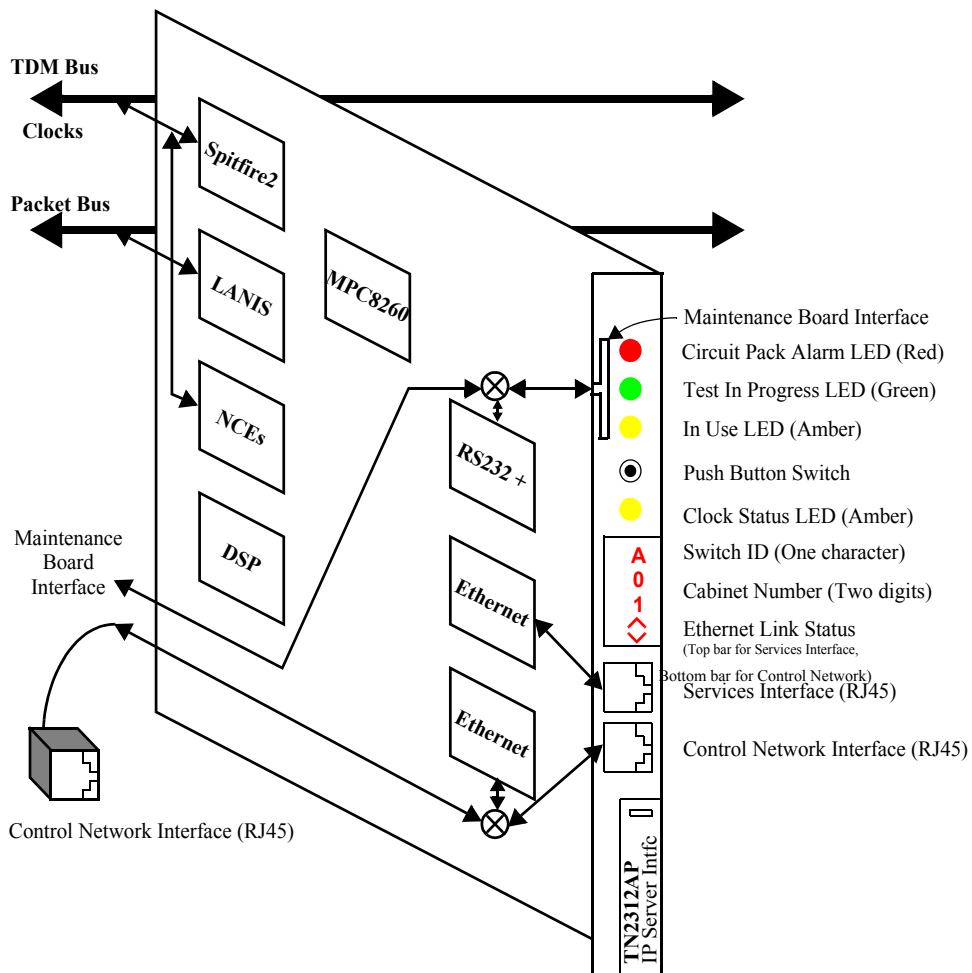
Figure 78: TN2312AP IPSI

The faceplate view of the TN2312AP IPSI is shown in [Figure 78: TN2312AP IPSI](#) on page 1416 and described in the following sections.

This is a 10/100 BaseT Ethernet interface used to connect to the Control network. This interface is available through the backplane I/O as well as through the faceplate. When the IPSI I/O adapter is plugged onto the Amphenol connector, located on the rear of the carrier, the backplane connections will be selected, otherwise, connectivity to the faceplate will be selected. For the PN control carriers, the backplane connections are available only when the new PN control carriers are used.

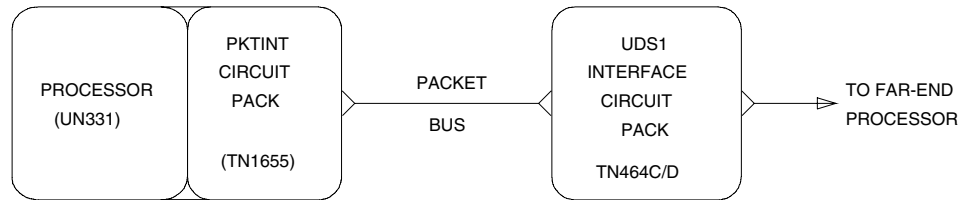
Figure 79: Remote Layer 3 Query Test (#637)

Tests #639 and #636 check the health of the D channels and DS1/UDS1 Interface circuit packs or MM710 DS1 Interface Media Module. As shown in [Figure 79](#), this test goes one step further by checking the communication path from the processor, through the TDM/packet bus and DS1/UDS1 Interface circuit pack, or through the MM710 Media Module, and on to the far-end switch or terminal adapter. A special ISDN message is sent to the far-end switch or terminal adapter, which must respond within a specified amount of time. This test is designed to ensure that the communication path between the switch and the far end is up and operational, and that the two endpoints can properly exchange ISDN control messages.

For systems supporting circuit packs (S8700, S8500) [Figure 79](#) illustrates a UDS1 Interface circuit pack located in the PN. When the UDS1 board resides in a PN, there is additional PNC hardware connecting the packet buses of the IPSI PN and PN. Examples of such hardware are the Center Stage Switch and fiber-optic cables.

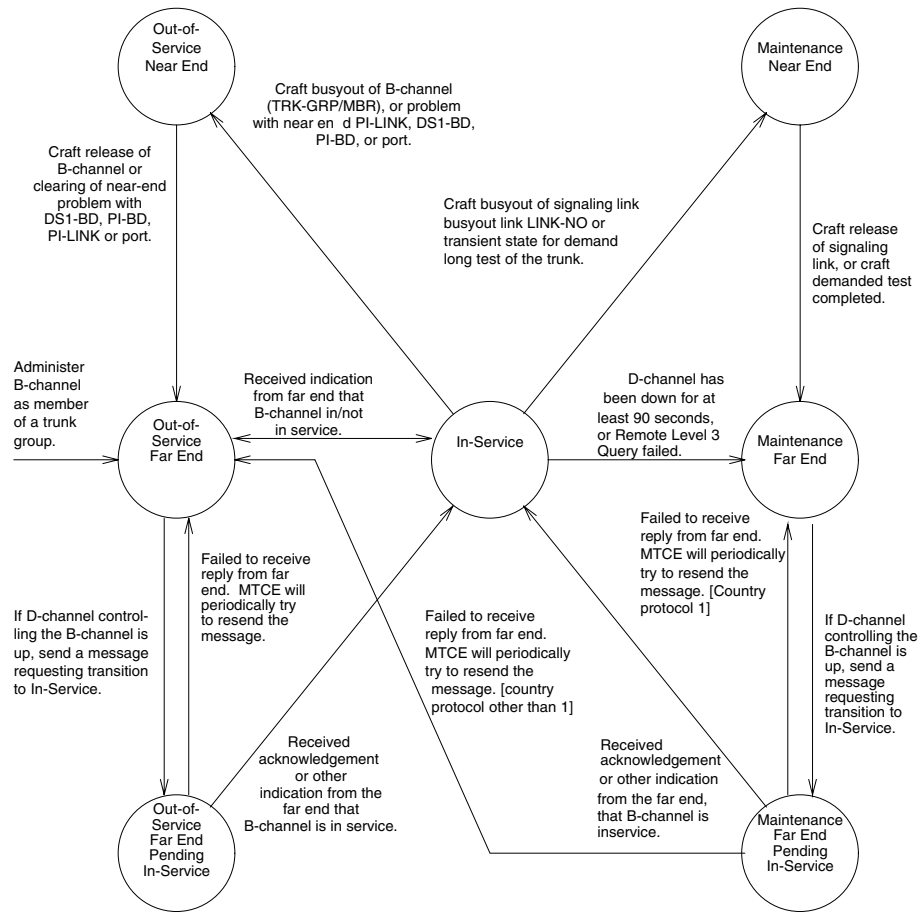
Figure 80: Common Progressions in Service States

The following diagram of the DS1 ISDN Trunk service states shows the common progression from one service state to another and the event that caused the change of state.

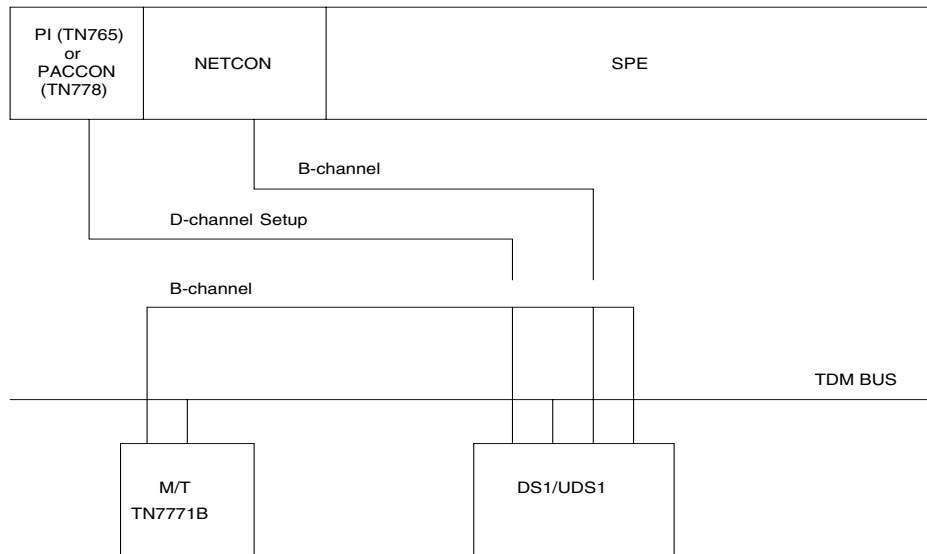
Figure 82: ISDN-PRI Outgoing Test Call

In the second method, the test call connection is established over the TDM Bus of the transmit and receive sides of the ISDN-PRI trunk to a digital trunk testing port on the Maintenance/Test circuit pack. The Maintenance/Test Digital Port generates a pseudo bit stream. A pictorial description of the outgoing ISDN-PRI test call connectivity is contained in [Figure 82: ISDN-PRI Outgoing Test Call](#) on page 1468.

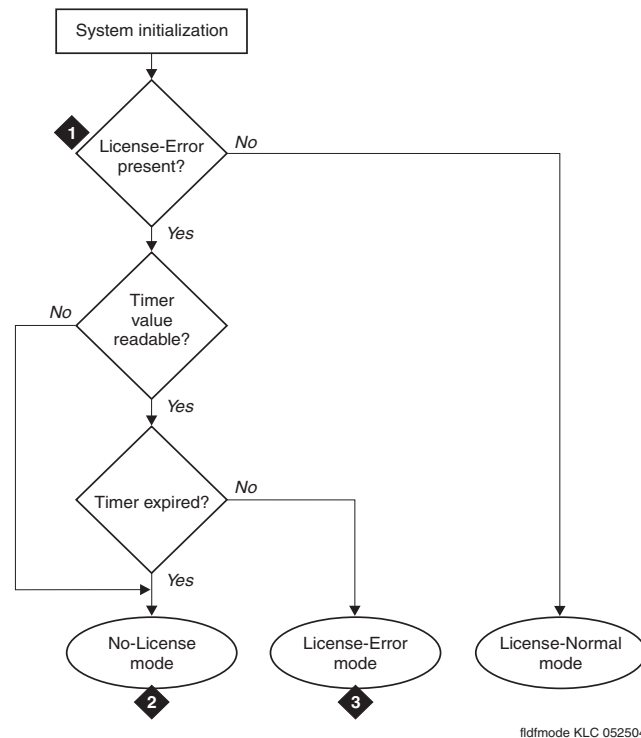
Figure 83: License mode algorithm

Entry into License Error mode starts a timer that, when expired, causes the system to enter No-License mode (see [Figure 83: License mode algorithm](#) on page 1479).

- 1 See [Troubleshooting License File errors](#) on page 1482.
- 2 See [NO-LIC \(No License\)](#) on page 1727.
- 3 See [Troubleshooting License File errors](#) on page 1482

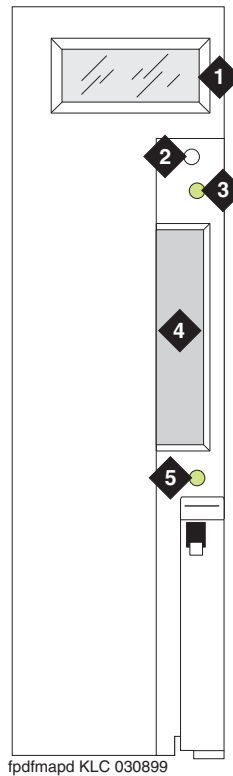
[Figure 84: TN802 faceplate](#) on page 1513 shows the TN802 faceplate.

Step	Description	Comments
1.	Restore IP Trunk administration	At the Windows 2000 desktop, double-click on the IP Trunk Backup/ Restore icon. The IP Trunk Backup/Restore Utility screen appears.
2.	Select utility	In the IP Trunk Backup/Restore Utility dialog screen, click Files> Restore . The IP Trunk Backup screen appears.
3.	Select restore	In the IP Trunk Backup screen, click on the Restore button.
4.	Wait	Wait until the amber Disk-In-Use LED (Note 5 in Figure 84: TN802 faceplate on page 1513) light is out.

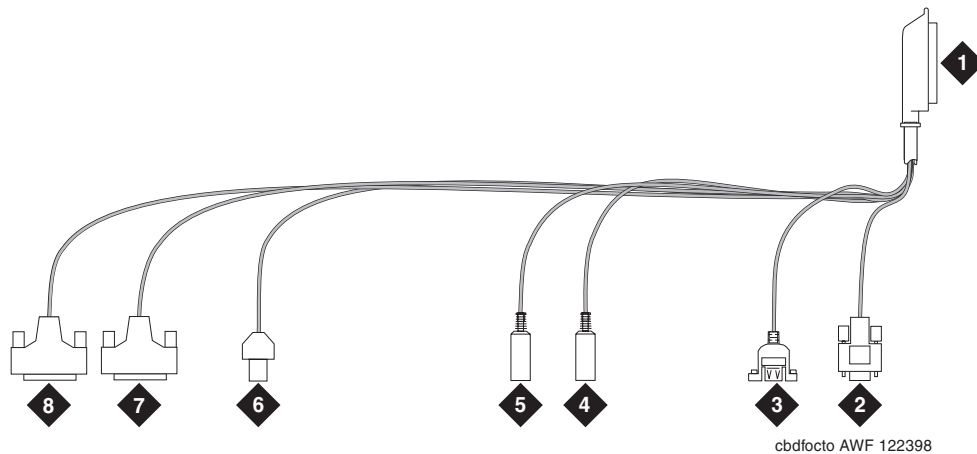
Figure 85: TN802 external cable assembly

1. Attach a male-to-male serial cable and a NULL modem connector (if not built into the cable you use) to the COM2 connector (Note 8 in [Figure 85: TN802 external cable assembly](#) on page 1515). Attach the other end to the serial port of your laptop.
2. Launch the pcANYWHERE application.
3. Click on Add Remote Control Item.
4. In the Properties window, choose the communication port to which you connected the cable in Step 1.

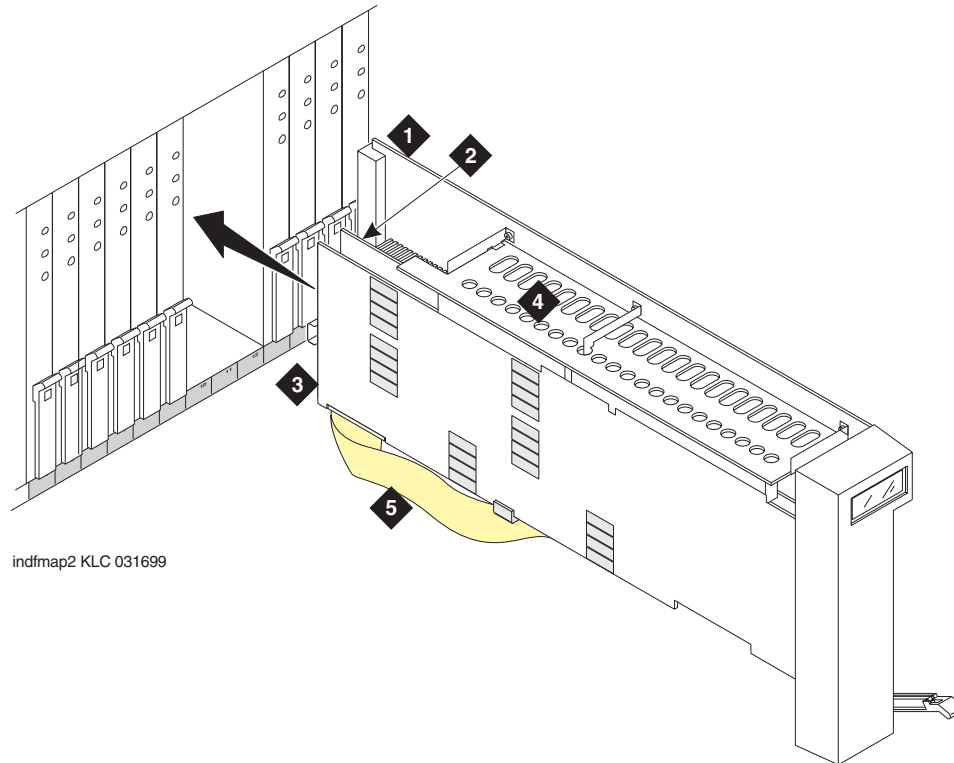
Figure 86: TN802 board assembly

[Figure 86](#) shows the circuit pack with the two additional boards connected through the side plane.

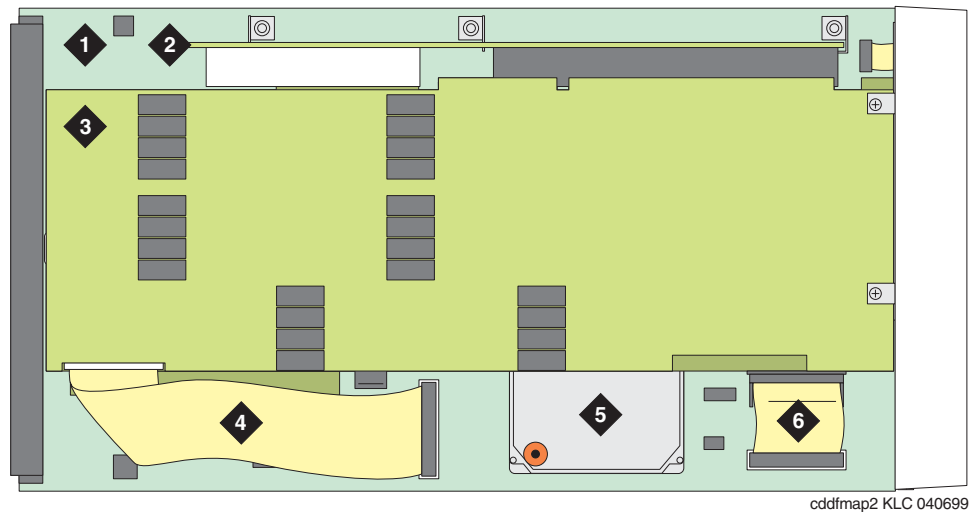
Figure 87: TN802 board assembly and cables (side view)

[Figure 87: TN802 board assembly and cables \(side view\)](#) on page 1520 shows a side view of the three boards and interconnecting cables that make up the TN802.

- a. Verify the IP address.
 - b. Check the physical connections to and from the TN802 circuit pack.
 - c. Check the internal cables on the TN802 circuit pack (Notes 4 and 6 in [Figure 87: TN802 board assembly and cables \(side view\)](#) on page 1520).
 - d. Try pinging another device in the same subnet.
 - e. Try pinging the gateway to the rest of the network from the subnet.
 - f. Try pinging a device outside the local subnet but inside the network or another subnet.
5. When finished, type `exit` at the command prompt, and press **Enter**.

- a. Check that the internal cables on the TN802 circuit pack (Notes 4 and 6 in [Figure 87: TN802 board assembly and cables \(side view\)](#) on page 1520 have not worked loose.
- b. Otherwise, replace the circuit pack.

- a. Check that the internal cables on the TN802 circuit pack (Notes 4 and 6 in [Figure 87: TN802 board assembly and cables \(side view\)](#) on page 1520) have not worked loose.
 - b. Otherwise, replace the circuit pack.
4. At the command prompt, type `ping 10.32.64.96` (the IP address of the internal Motorola MPC860 processor), and press **Enter**.
If configured correctly, the system displays:
Reply from nnn.nn.nn.nn: bytes=32 time <##ms TTL=###
If there is no reply:
 - a. Check that the internal cables on the TN802 circuit pack (Notes 4 and 6 in [Figure 87: TN802 board assembly and cables \(side view\)](#) on page 1520) have not worked loose.
 - b. Otherwise, replace the circuit pack.
 5. Ping the gateway: at the command prompt, type `ping xx.xxx.xxx.xxx` (the IP address of the gateway), and press **Enter**.
 6. When finished, type `exit` at the command prompt, and press **Enter**.

The TN802 hard drive (Note 5 in [Figure 87: TN802 board assembly and cables \(side view\)](#) on page 1520) can be replaced in the field.

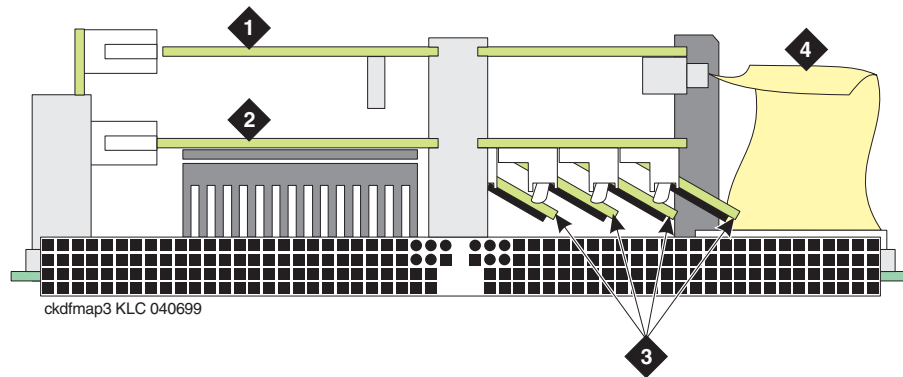
Figure 88: TN802 board assembly and cables (end view)

[Figure 88: TN802 board assembly and cables \(end view\)](#) on page 1521 shows the end view of the three boards and interconnecting cables on the TN802.

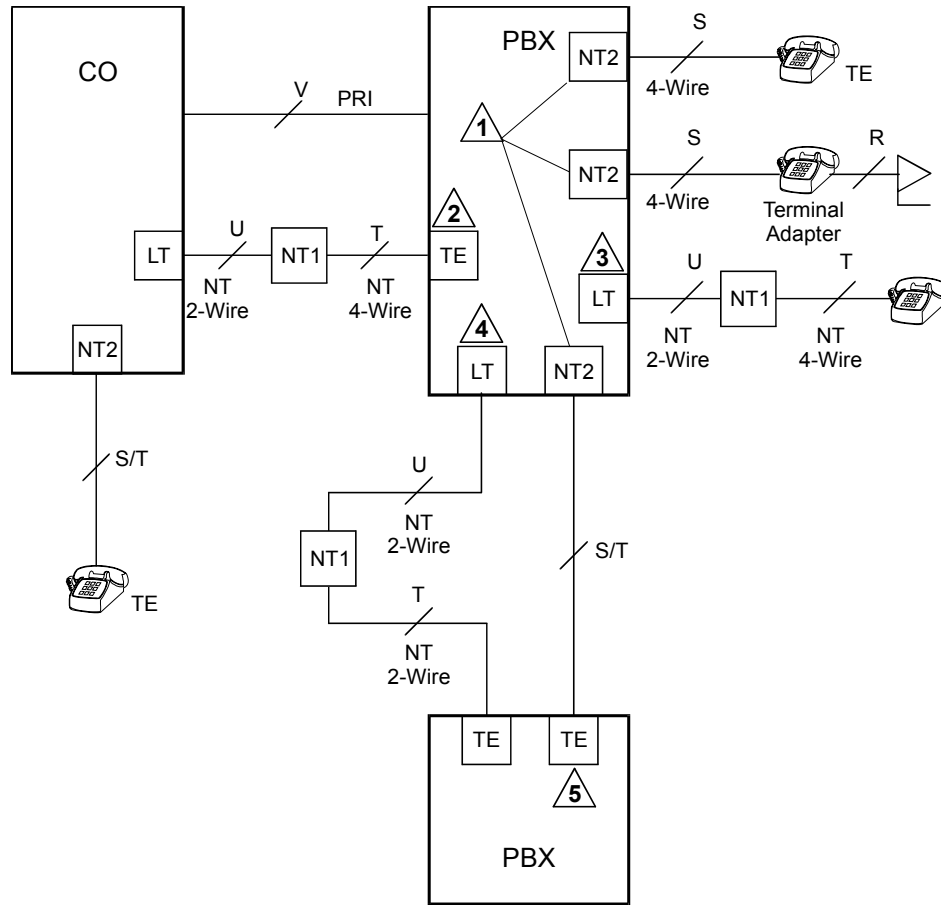
Figure 89: Integrated Trunk-Side BRI, ISDN Interface Reference Points

[Figure 89: Integrated Trunk-Side BRI, ISDN Interface Reference Points](#) on page 1588 shows, for a generic integrated trunk-side BRI, the ISDN Interface Reference Points. [Table 587: ISDN Interface Reference Point definitions](#) on page 1588 gives definitions for the generic ISDN Interface Reference Points.
