Maintenance Alarms for Avaya Communication Manager 3.0, Media Gateways and Servers

03-300430
Issue 1
June 2005

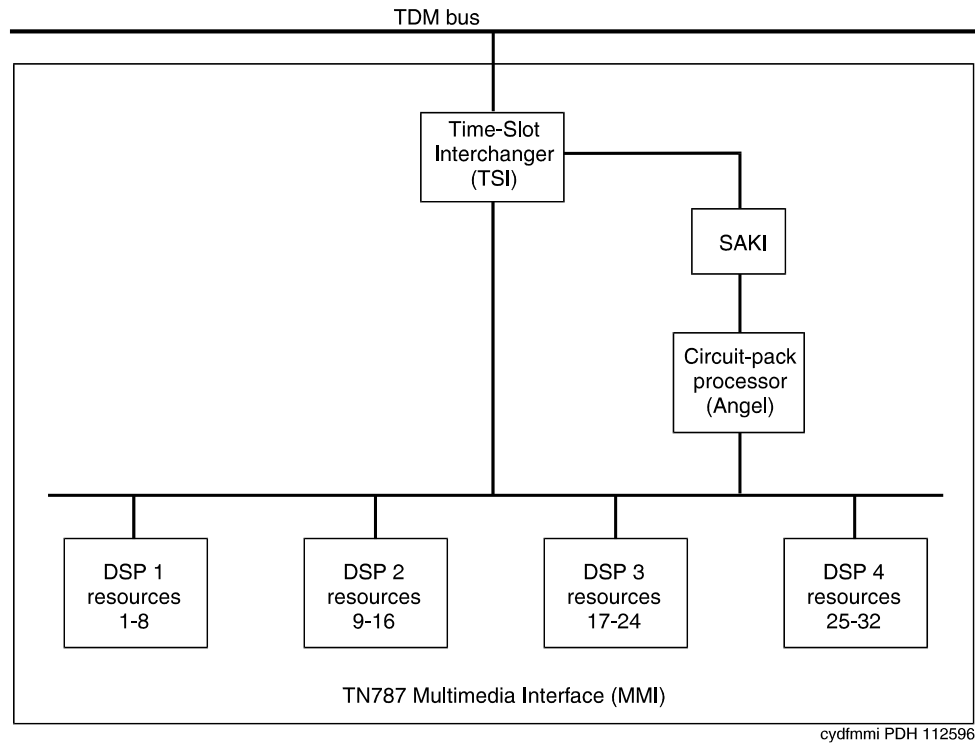
Figure 90: TN787 Multimedia Interface (MMI) Circuit Pack

The MMI circuit pack contains 4 digital signal processors that manage the 32 resources.

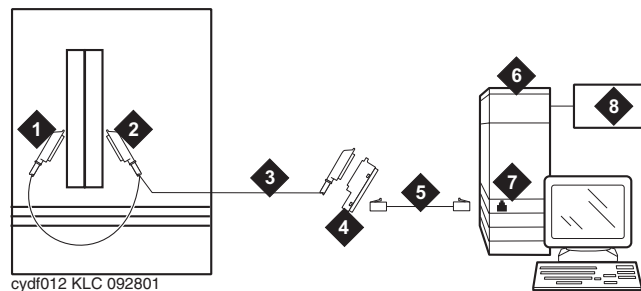
Figure 91: Typical ESM connections

The TN2207 circuit pack permits connecting an ESM (Expansion Services Module). See [Figure 91: Typical ESM connections](#) on page 1657 for connectivity.

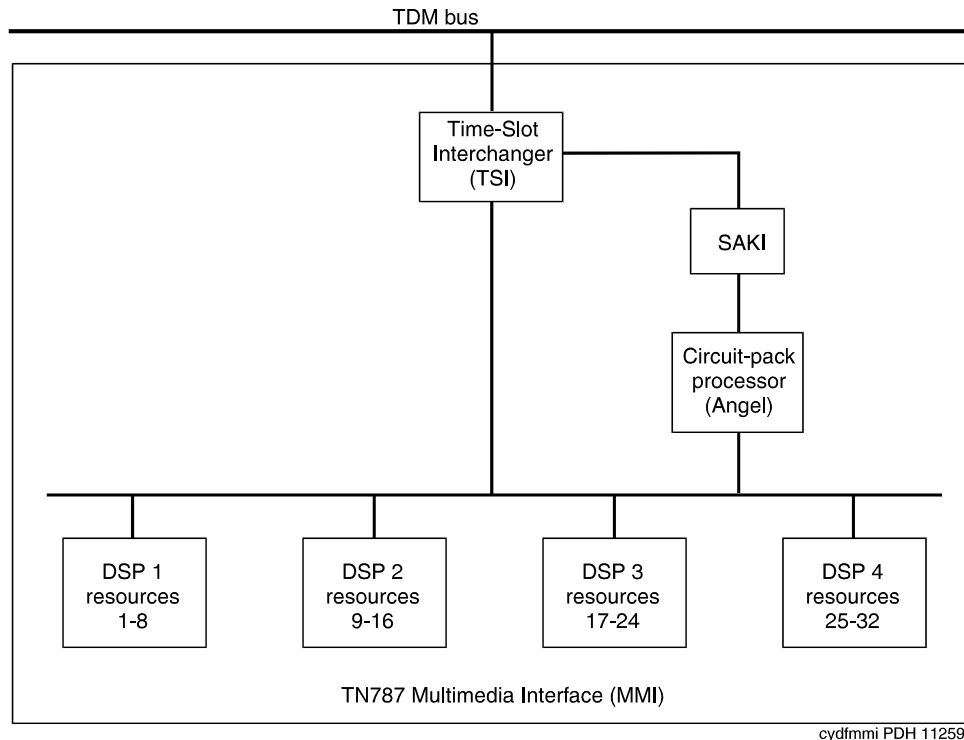
Figure 92: TN787 MMI (MULTIMEDIA INTERFACE) CIRCUIT PACK

All 8 resources that the circuit pack controls may be placed out of service by the failure of one of these DSPs.

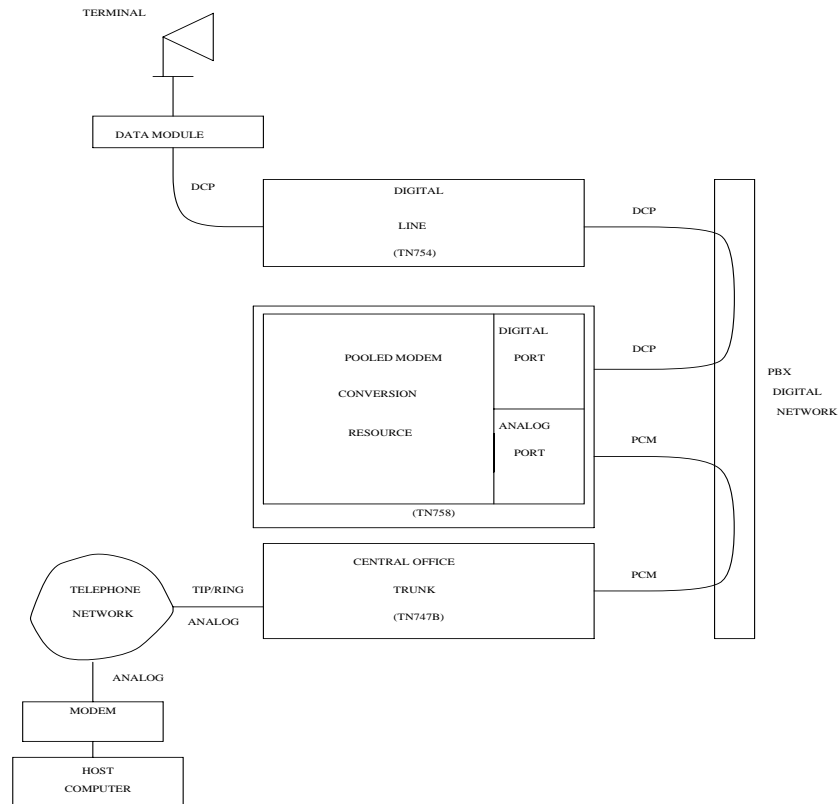
Figure 93: Typical Modem Pool Switched Connection with Integrated Pooled Modem

There are two primary types of Modem Pool conversion resources available: an Integrated Pooled Modem and a Combined Modem Pool. The integrated TN758 Pooled Modem circuit pack contains two independent 300- or 1200-bps conversion resources. Each conversion resource contains two interfaces to the PBX digital network: an analog port and a digital port. The analog port is connected through the PBX network to the analog line or trunk port containing the analog modem signals. The digital port connects through the PBX network to the digital line or trunk port in the call. [Figure 93: Typical Modem Pool Switched Connection with Integrated Pooled Modem](#) on page 1679 shows a typical end-to-end connection using a conversion resource on the integrated Pooled Modem circuit pack.

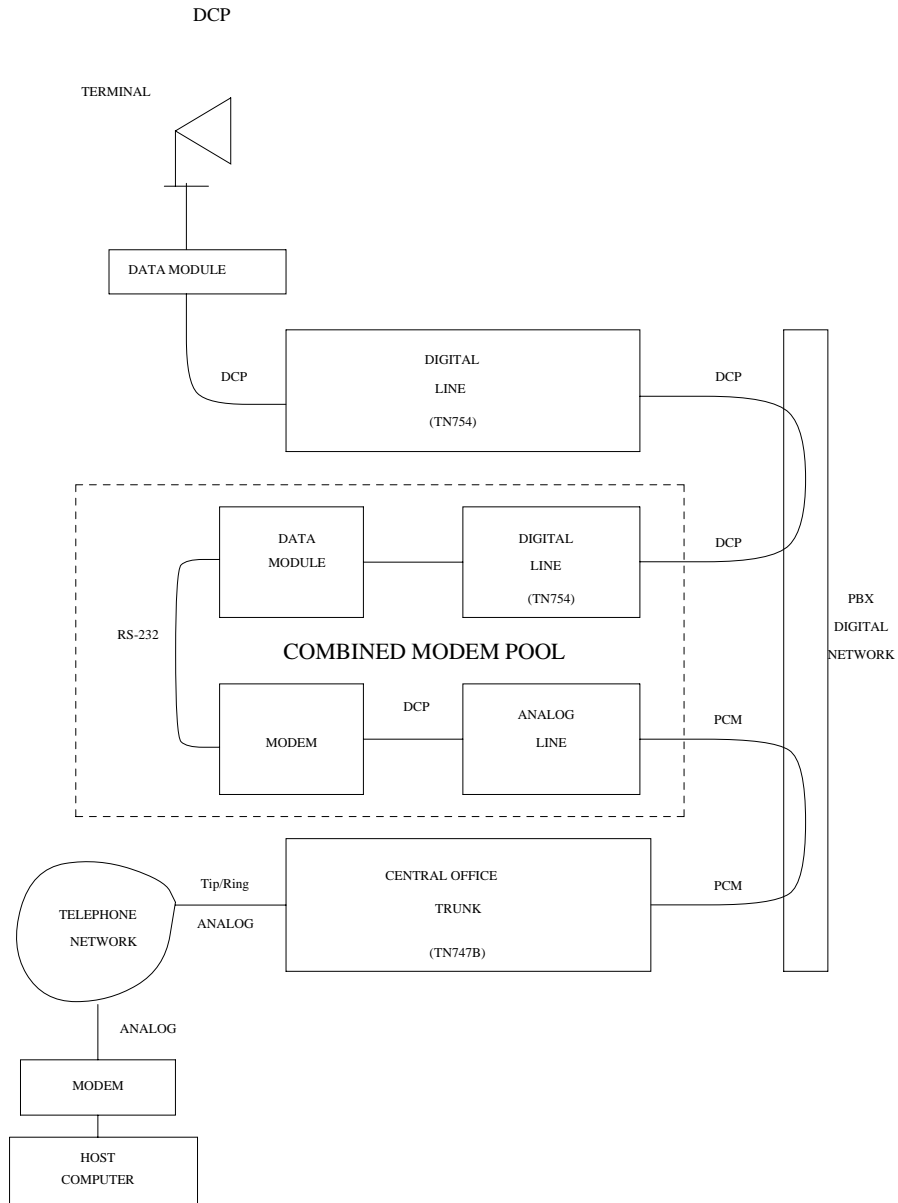
Figure 94: Typical Modem Pool Switched Connection with Combined Modem Pool

The Combined Modem Pool conversion resource is the second type available. The function served by the Combined Modem Pool is similar to that of the integrated Pooled Modem circuit pack, but the physical implementation is much different. It has the advantage of supporting any speed the external modem can support. The integrated Pooled Modem circuit pack can only support 300- or 1200-bps transmission rates. The Combined Modem Pool conversion resource consists of a port on an Analog Line circuit pack, an external modem, a Data Module, and a port on a TN754 Digital Line circuit pack. The tip and ring interface of the Analog Line is connected to the modem, the RS-232C interface of the modem connects to the Data Module, and the DCP interface on the Data Module is connected to the Digital Line port.

The analog modem signals pass through the Analog Line port to the modem. The modem converts these to RS-232C signals which are passed on to the Data Module. The Data Module further converts the signals to the DCP protocol for the Digital Line port which passes the signals on to the PBX network.

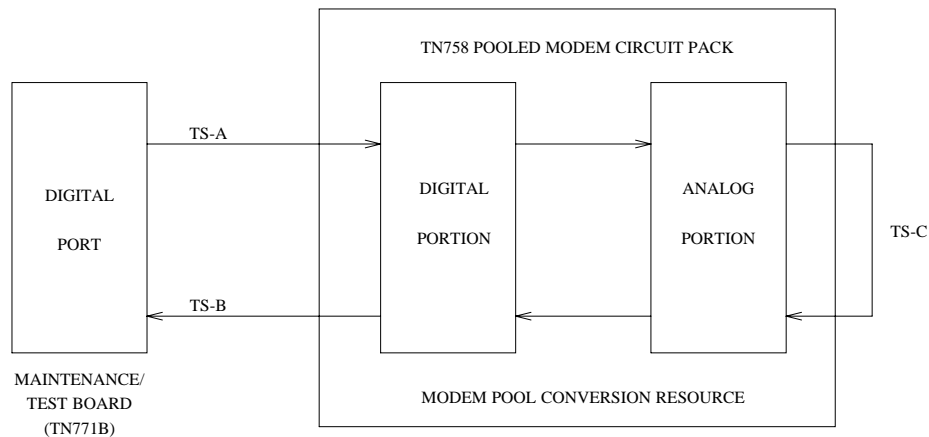
Figure 95: Modem Pool Conversion Resource Loop-Around

The Modem Pool Conversion Resource Loop-Around test is set up as follows:

Test data patterns are transmitted from a Maintenance/Test board's digital port over network time slot A through the digital port on the conversion resource, looped around through the analog port via time slot C back to the Maintenance/Test board's digital port circuit via time slot B where the patterns are checked for accuracy. Finally, the test forces a disconnect by breaking the connection between the Maintenance/Test board's digital port and the Modem Pool port (time slot A) and verifying that the Maintenance/Test board's digital port and Modem Pool port go on-hook within the proper time. This test attempts to allocate a Maintenance/Test board's digital port, Modem Pool port, and other internal resources. If any of these allocation attempts fail, the test cannot be completed, and a specific abort error is reported.

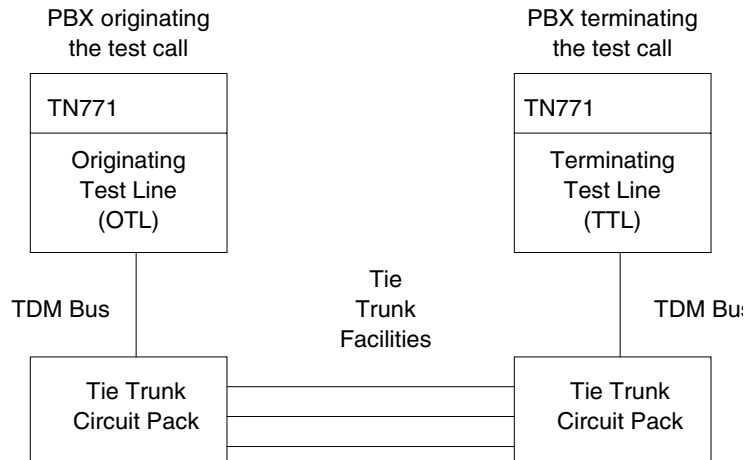
Figure 96: ATMS Tie Trunk Test Call

The Maintenance/Test analog port is port number 1 on the TN771D Maintenance/ Test circuit pack. This port is used by the Automatic Transmission Measurement System (ATMS) as an Originating Test Line (OTL) or Terminating Test Line (TTL) for test calls over analog trunks. For more details, see [Automatic Transmission Measurement System](#) in *Maintenance Procedures (03-300192)*. [Figure 96](#) shows a typical ATMS configuration.

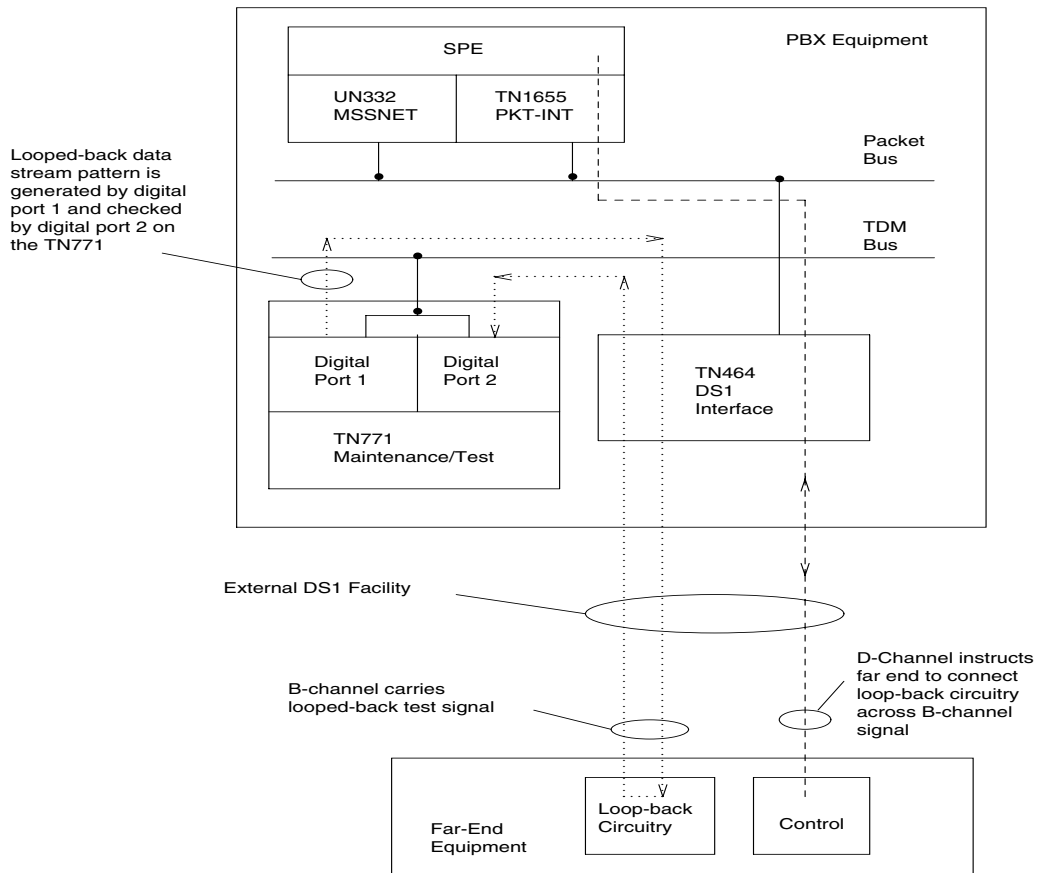
Figure 97: ISDN-PRI Outgoing Test Call

The Maintenance/Test digital port is a port on the TN771D circuit pack. Ports 2 and 3 are digital ports. The Maintenance/Test digital port provides the ability to perform digital (i.e., ISDN-PRI) trunk testing via the TDM bus. For an ISDN-PRI test call, connections are set up in the system as shown in [Figure 97: ISDN-PRI Outgoing Test Call](#) on page 1710.

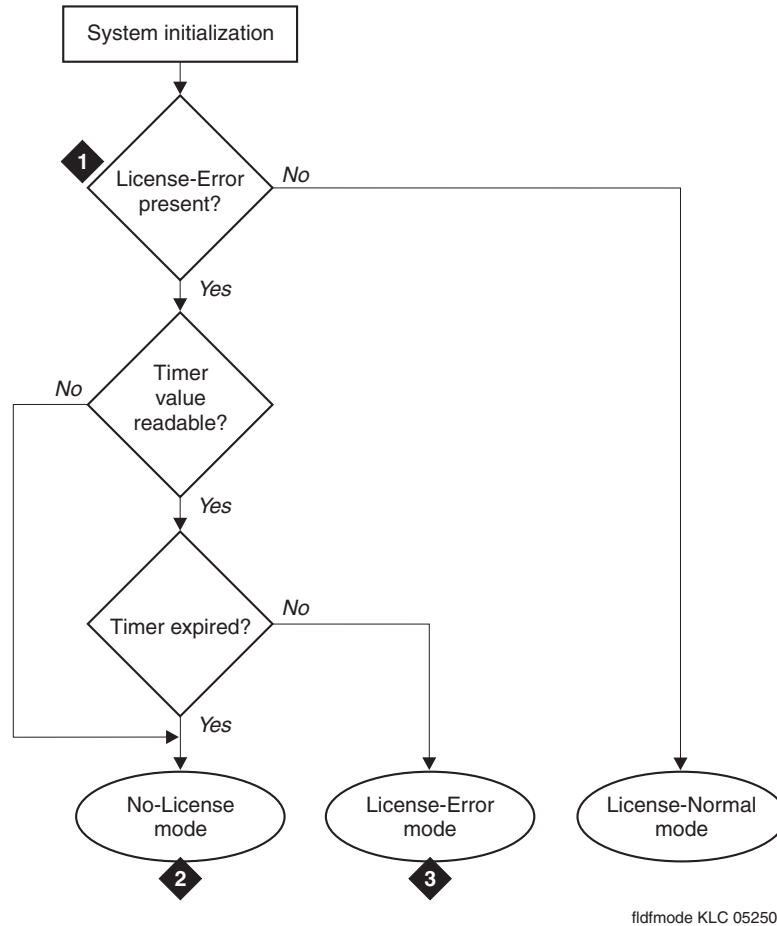
Figure 98: License mode algorithm

Entry into License-Error mode starts a timer that, when expired, causes the system to enter No-License mode (see [Figure 98: License mode algorithm](#) on page 1728). When Communication Manager enters No-License mode, the following SAT warning message displays:

1. See [Troubleshooting License File errors](#) on page 1482.
2. See [How systems go into No-License mode](#) on page 1727.
3. See [Troubleshooting License File errors](#) on page 1482.

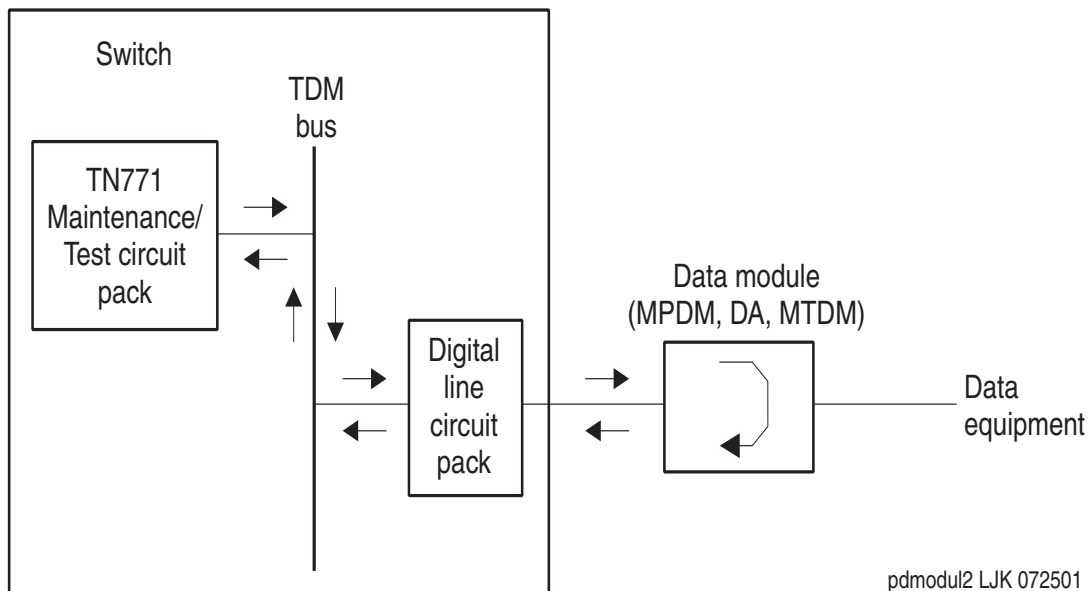
Figure 101: Internal Loop-Around Test

A signaling message is sent through the digital port circuit pack to the data module, requesting it to enter loop-around mode. A test pattern is then sent from the TN771D Maintenance/Test circuit pack, over the path illustrated above, and back to the TN771D where it is checked for consistency.

The test aborts if any of the following local PBX resources are not available: a digital port on the TN771D (there are two such digital ports, but only one may be used at a time), two TDM time slots and an idle digital port connected to the data module.

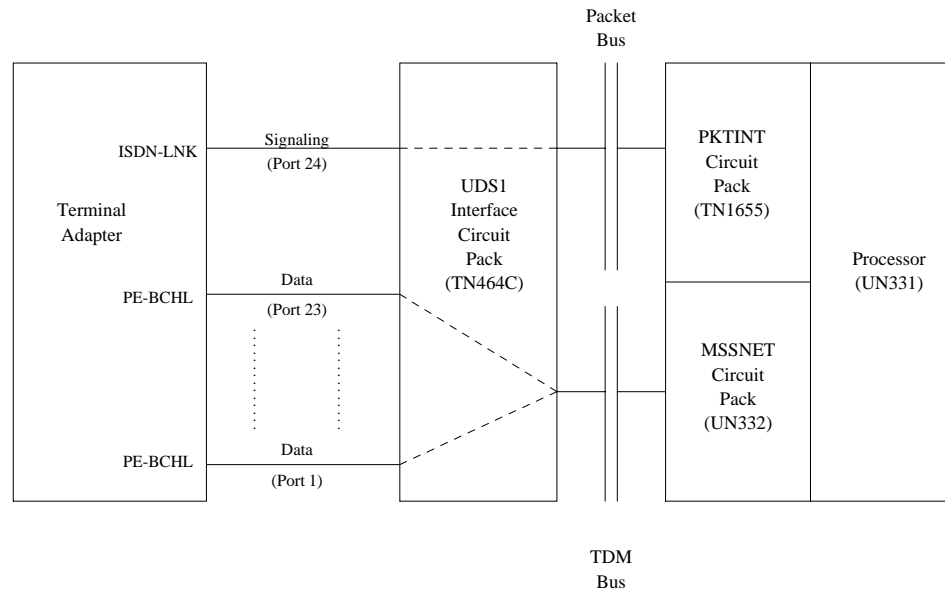
Figure 102: PRI Endpoint Port Interactions

A PRI endpoint port is a port on a UDS1 interface circuit pack and thus depends on the health of the circuit pack for proper operation (see the following figure). A problem on the associated ISDN-LNK's (ISDN-PRI signaling-link port's) D channel can also affect the PRI endpoint. In turn, the ISDN-LNK depends on the SYS-LINK (system link) to the packet interface. Keep this hierarchy of dependencies in mind when diagnosing problems.

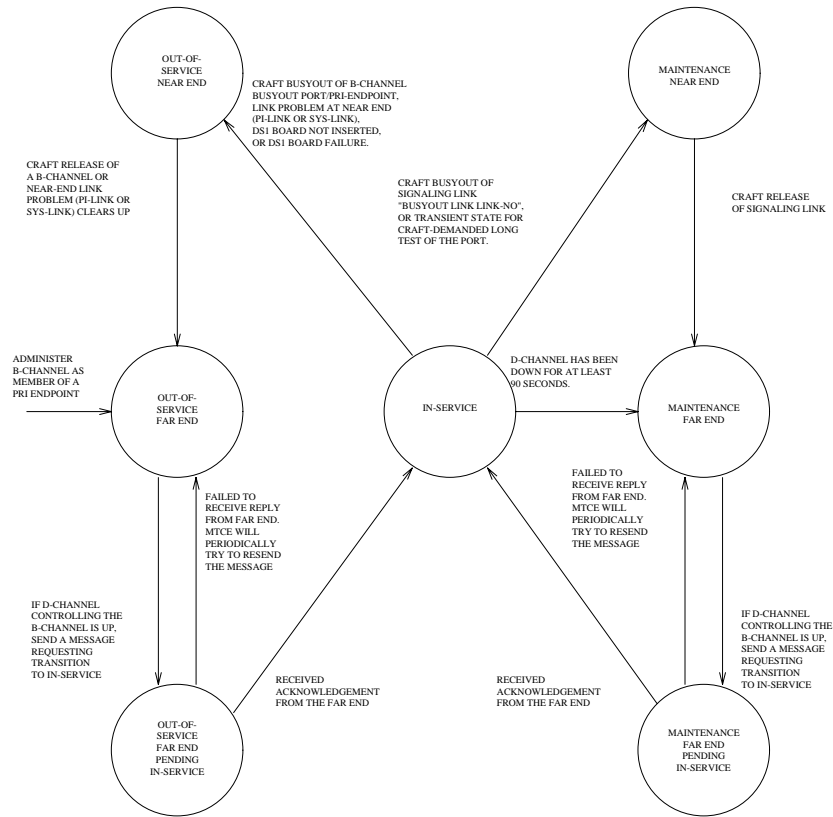
Figure 103: Common Progressions in PRI Endpoint Service States

The `status pri-endpoint extension` command displays the following possible service states for PRI endpoint ports. The table that follows gives recommended procedures for each state. The figure following that shows typical progressions from one service state to another. Refer also to [Troubleshooting ISDN-PRI endpoints \(wideband\)](#) in *Maintenance Procedures (03-300192)* for a layered approach to addressing PRI endpoint problems.

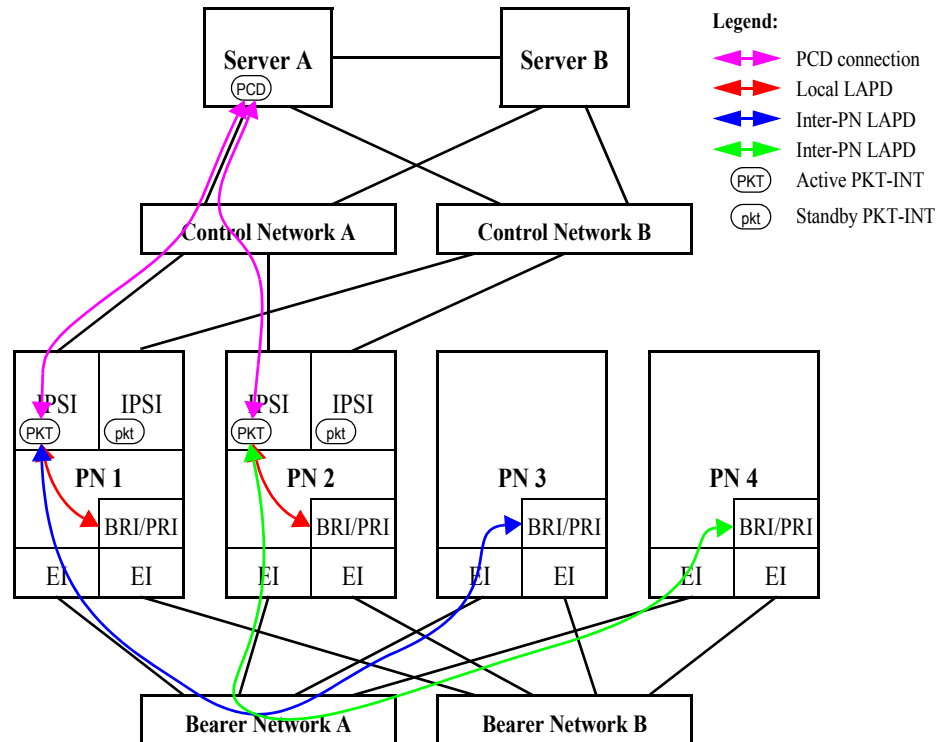
Figure 104: Distributed PKT-INTs

S8700 MC: As shown in [Figure 104: Distributed PKT-INTs](#) on page 1801, PNs 1 and 2 have IPSIs that terminate LAPD links. PNs 3 and 4 do not have local IPSIs, so their LAPD links are terminated by IPSIs in PNs 1 and 2.

The Packet Interface module is a single point of failure in a standard- or duplex-reliability system, with unduplicated IPSIs. If not acceptable, an S8700 customer can upgrade to a high- or critical-reliability system with duplicated IPSIs. [Figure 104: Distributed PKT-INTs](#) on page 1801 shows an S8700 Multi-Connect configuration with duplicated IPSIs. The following concepts apply to duplicated IPSIs:

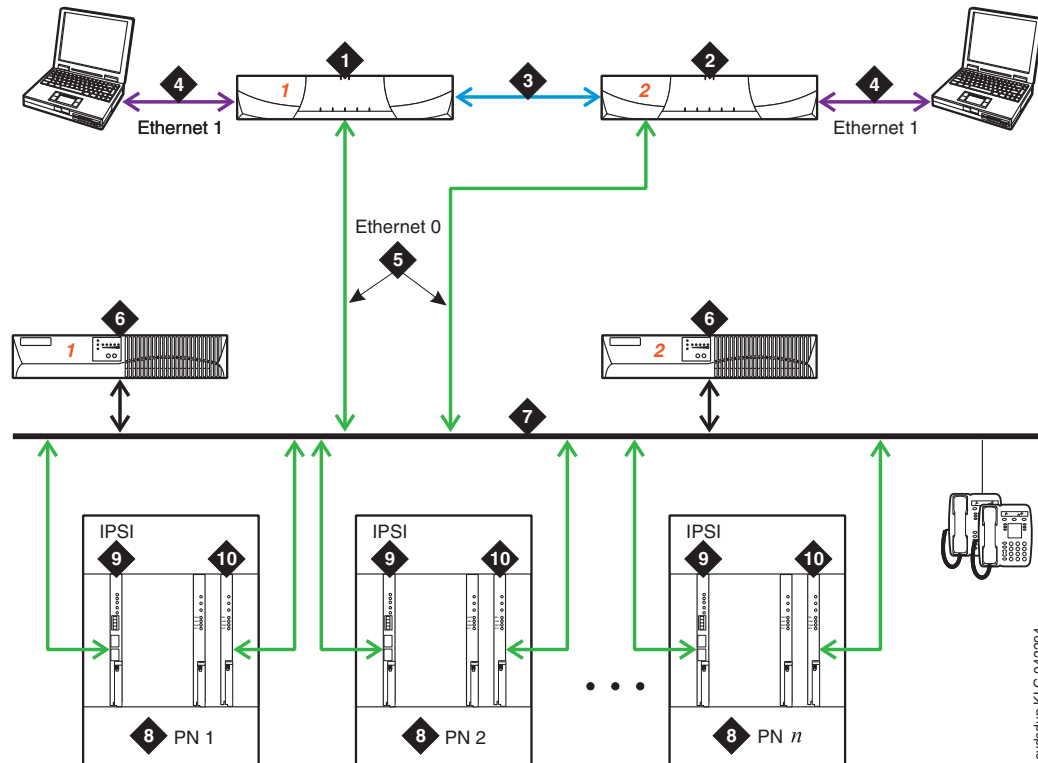
Figure 105: IP Connect Duplex Reliability - Simplex Control Network

A PKT-INT module resides on each IPSI board. On an S8700 IP Connect, there is a duplicated server, and one server is in active mode and one server is on standby. The control network(s) for S8700 IP Connect may be implemented in a simplex, see [Figure 105: IP Connect Duplex Reliability - Simplex Control Network](#) on page 1805, or a optional duplicated configuration. There is only one PKT-INT per port network.

Duplicated control networks require G650 media gateways (not G600) because the G600 does not support duplicated clocks. The clock is a component of the TN2312 IPSI.

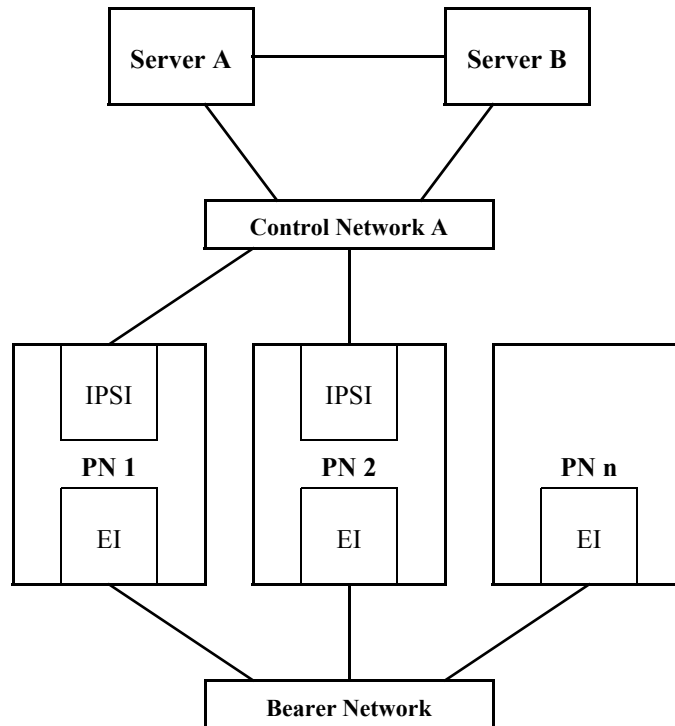
Figure 106: Duplex-Reliability Configuration

The duplex-reliability configuration shown in [Figure 106: Duplex-Reliability Configuration](#) on page 1807 has duplicated media servers, an unduplicated control network, unduplicated IPSIs in the IPSI connected PNs, and an unduplicated bearer network. Because the IPSIs are not duplicated, the PKT-INT modules contained within them are not duplicated.

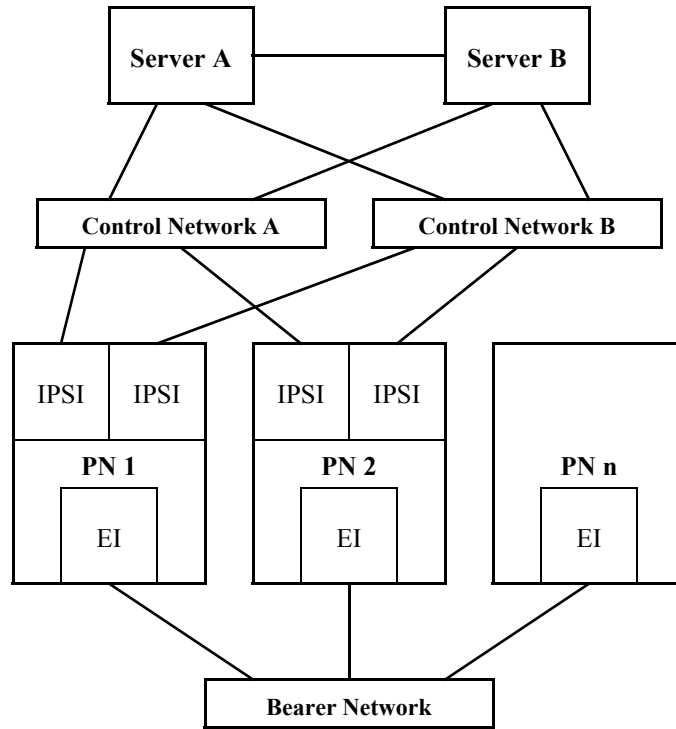
Figure 107: High-Reliability Configuration - Multi-Connect

The high-reliability configuration shown in [Figure 107: High-Reliability Configuration - Multi-Connect](#) on page 1808 has duplicated media servers, duplicated control networks, and duplicated IPSIs in the IPSI connected PNs. With this configuration, every IPSI connected PN must have duplicated IPSIs. The duplicated control network prevents a single fault in the control network, such as a bad Ethernet switch, from bringing the whole system down. Because the IPSIs are duplicated in this configuration, the PKT-INT modules are duplicated.

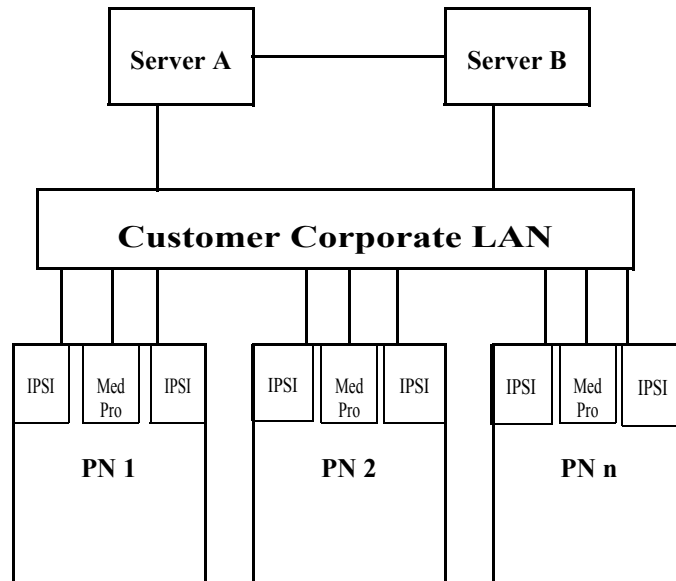
Figure 108: High-Reliability Configuration - IP Connect

The IP Connect high reliability configuration is similar to the multi-connect configuration. There are no expansion interface circuit packs in the IP connect configuration. There are duplicated IPSI circuit packs in each port network. Port networks must use the G650 rack mounted carrier to accommodate the duplicated clock circuits located on the IPSI circuit packs. See [Figure 108: High-Reliability Configuration - IP Connect](#) on page 1808

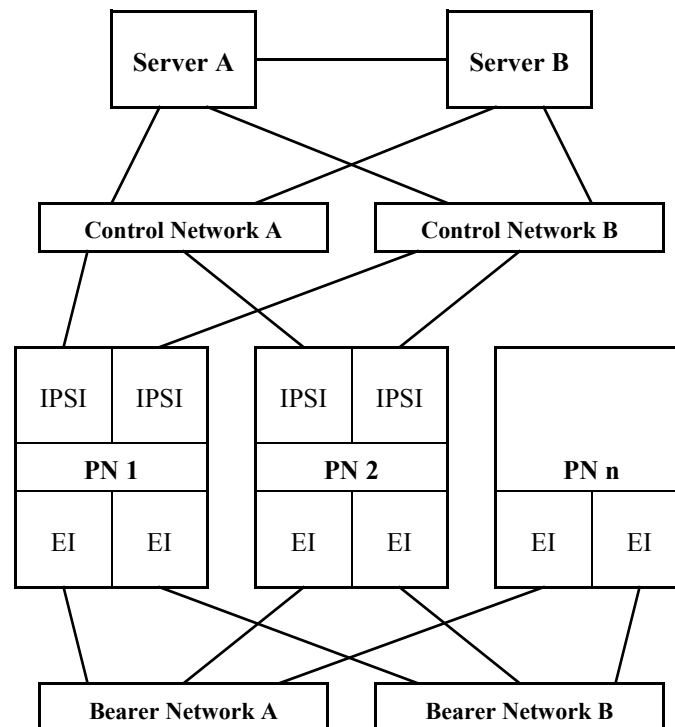
Figure 109: Critical-Reliability Configuration - Multi-Connect

The critical-reliability configuration shown in [Figure 109: Critical-Reliability Configuration - Multi-Connect](#) on page 1809 has full duplication of the following options: media servers, control networks, IPSIs and PNCs (bearer networks). As with the high-reliability configuration, this configuration requires that IPSI connected PNs have duplicated IPSIs. Because the IPSIs are duplicated in this configuration, the PKT-INT modules are duplicated.

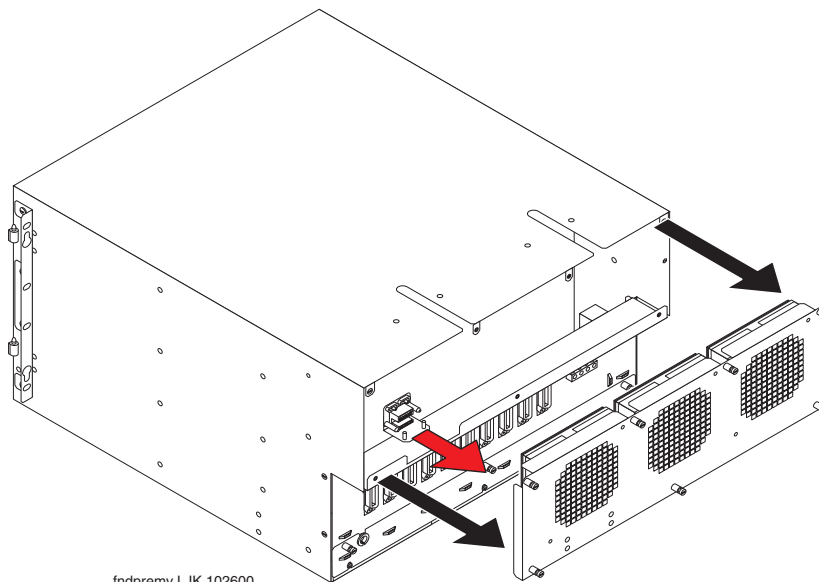
Figure 113: Fan Removal

1. Place the new fan assembly close to the G600.
2. Loosen the thumb screws on the fan assembly, and pull it straight out (unplug it) as shown in [Figure 113: Fan Removal](#) on page 1952. The power for the fan automatically disconnects when the assembly is unplugged.
3. Plug in the new fan assembly. The power for the fan automatically connects when the fan assembly is plugged in.
4. Tighten every thumb screw on the fan assembly.

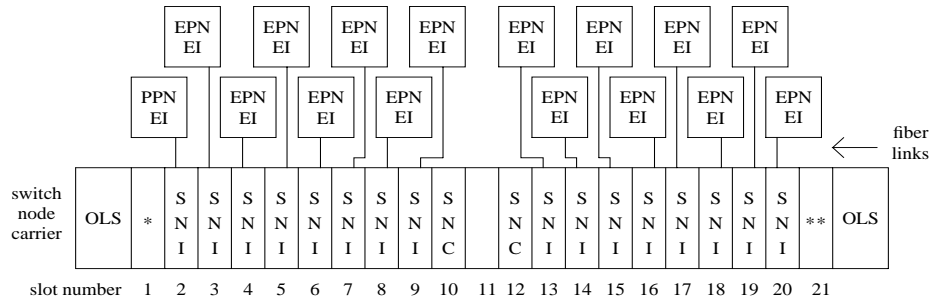
Figure 116: A Center Stage Switch Configuration

* = An EI or a DS1C circuit pack may reside in this slot
 ** = A DS1C circuit pack may reside in this slot

- Switch Node Clock (SNC) TN572
- Switch Node Interface (SNI) TN573
- Expansion Interface (EI) TN570
- DS1 Converter (DS1C) TN574
- Online Switcher (OLS) power supply

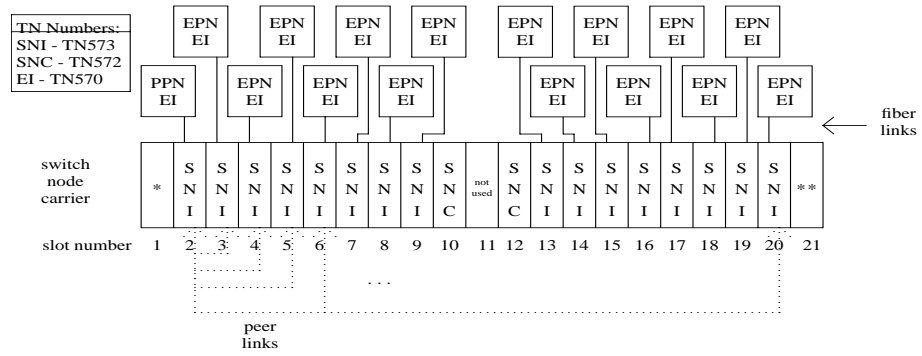
Figure 118: CSS Configuration with Unduplicated PNC and 1 Switch Node Carrier

[Figure 118: CSS Configuration with Unduplicated PNC and 1 Switch Node Carrier](#) on page 2047 shows an unduplicated CSS with one switch node. A single switch node can accommodate up to 16 port networks. A system with two switch nodes can accommodate up to 22 port networks. [Figure 119: CSS Configuration with Duplicated PNC and 4 Switch Node Carriers](#) on page 2048 shows a two-switch node CSS with duplicated PNC (four switch node carriers). In this configuration, each PNC (A and B) contains two switch nodes. The cabinet numbers for the switch node carriers are typical cabinet numbers. The PNs on the top half of the figure (PNC A) are the same as the PNs on the bottom half of the figure (PNC B).

* = An EI or a DS1C circuit pack may reside in this slot
 ** = A DS1C circuit pack may reside in this slot

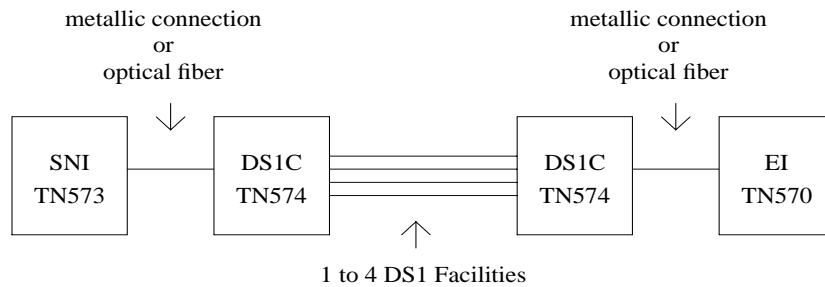
Figure 120: Fiber Link over a DS1 Converter Complex

A DS1 converter complex can be used to provide connectivity to a remotely located port network. The DS1 converter complex consists of two TN574 DS1 converter (DS1C) circuit packs connected by 1 to 4 DS1 facilities. The DS1C complex is administered as a fiber link.

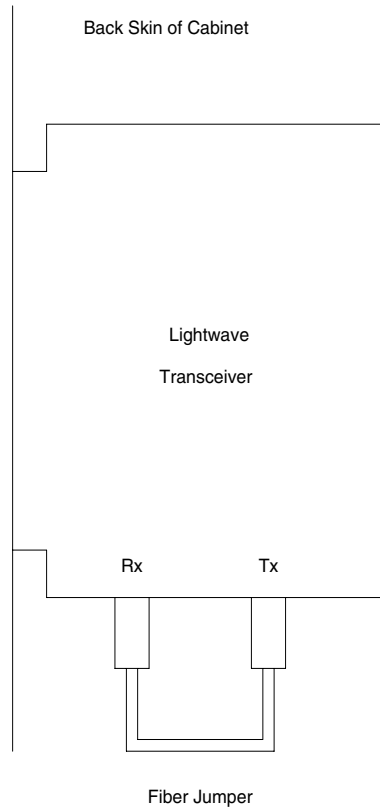
Figure 121: Interconnection of Lightwave Transceiver Transmit/Receive Jacks

3. Using a spare fiber jumper cable, interconnect the transmit and receive jacks of the lightwave transceiver as shown in [Figure 121: Interconnection of Lightwave Transceiver Transmit/Receive Jacks](#) on page 2055.

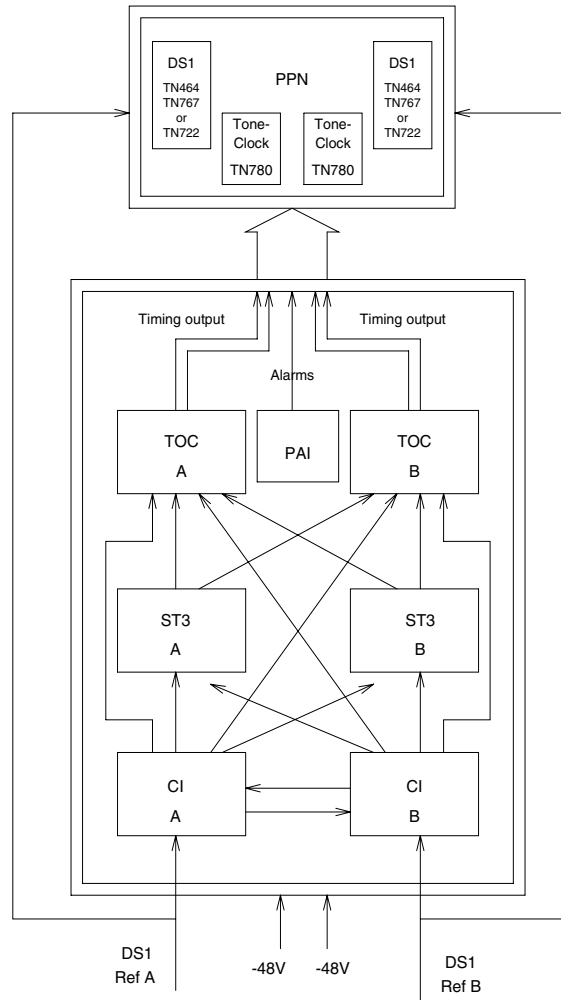
Figure 122: Stratum-3 Clock Hardware Configuration

In the system, the Stratum-3 clock has been implemented as an external which follows the specification in PUB 60110 for Stratum 3. The only external Stratum-3 clock that is supported is the Telecom Solutions Digital Clock Distributor for Customer Premise Timing (DCD-CPT) Stratum-3 clock. [Figure 122: Stratum-3 Clock Hardware Configuration](#) on page 2129 shows how the Stratum-3 hardware configuration provides clock and alarm signals to the TN780 Tone-Clock circuit pack(s). The reference DS1 facilities connect directly to the Stratum-3 clock for timing purposes, but the DS1 data may be routed into the switch by using a Y connector (H-600-274 G1 for the 50-pin DS1 end or H-600-274 G2 for the 15-pin DS1 end).

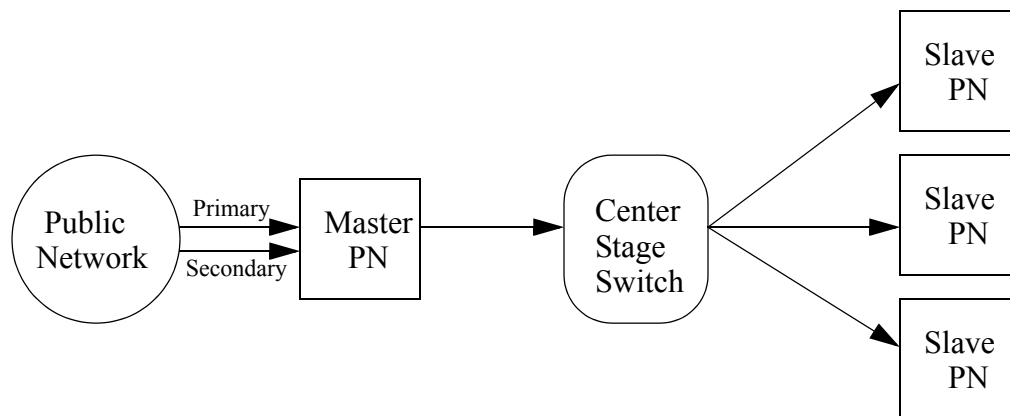
Figure 123: Traditional Sync Operation

This creates a hierarchy where the master PN receives timing from the public network, and every other PN derives its timing from the master through the CSS. See [Figure 123: Traditional Sync Operation](#) on page 2144.

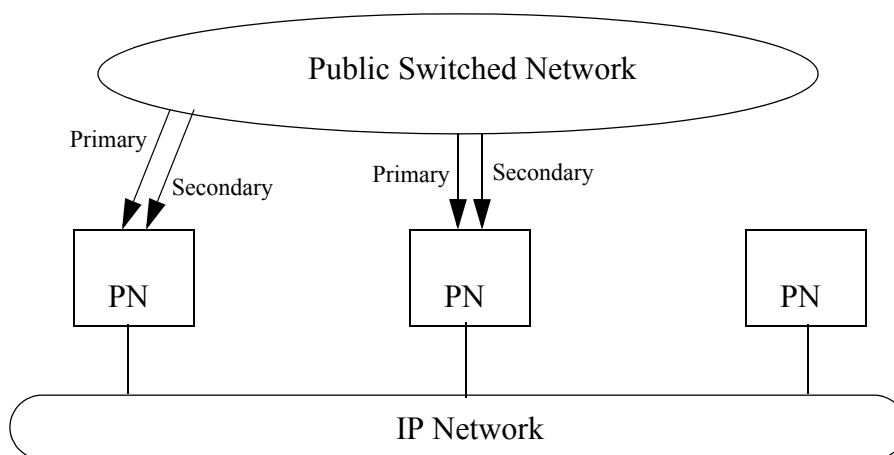
Figure 124: S8700 Media Server IP-Connected Sync Operation

A typical S8700 IP Connect configuration is shown in [Figure 124: S8700 Media Server IP-Connected Sync Operation](#) on page 2145.

This figure also shows the far-right S8700 IP Connect system's PN without public-network digital interface. A PN without public-network connectivity runs off of its local IPSI circuit pack's Tone-Clock circuit.

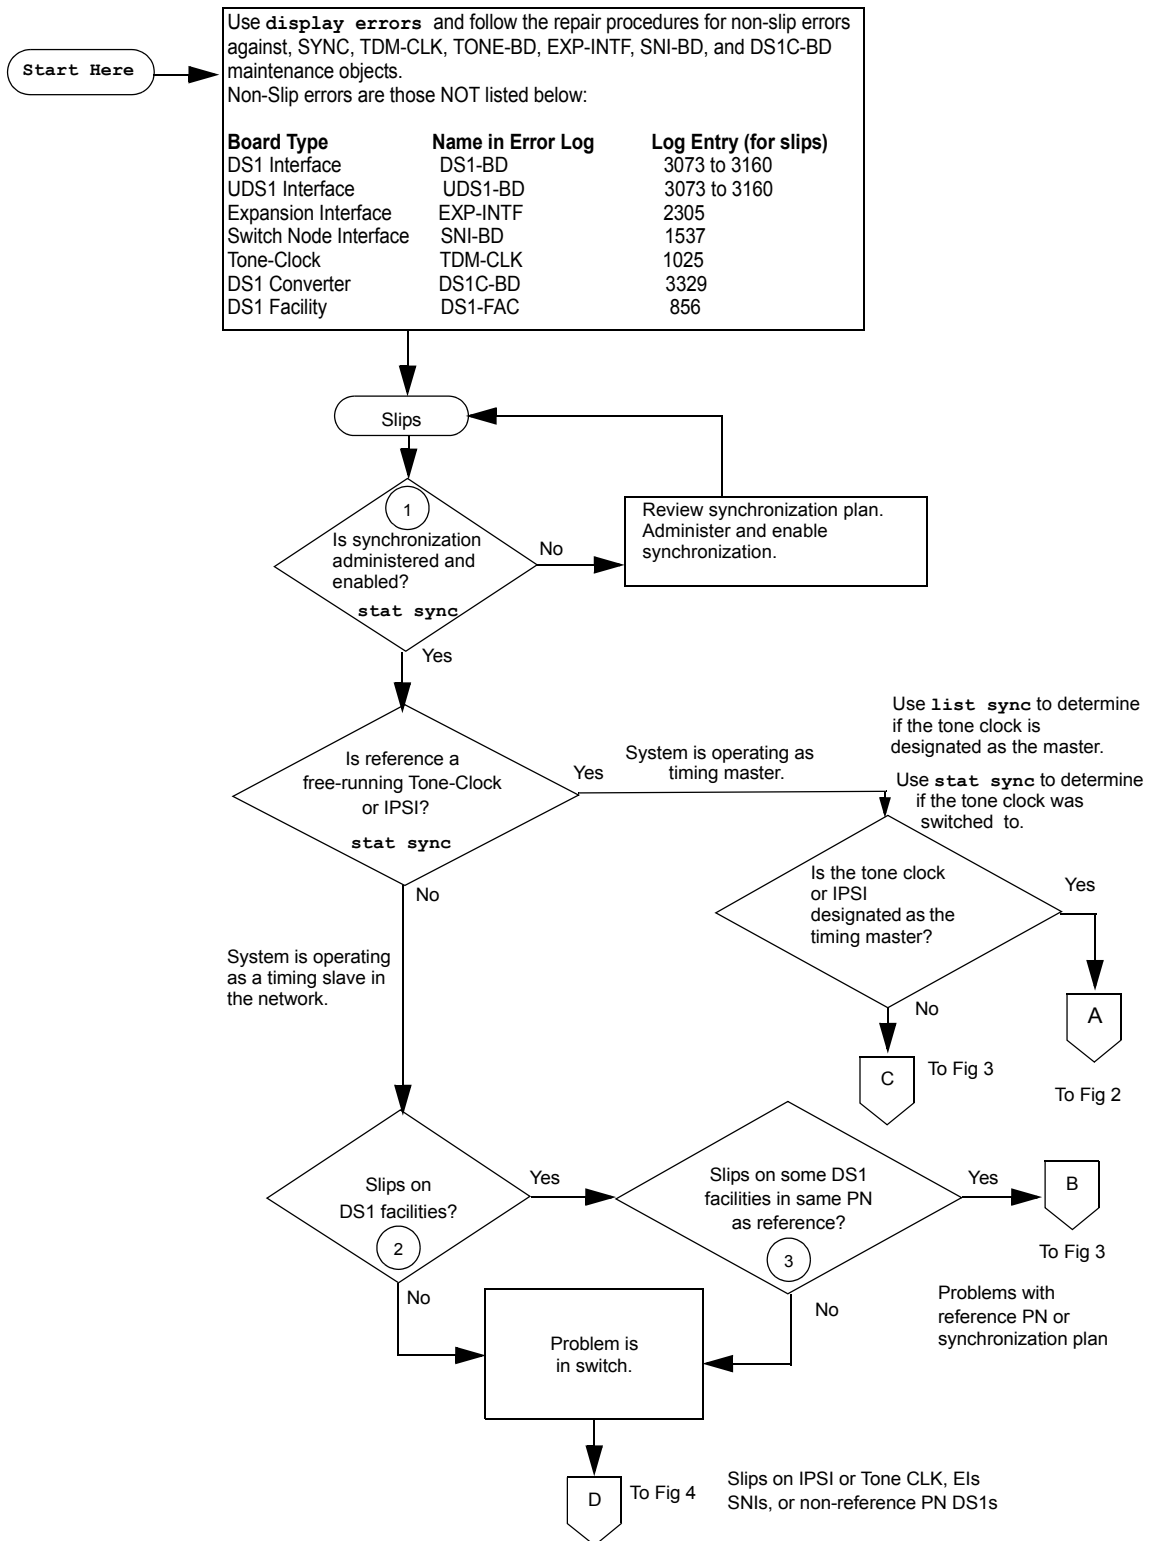
Figure 125: Synchronization Troubleshooting, Fig. 1 of 5

The following flow chart presents a logical approach to troubleshooting synchronization problems in conjunction with the previous background information. Explanatory notes follow the charts.

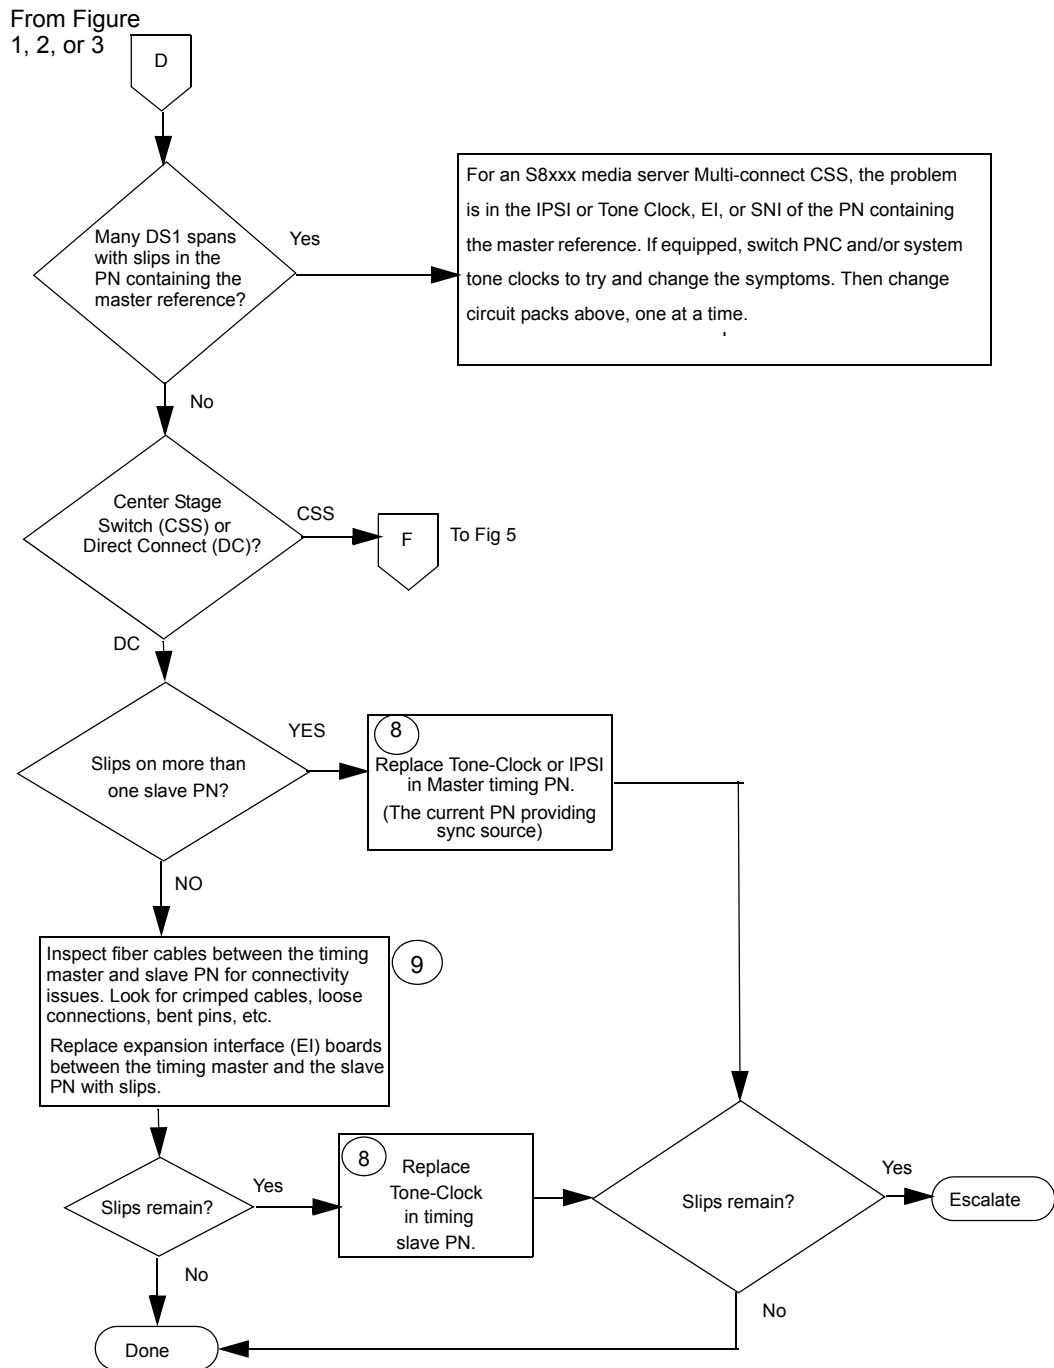
Figure 129: Synchronization Troubleshooting, Fig 5 of 5

The synchronization issue covers a large portion of the system. The problem is in a center stage switch (CSS), IPSI or Tone-Clock, EI, SNI, or DS1 spans in port networks (PN) other than the timing master PN.
 This procedure attempts to isolate the problem.
 When instructed to do so, perform the steps indicated while slips remain.

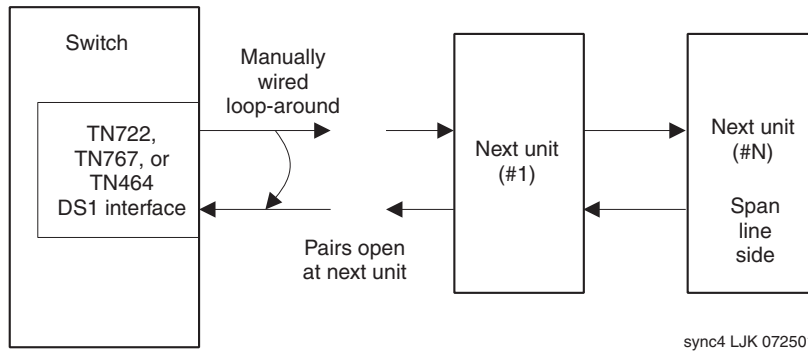
Figure 134: Manual Loop-Around for Facility Fault Sectionalization

[Figure 134: Manual Loop-Around for Facility Fault Sectionalization](#) on page 2162 shows a sequence of units (1 through n) that may be connected as the on-site equipment. A typical example is the case where the only on-site equipment is channel-terminating equipment designated Unit #1. A more complex, less typical example might have a DACS as Unit #1, a protection switch as Unit #2, and a DS1-level microwave radio system as Unit #3.
