Maintenance Alarms for Avaya Communication Manager 3.0, Media Gateways and Servers

03-300430
Issue 1
June 2005

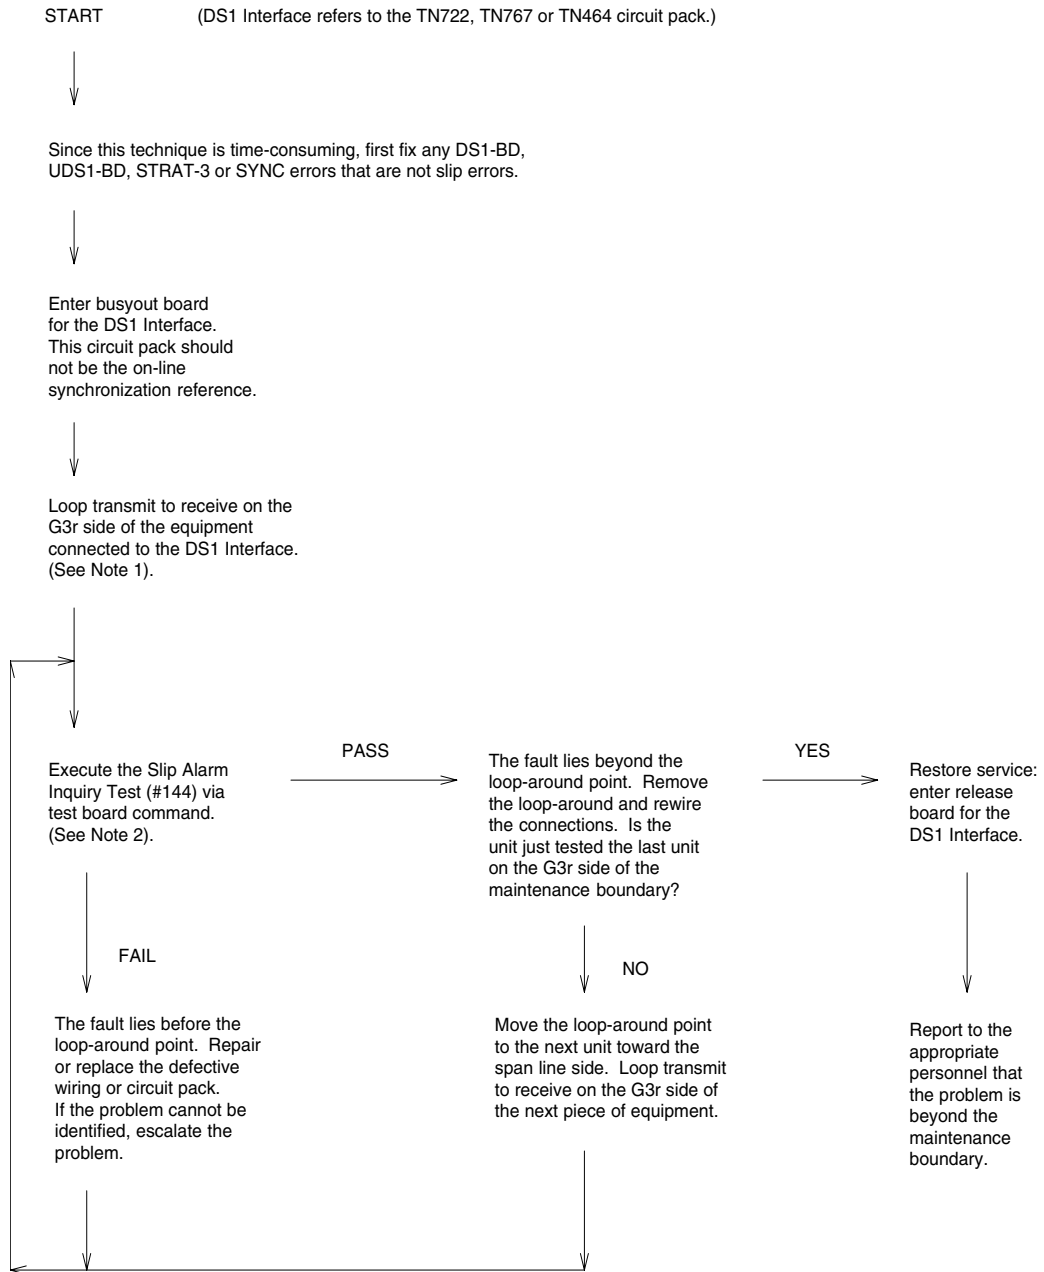
Figure 135: Facility Fault Sectionalization

The flowchart in [Figure 135: Facility Fault Sectionalization](#) on page 2163 gives an overview of the facility fault sectionalization technique. It is important that you know the configuration and wiring of the equipment for the problem facility in order to support this technique.

Notes to Facility Fault Sectionalization Flowchart

1. Loop transmit to receive on the system side.

2. Execute `test board location` for the TN722, TN767 or TN464. Look at results of Test #144, the Slip Alarm Inquiry test. When this test fails, the error code gives the number of slips detected since the last Slip Inquiry test was run. If the test fails, run it at least one more time to ensure that slips have occurred since the loop around was installed.

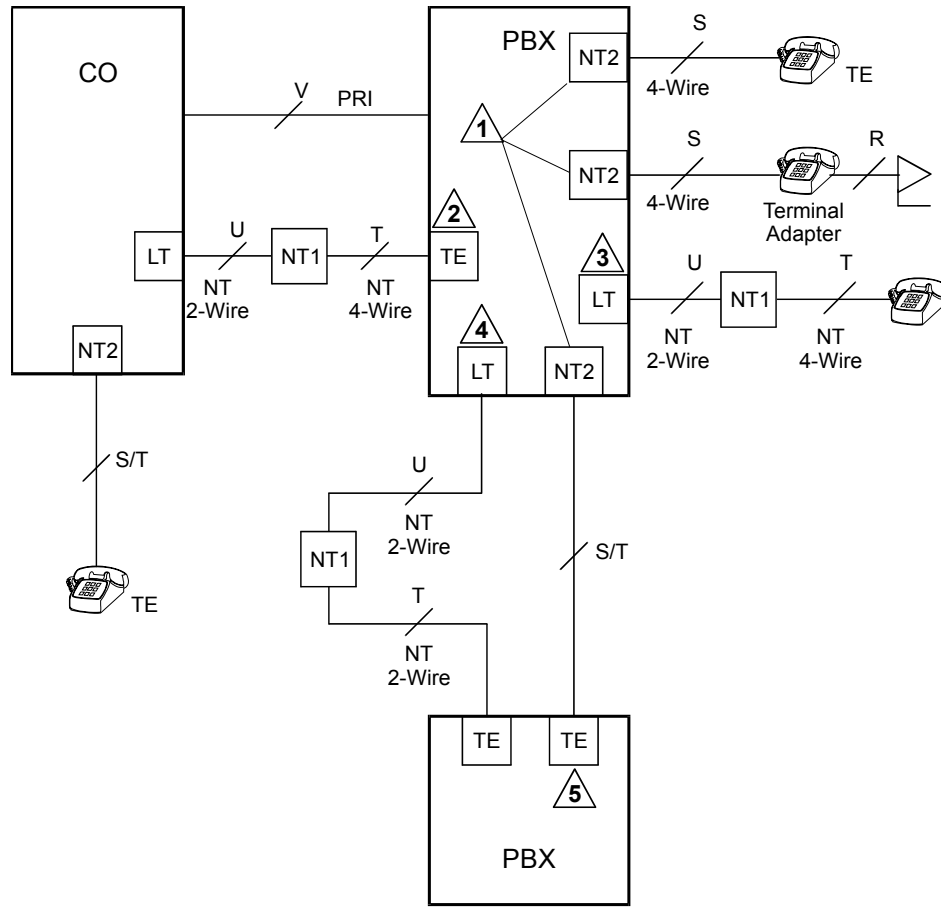
Figure 137: Integrated Trunk-Side BRI, ISDN Interface Reference points

ISDN Interface Reference Points

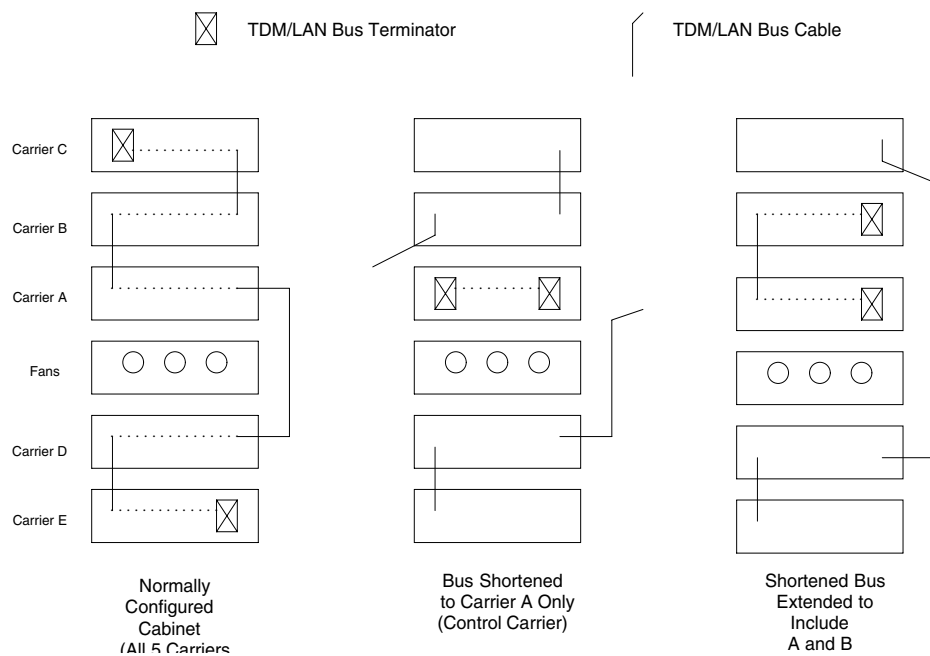
Figure 138: Carrier Rewiring Example — Rear View of 5-Carrier Cabinet

If replacement does not resolve the TDM-bus fault, the cabinet is reconfigured so that certain carriers are disconnected from the TDM bus. This is done by moving the TDM/LAN bus terminators (ZAHF4) on the carrier's backplane. To terminate a TDM bus at the end of a particular carrier, the TDM bus cable that connects the carrier to the next carrier should be unplugged and replaced with a TDM/LAN bus terminator (see [Figure 138](#)). As the length of a TDM bus is *modified*, any essential circuit packs to the system's operation and TDM-bus maintenance (for example, MSSNET and Tone-Clock), must still be connected to the *shortened* TDM bus.

After cabling changes are made and verified, power must be restored to the PN. Circuit packs in carriers outside the shortened bus are not inserted. As a result, these circuit packs are alarmed. Ignore these alarms for now. Every alarm should be resolved when the cabinet is restored to its original configuration.

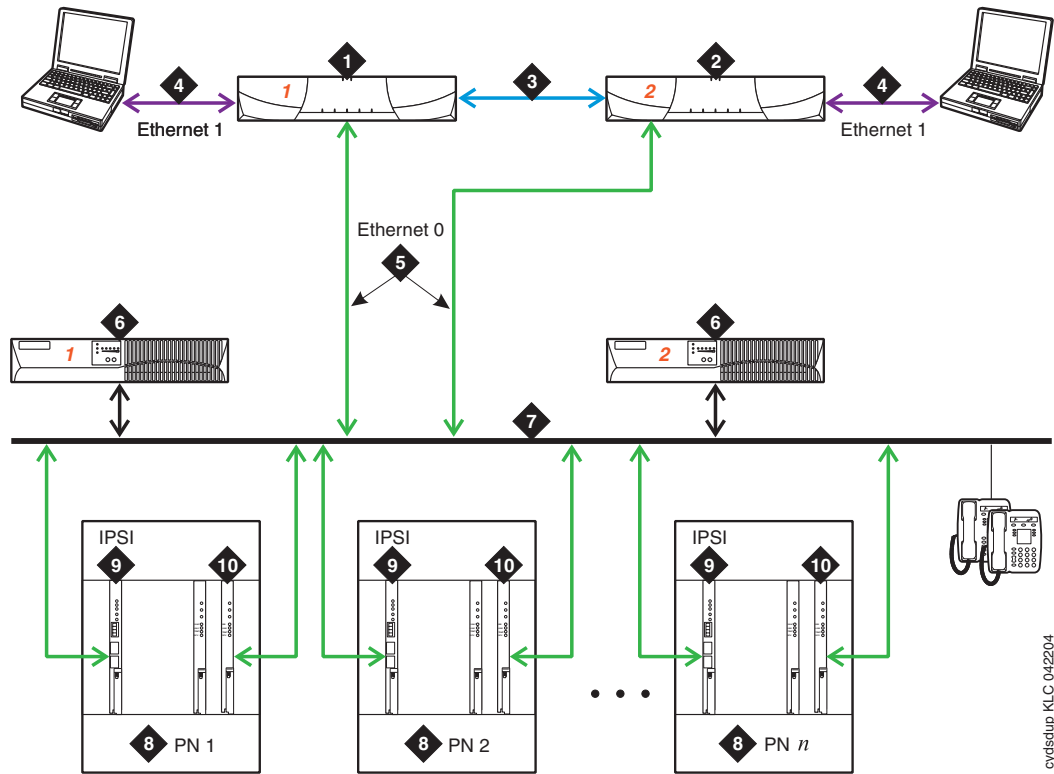
For systems using ATM-EI (TN2305/6 circuit packs) and where link alarms are present, see [ATM-EI \(Expansion Interface Circuit Pack\)](#) on page 525 and [Troubleshooting ATM](#) in *Maintenance Procedures (03-300192)*.

A Tone Clock circuit resides on each IPSI board. For increased reliability, there is a duplicated server, one in active mode and one on standby. However, there is only one control network and one IPSI per port network as shown in [Figure 139](#). Therefore there is only one Tone Clock circuit per port network.

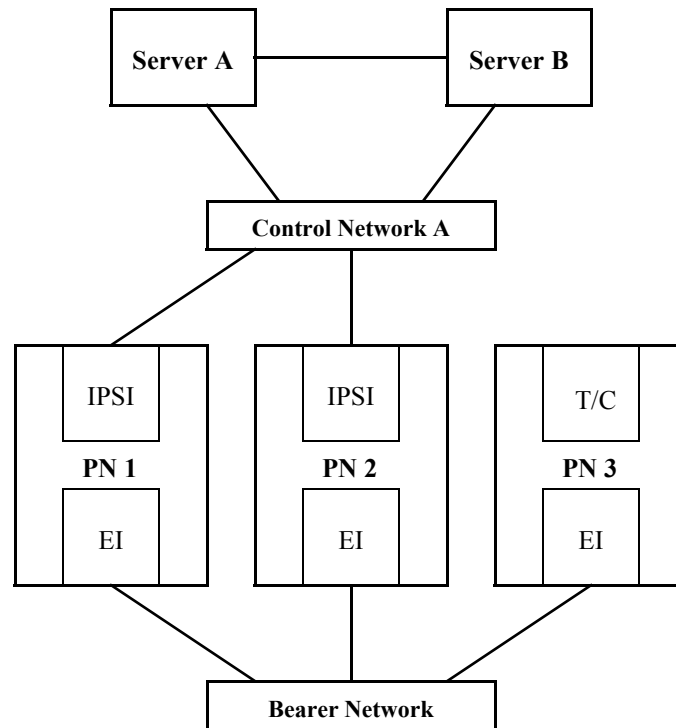
Figure 140: Duplex-Reliability Configuration

The duplex-reliability configuration shown in [Figure 140](#) has a duplicated server, an unduplicated control network, unduplicated IPSIs in the IPSI connected port networks, and an unduplicated bearer network. Therefore the Tone Clock is not duplicated in the IPSI connected port network. In the non IPSI connected port network, the Tone Clock boards are also not duplicated.

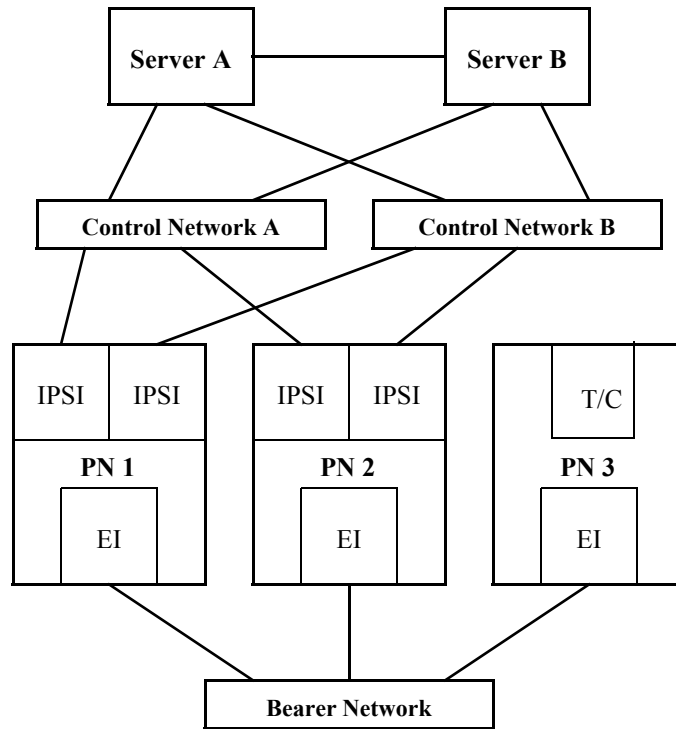
Figure 141: High-Reliability Configuration

S8700 MC: The high-reliability configuration shown in [Figure 141](#) has a duplicated server, a duplicated control network, and duplicated IPSIs in the IPSI connected port networks. With this configuration, every IPSI connected PN must have duplicated IPSIs. The control network is duplicated so that a single fault in the control network, such as a bad Ethernet switch, won't bring the whole system down. The non IPSI connected port networks have unduplicated Tone-Clock boards.

An EPN's Tone-Clock circuit pack configuration is the same as for the standard-reliability option. Each PN's Tone-Clock circuit is active for both tones and clock signals for its port network.

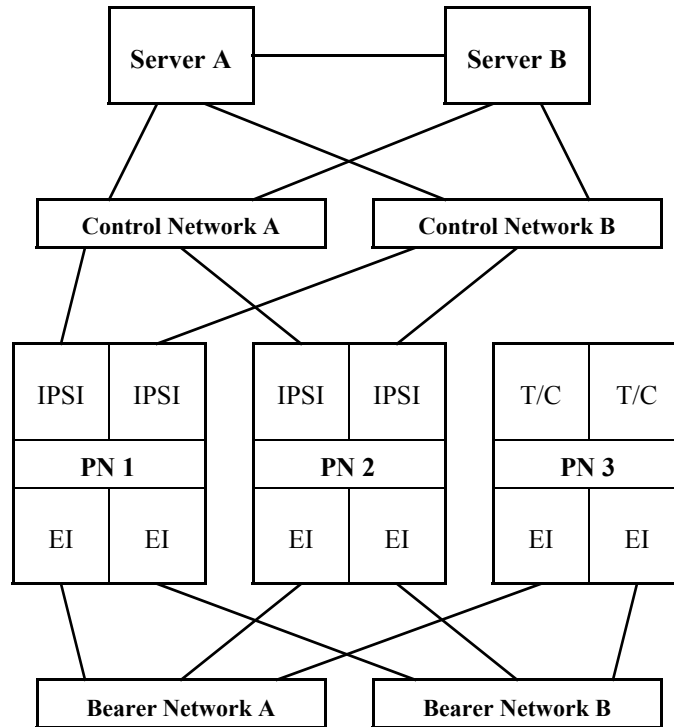
Figure 142: Critical-Reliability Configuration

S8700 MC: The critical-reliability configuration shown in [Figure 142](#) has full duplication of the following options: servers, control networks, IPSIs and PNCs (bearer networks). As with the high-reliability configuration, this configuration also requires that IPSI connected port networks have duplicated IPSIs. This configuration also requires that the non IPSI connected port networks have duplicated Tone-Clock boards (either TN2182 or TN780).

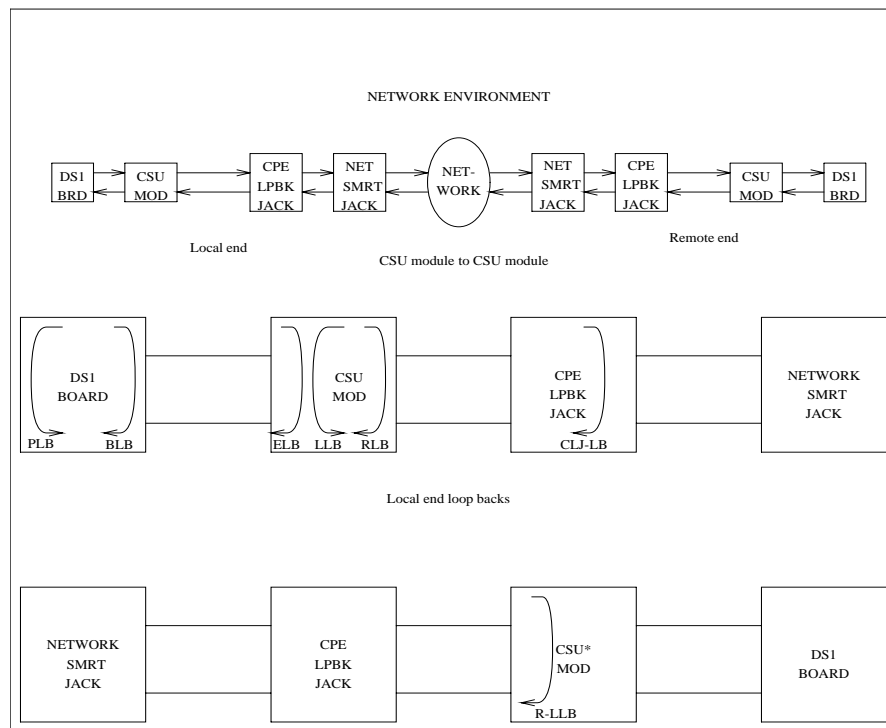
Figure 143: High Level Overview Of Loopback Points

These loop-back tests are explained in detail later in this UDS1-BD MO, but [Figure 143](#) gives a high level overview of the loop-back points.

The following list of acronym definitions are for the [Figure 143: High Level Overview Of Loopback Points](#):

- PLB = Payload Loopback

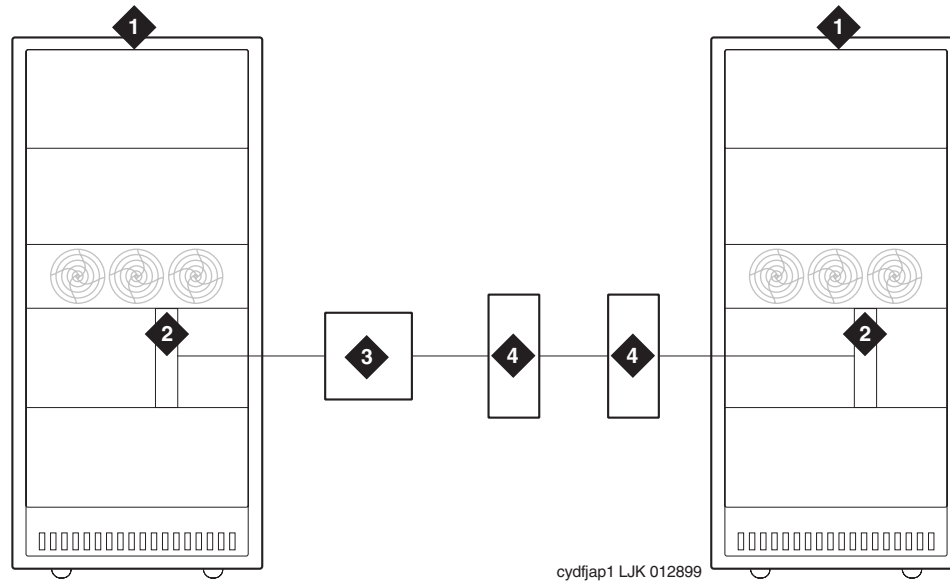
Figure 144: Japanese TTC public network connections

[Figure 144](#) shows the hardware connections for public network access in Japan. The upgrade procedure requires removing the JRC (Japan Radio Corporation) external converter.

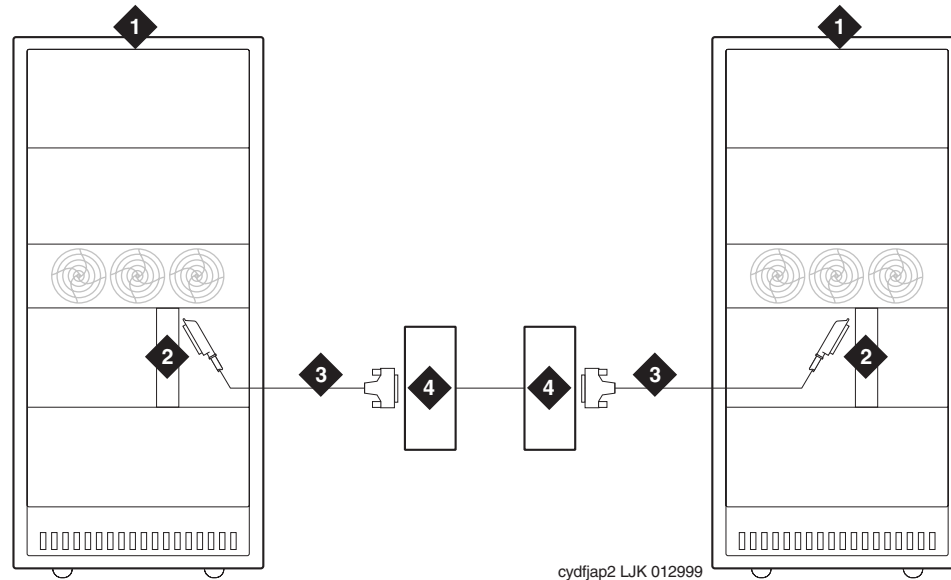
Figure 145: TN2242 Japan trunk TTC private network connections

[Figure 145: TN2242 Japan trunk TTC private network connections on page 2378](#) shows the hardware connections for private network access using the TN2242 circuit pack.

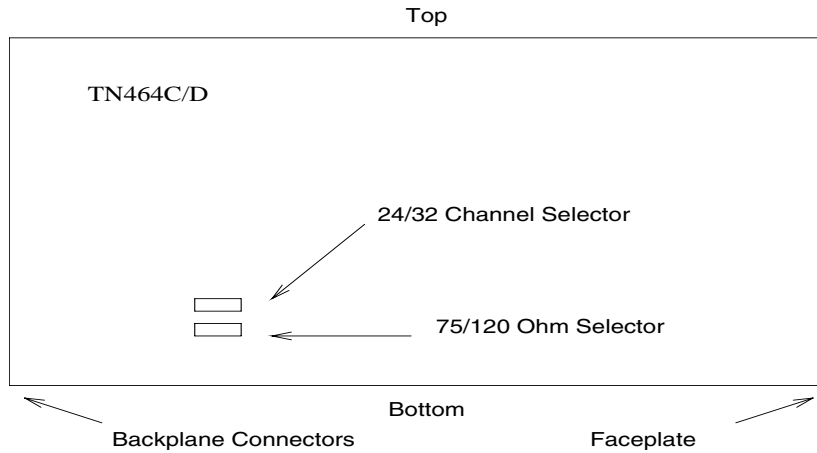
Figure 146: TN464C/D DS1 Option Jumpers

Two option jumpers located on the side of the TN464C/D circuit pack must be installed correctly. The figures on the following page show how to configure the circuit pack for 24- or 32-channel DS1, and for 75*W (coaxial) or 120*W trunk connections. The channel selection must match the parameters administered on the corresponding DS1 Circuit Pack screen. (US applications use 24 Channels.)

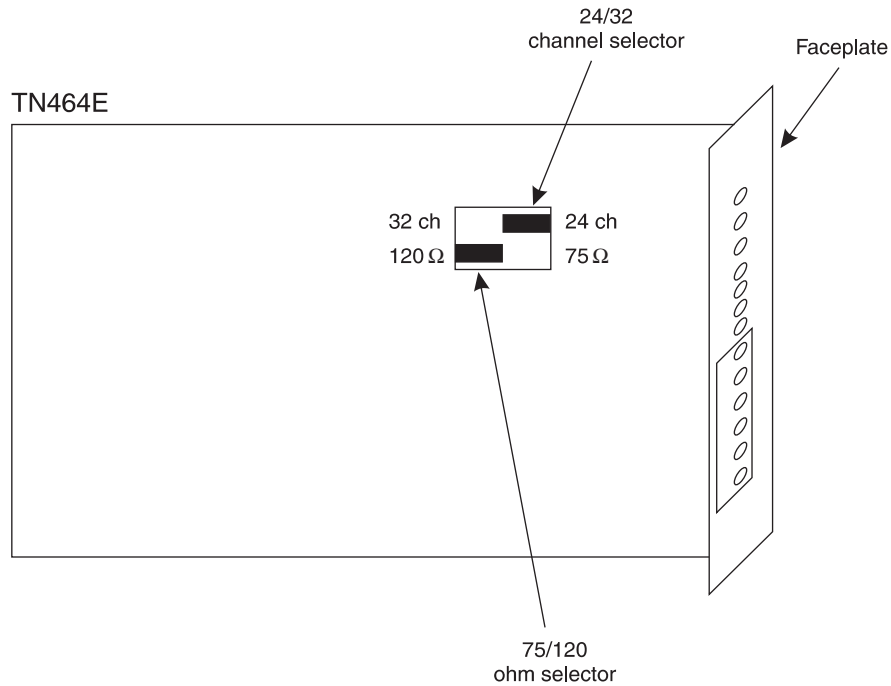
Figure 148: TN464E/F DS1 Option switches

The option switch located on the component side of the TN464E/F circuit pack must be set correctly. [Figure 148: TN464E/F DS1 Option switches](#) on page 2387 shows how to configure the circuit pack for 24-channel or 32-channel DS1. The channel selection must match the parameters administered on the corresponding DS1 Circuit Pack screen. (US applications use 24 Channels.)

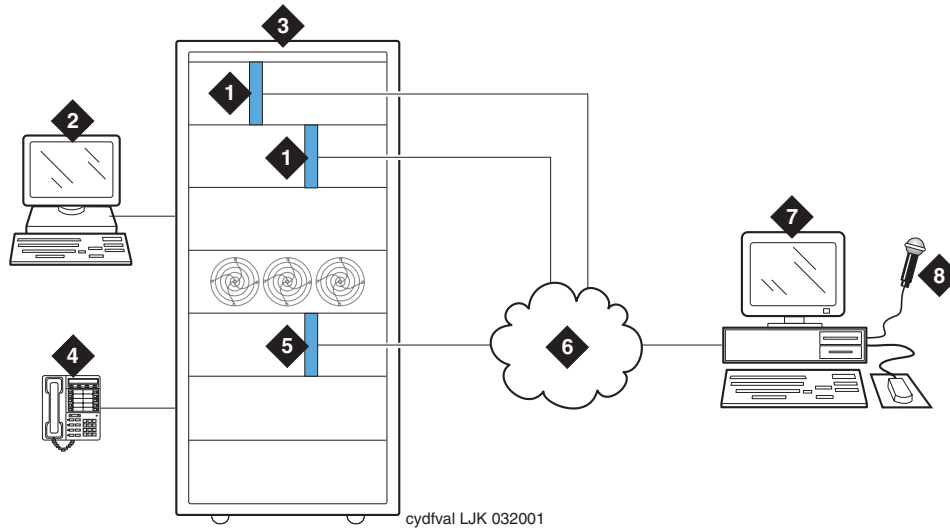
Figure 149: VAL configuration options

[Figure 149](#) shows the configuration options for the TN2501AP (VAL) circuit pack within a system.

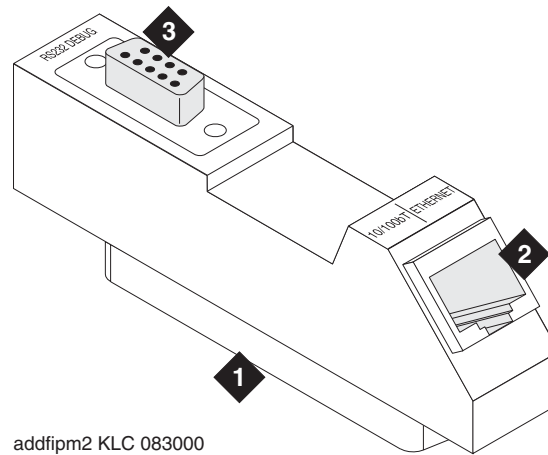
Figure 151: Backplane Adapter

The following figure shows the Backplane Adapter (label reads IP Media Processor).

Ethernet connection speed	Cable	Connection description
10 Mbps	Category 3	Connects through the RJ45 jack (note #2 in Figure 151),
100 Mbps	Category 5	Connects through the RJ45 jack (note #2 in Figure 151),

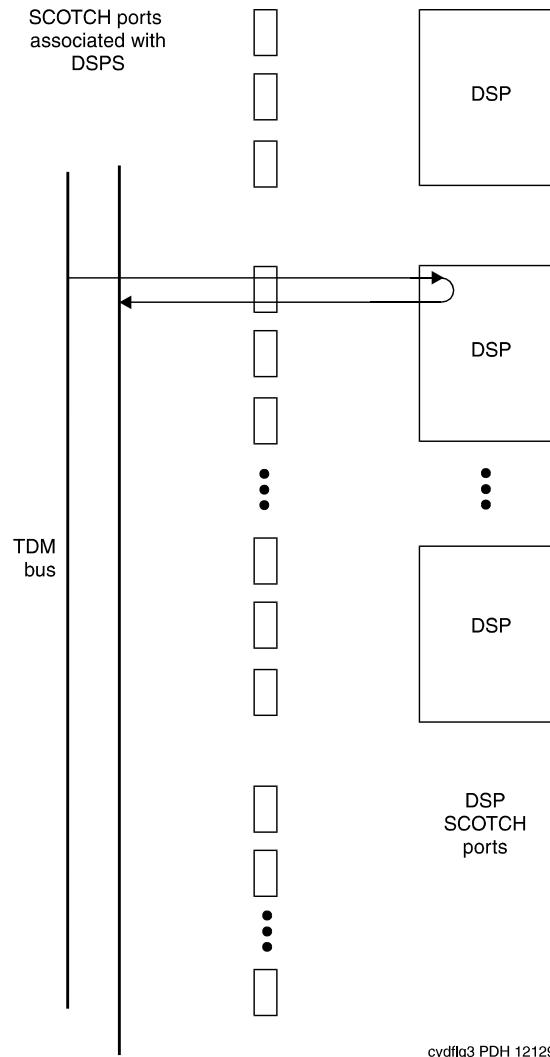
Figure 153: VC Circuit pack DSP Port DSP Loop-Around Test

This test verifies the connectivity of a VC-DSPPT across the TDM bus. It aborts if calls associated with the port are in progress. Failure of this test indicates an on-board fault associated with the port hardware on the circuit pack.
