Maintenance Alarms for Avaya Communication Manager, Media Gateways and Servers

03-300430
Issue 4
January 2008

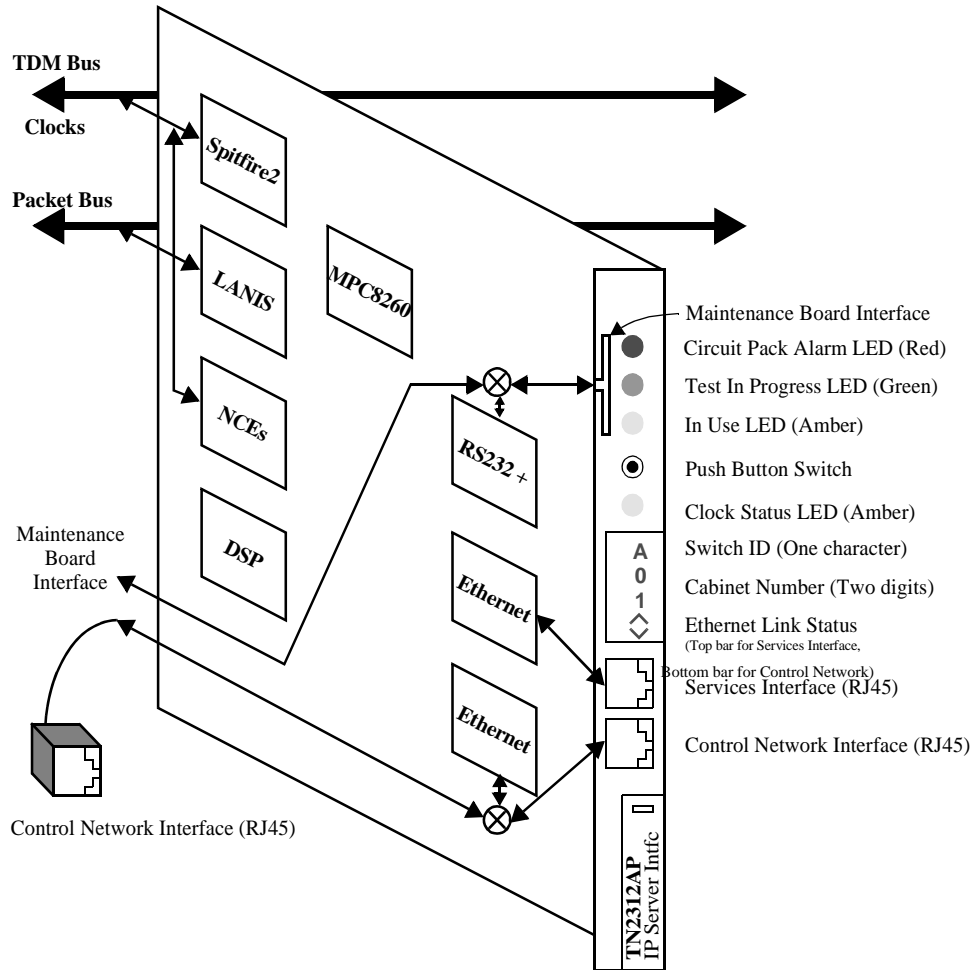
Figure 69: TN2312AP IPSI

The faceplate view of the TN2312AP IPSI is shown in [Figure 69: TN2312AP IPSI](#) and is described in the following sections.

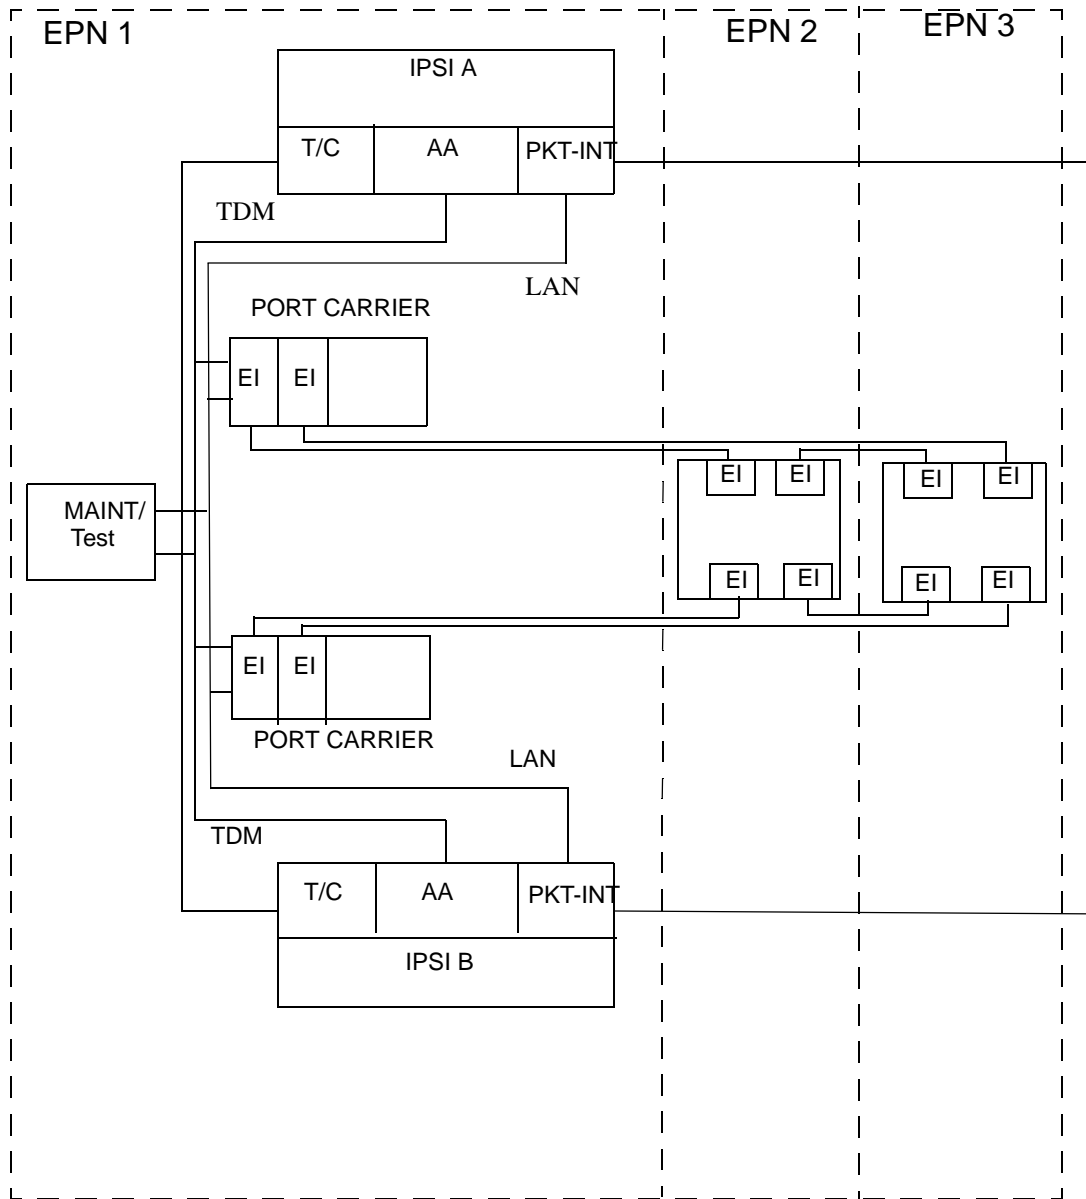
Figure 96: Duplicated Direct Connect PNC Connectivity

Although not part of the PNC, Tone-Clock circuit packs are also duplicated in each PN. The PNC is available in two different configurations: direct connect, in which each port network is connected directly by fiber optic links to each other PN; and Center Stage Switch (CSS) which utilizes one or two switch nodes to interconnect the PNs. Direct connect systems can have up to two PNs. CSS systems with one switch node can have up to 15 PNs. CSS systems with three switch node can have up to 44 PNs. See [Figure 96: Duplicated Direct Connect PNC Connectivity](#) and [Figure 97: Duplicated PNC with Center Stage Switch Connectivity](#).
