## IP Office Technical Bulletin

**Bulletin No:** 37  
**Date:** 31 March 2004  
**Region:** Global

Avaya is pleased to announce the availability of IP Office 2.1(31) Software. This is a scheduled maintenance release addressing a number of field issues found in the IP Office 2.1 releases.

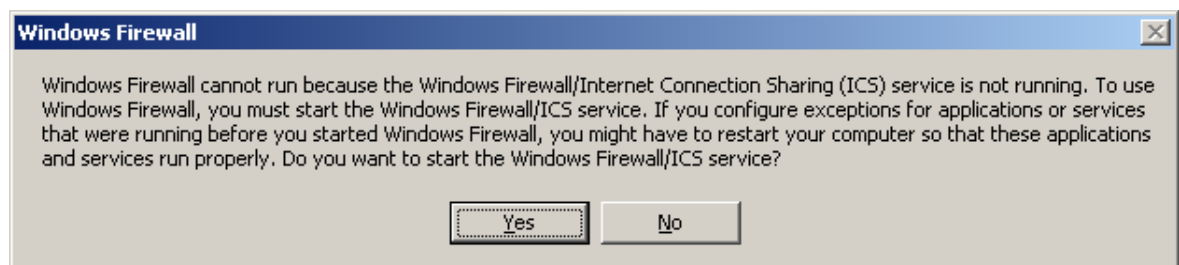
By selecting the firewall applet through the control panel in Server 2003 Service Pack 1, the user is presented by the following dialogue box.

If Internet Connection Sharing service is enabled, the operation of web services is affected. This has implications for the server, especially when used as a Compact Call Centre Server, for the Delta Server Service and the Reporter Service which are both accessed through web portals.

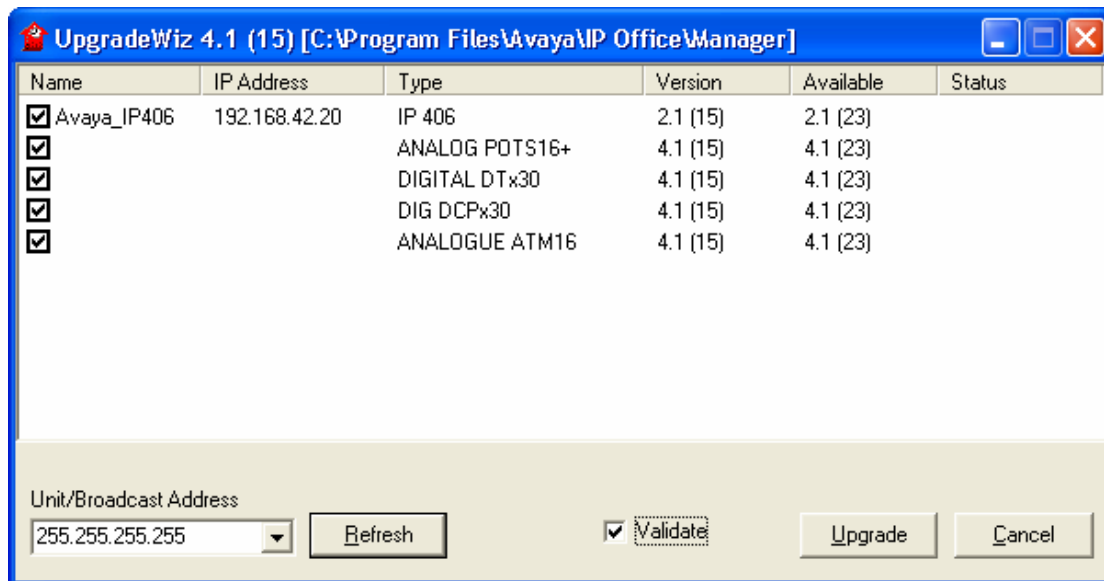
1. Ensure that you have received and made a backup copy of the latest IP Office configuration. If for any reason the upgrade fails the current configuration may be erased, so a backup copy is essential.
2. In Manager select File | Advanced | Upgrade. This will start the UpgradeWiz application.
3. After a few seconds the upgrade wizard should show the Control and Expansion units found.
4. If no units are found using the broadcast address 255.255.255.255 this implies that the Manager PC is not on the same LAN as the IP Office. You should not continue in this case until you identify a Manager PC on the same LAN as the IP Office.
5. A window similar to the following is displayed. The list shows the current software levels of the units and the level of the appropriate bin file that is available in the Manager/Binary working directories.

6. The current version and available versions are displayed. Tick the check box under Name if it is not already ticked then click on Upgrade.
7. Enter the password of the existing configuration (not the default). Click OK and IP Office will reboot and undergo the upgrade cycle. This takes around a minute to complete. Click OK to finish once the upgrade has completed. This will close the UpgradeWiz window.

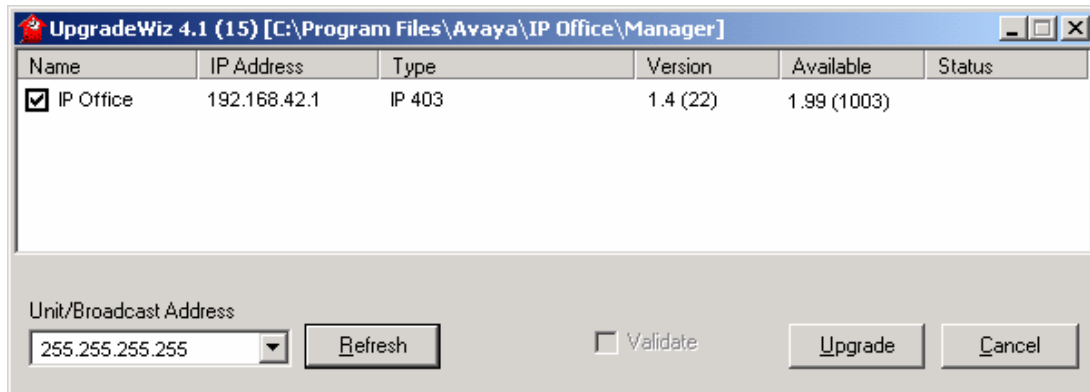
6. If no units are found using the broadcast address 255.255.255.255, this implies that the Manager PC is not on the same LAN as the IP Office. You should not continue in this case until you identify a Manager PC on the same LAN as the IP Office.
7. A window similar to the one below is displayed. The list shows the current software levels of the units and the level of the appropriate bin file that is available in the Manager/Binary working directories.

8. The current version and available versions are displayed. Tick the check box under Name if it is not already ticked then click on Upgrade.
9. Enter the password of the existing configuration (not the default). Click OK and IP Office will reboot and undergo the upgrade cycle. This takes around a minute to complete. Click OK to finish once the upgrade has completed. This will close the UpgradeWiz window.
