# **Intuity™ Messaging Solutions Integration with System 75, DEFINITY®**

Generics 1 & 3, and R5/6 Addendum:  
Centralized Voice Mail Installation

585-310-257ADD  
Comcode 108780396  
Issue 1-2  
April 2000

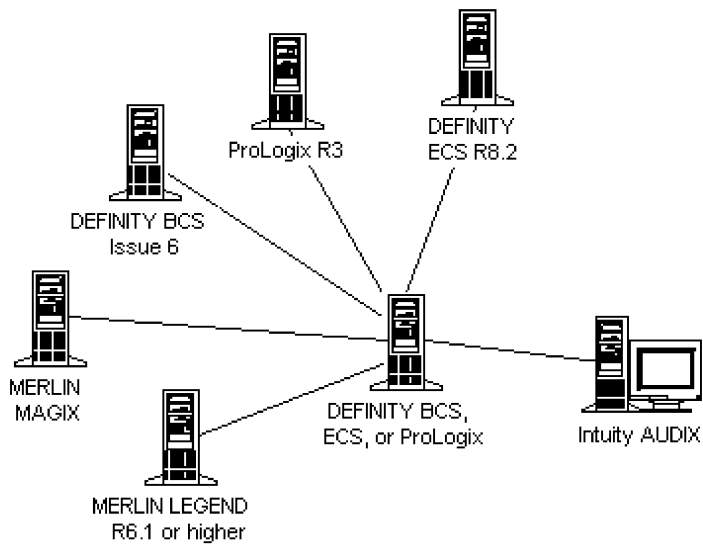
**Figure 1-1. DEFINITY R8.3 Network Configuration Example**

Centralized Voice Mail–Interswitch Mode Code provides customers with the ability to network together a number of small switches that can share one Lucent Intuity voice mail system. The feature uses mode code protocol for call transfer and communications. The set of disparate switches are networked to one switch hub, which then provides call transfer ability to the Lucent Intuity.
