Release Notes — Software Release 7.1.3 Avaya Ethernet Routing Switch 8800/8600

7.1.3
NN46205-402, 08.04
July 2012

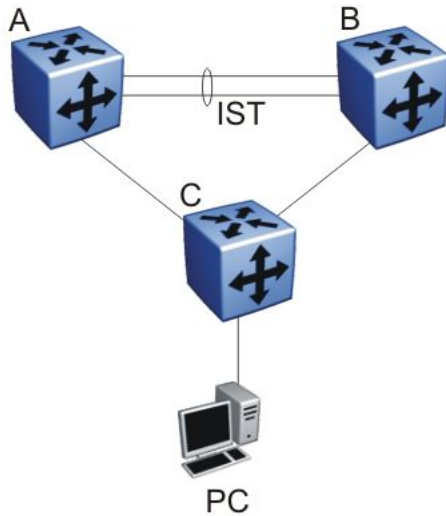
Consider the following figure, showing a triangle SMLT setup. In this case, the user intends to upgrade the IST peers (that are currently running 5.1.0.0) to 7.1.0.0.

Figure 1: SMLT upgrade scenario

Assume the user Telnets from the PC to manage switch A and switch B. When the Telnet traffic generated by the PC arrives at switch C, depending on the MLT hashing algorithm, the traffic can be hashed to the link toward switch A or switch B. So, it is possible to have a situation where the Telnet management traffic destined for switch A flows through switch B and vice-versa.

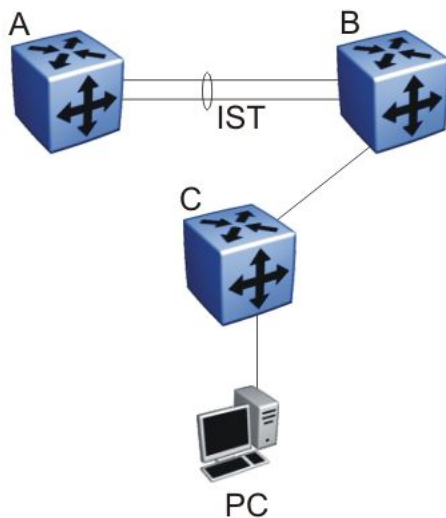
Assume that the user upgrades switch A to 7.1.0.0. Due to the SMLT behavior, the network diagram now looks like the following figure.

Figure 2: SMLT upgrade scenario after upgrading switch A to 7.1.0.0

In this situation the PC cannot communicate with switch A, and as a result Telnet access to switch A is unavailable. For in-band management, you can alternatively Telnet first into switch B, and then Telnet to switch A from there.
