Maintenance

DEFINITY ONE™
Communications System
Release 10

Volumes 1 and 2

555-233-130
Issue 1
December 2001

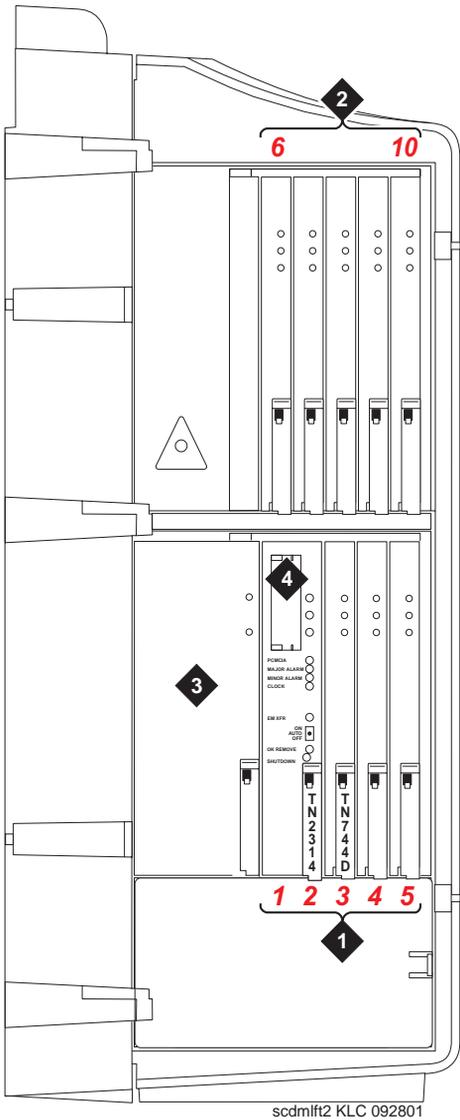
Figure 1-1. DEFINITY ONE Compact Modular Cabinet (CMC) slot configuration

1. Circuit pack slots 1 through 5
2. Circuit pack slots 6 through 10

WARNING:
The TN2314 processor circuit pack must be placed in slot 2 (shown)

- For more information about slot configuration in the primary CMC, see [Figure 1-1 on page 1-12](#).

The TN2314 Processor circuit pack must be located in slot 2. [Figure 1-1 on page 1-12](#) also shows the PCMCIA disk drive location.

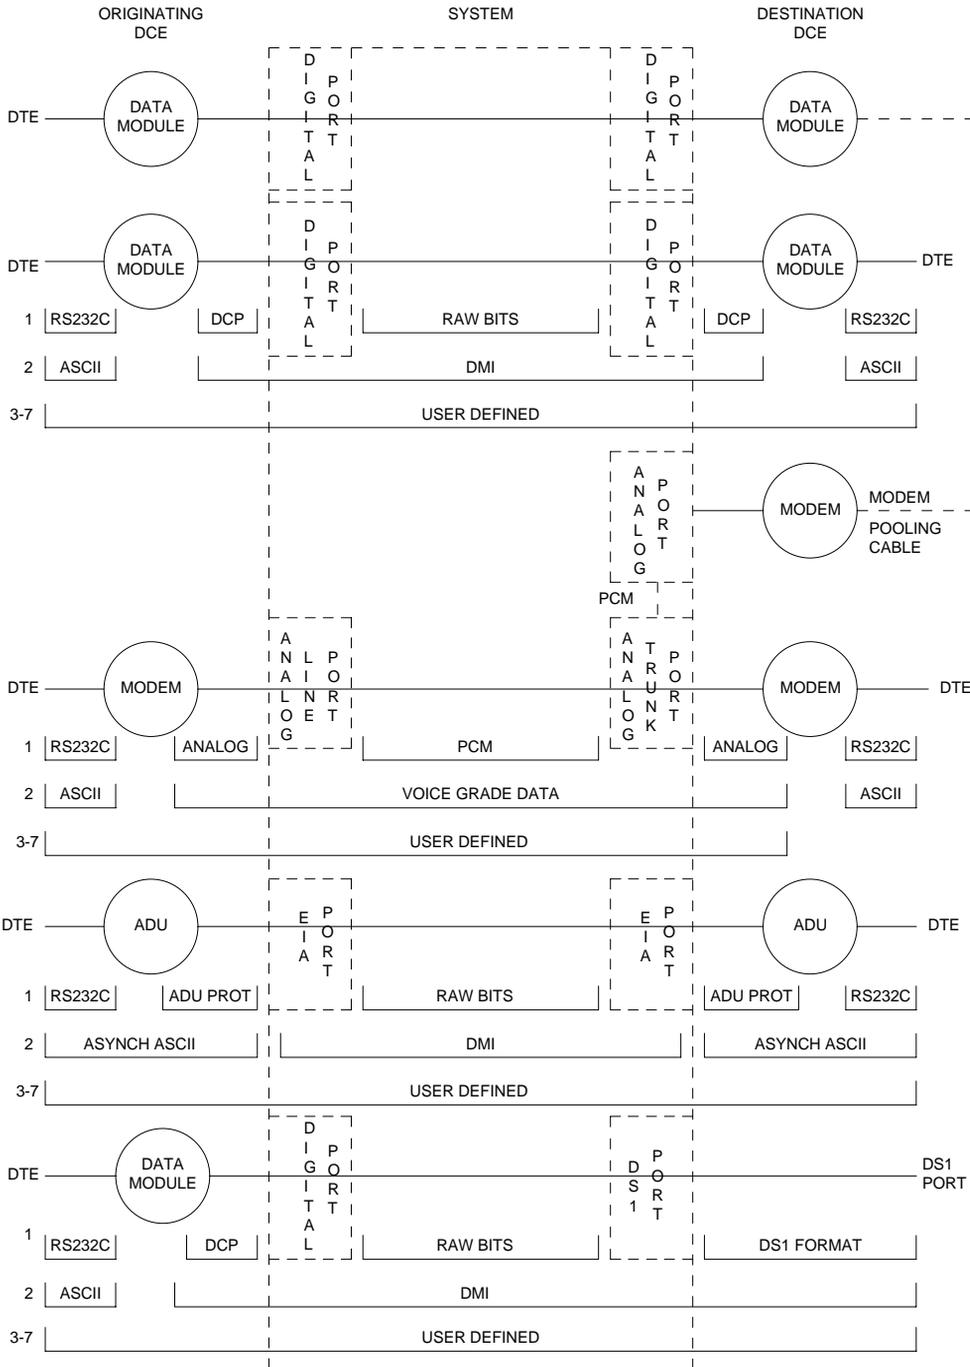
Figure 1-2. Data transmission states

Layers 3 to 7 (and the DTE-created layer 2) are embedded in the transmission stream and are meaningful only at the destination DTE equipment. Therefore, they are shown in [Figure 1-2 on page 1-24](#) as “user-defined,” with no state changes until the transmission stream reaches its destination.

The originating DTE equipment can also add layer-2 code to be analyzed by the destination DTE equipment. The DCE equipment treats this layer as data and passes it along to the destination DTE equipment as it would any other binary bits. Refer to [Figure 1-2 on page 1-24](#).

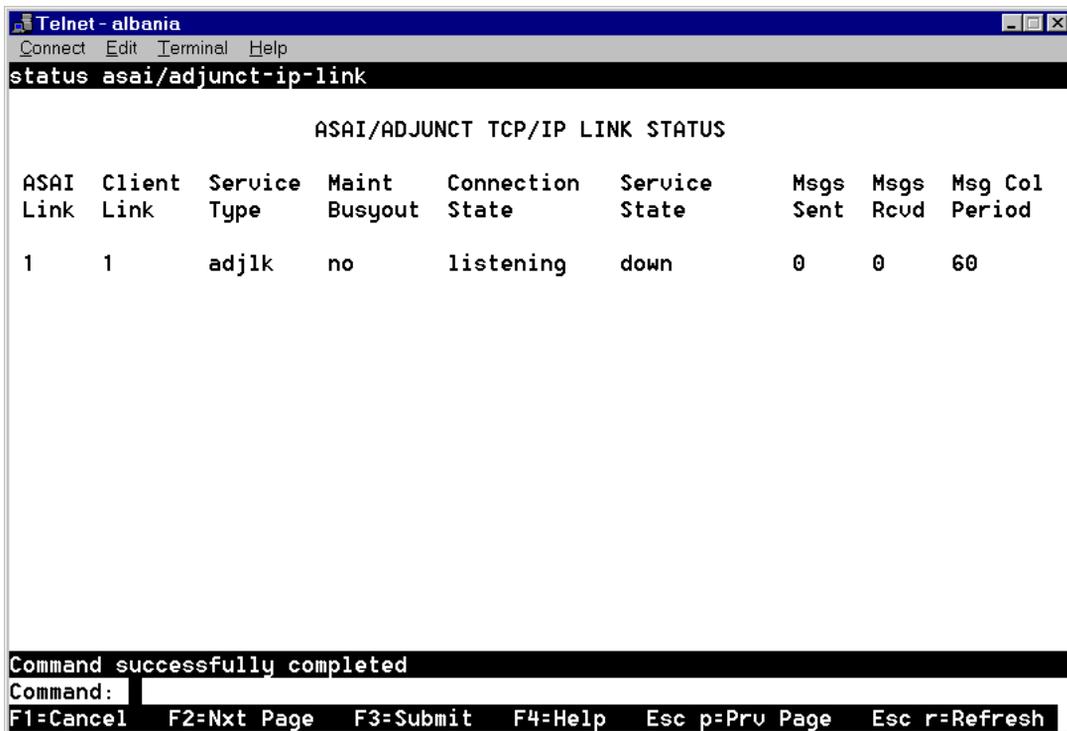
Figure 1-3. DLG links status

The Status ASAI/Adjunct-IP-Link form is used to obtain a summary of the connections to the built-in DLG feature. See [“ADJLK-IP \(ASAI Adjunct IP Link\)” on page 6-2](#). See [Figure 1-3](#). The form is provided here for reference only.

When a service is administered on the IP-Services form, the service type and link number are combined into a single keyword entry, for example, ADJLK1. However, on the above form the link number (1 in ADJLK1) is shown separately from the link or service type (ADJLK in ADJLK1). The *client's* link number is also shown for convenience. When using the TN801, this value is administered in DEFINITY as well as in the ASAI client. When using the DLG function, the client link number, assigned only in the client, is obtained by DEFINITY from the protocol and displayed on this form. It is not administered within DEFINITY.

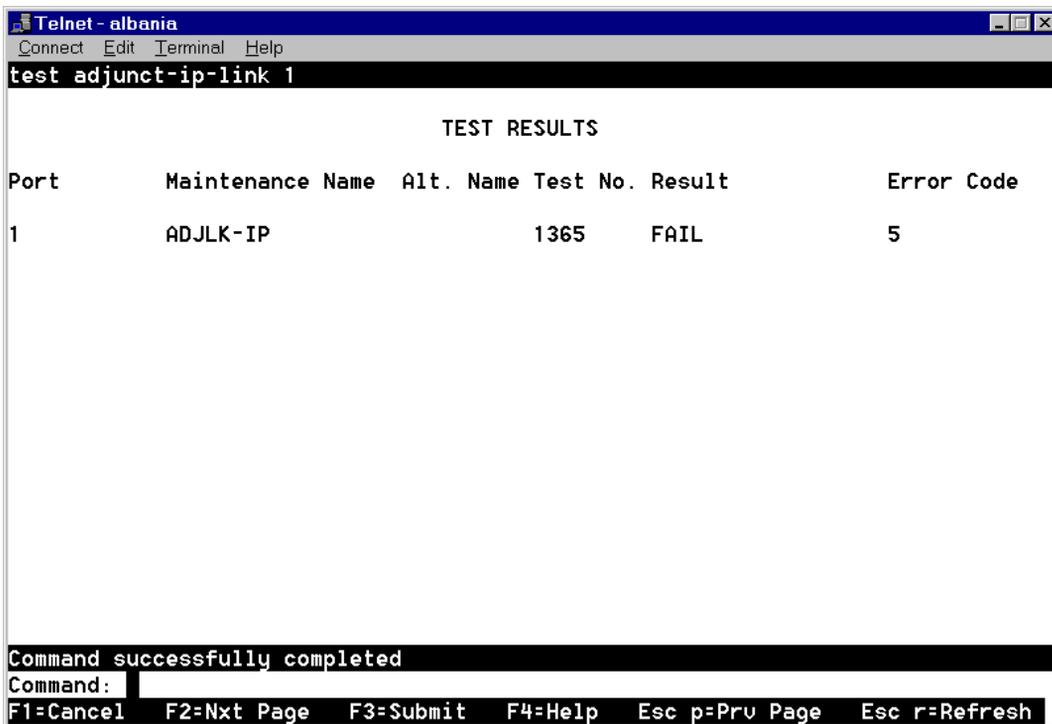
Figure 1-4. DLG links test

A test of these links is supported. The test causes a TCP-Tunnel Heartbeat message to be sent from DEFINITY and a Heartbeat Reply message to be returned from the client. See [Figure 1-4](#). The form is provided here for reference only.

```
Telnet - albania
Connect Edit Terminal Help
test adjunct-ip-link 1

TEST RESULTS

Port      Maintenance Name  Alt. Name Test No. Result      Error Code
1         ADJLK-IP          1365     FAIL        5

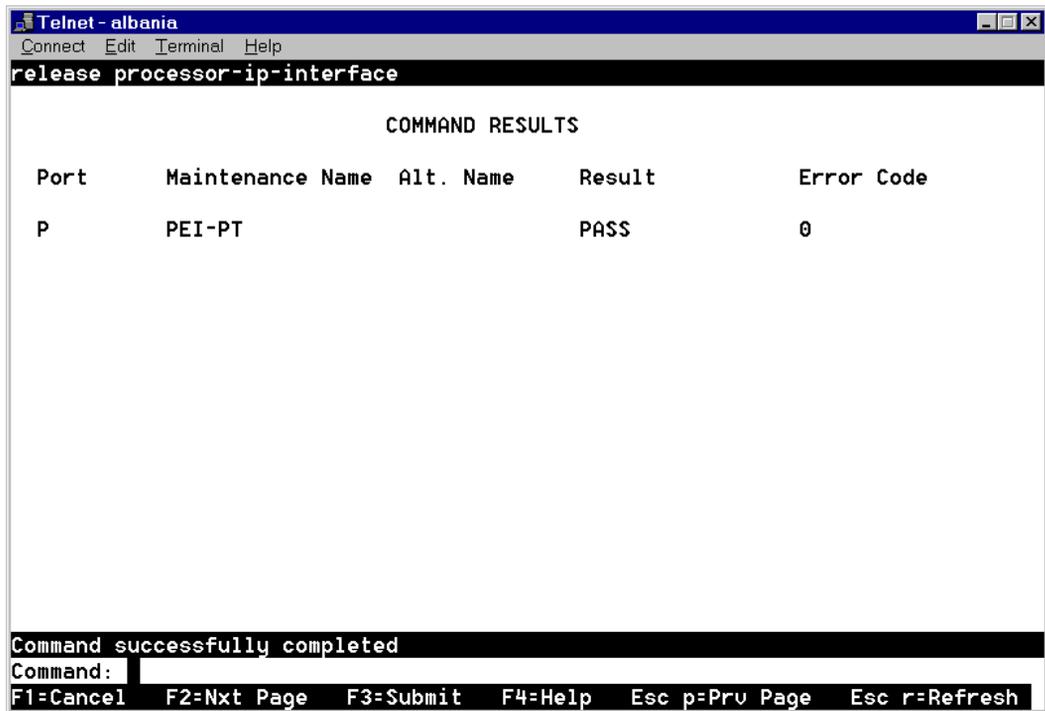
Figure 1-6. DLG release-from-busyout results

The **release** commands cause a message to be sent to the client indicating that link can again be used. See [“busyout adjunct-ip-link” on page 5-4](#). These commands do NOT busy out the TCP/IP connection. See [Figure 1-5](#).

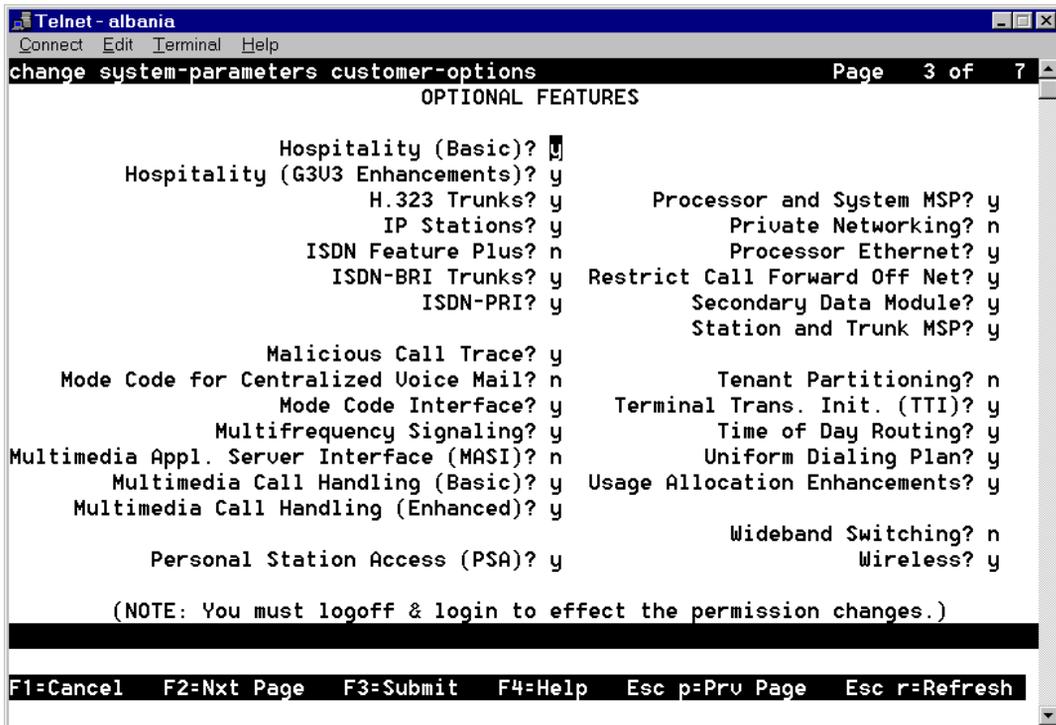
Figure 1-7. Processor ethernet customer option entry

Before the LAN interface on the TN2314 processor card can be used, it must be enabled on the Change System-Parameters Customer-Options form. See [Figure 1-7 on page 1-29](#). The form is provided here for reference only.

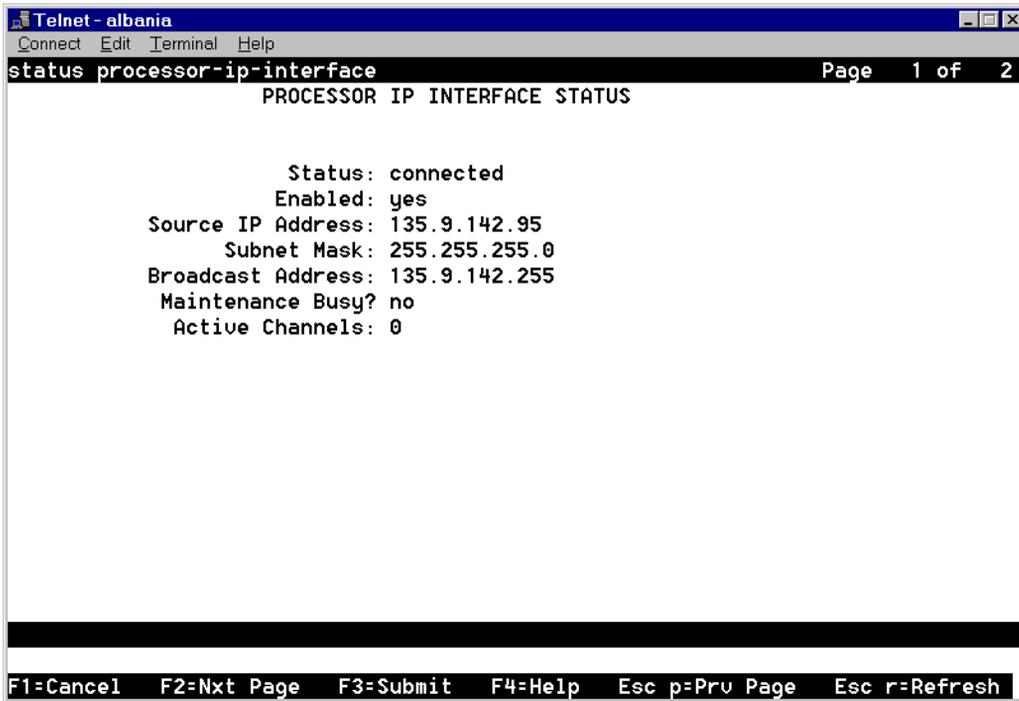
Figure 1-8. Processor interface status

For the **status** command, see [“status asai/adjunct tcp/ip link” on page 5-184](#). See [Figure 1-8 on page 1-30](#). This form is provided here for reference only.

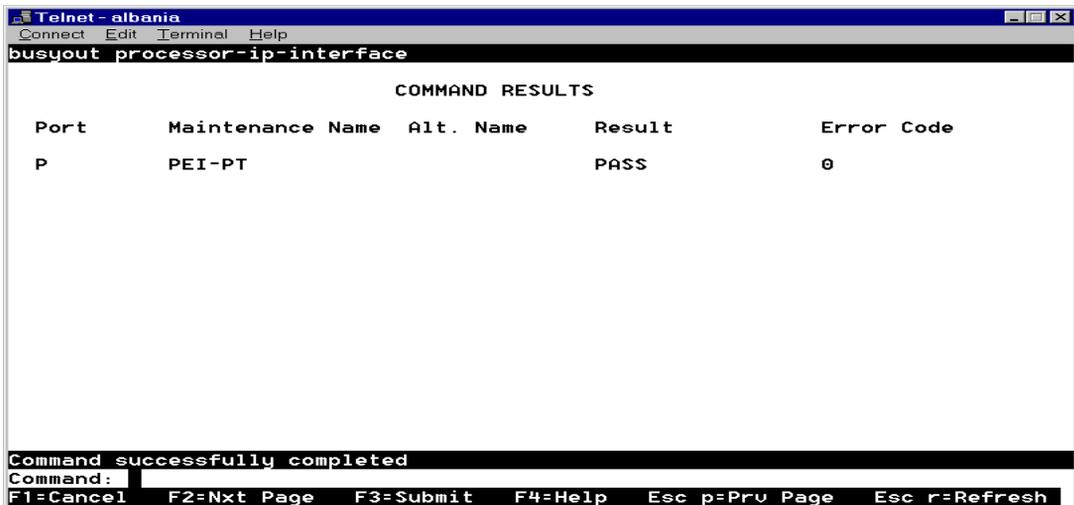
Figure 1-9. Processor busyout command results

For the **busyout** command, see [“busyout adjunct-ip-link” on page 5-4](#). See [Figure 1-9 on page 1-31](#). This form is provided here for reference only.

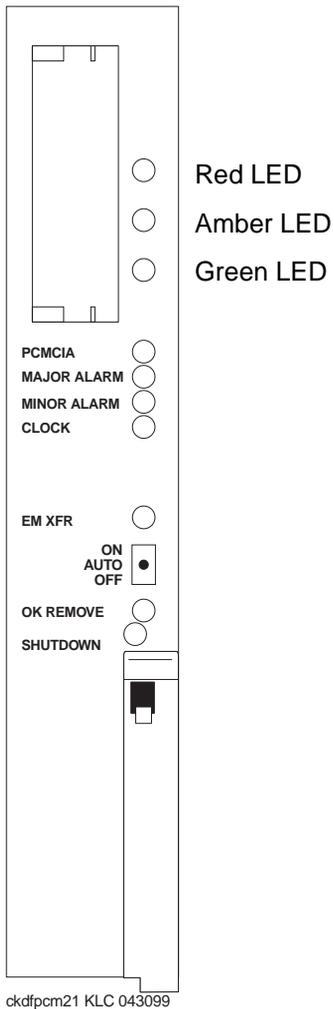
Figure 1-12. LED indicators on the TN2314 processor circuit pack

11. 860 Core test failed. Try power cycling the circuit pack. Replace circuit pack if it keeps failing.
12. Pentium BIOS update mode is activated.
13. Entering factory diagnostic mode. Wait about 35 seconds for 860 Core test to finish.

The front pane has two groups of LEDs. One group indicates the status of the pack, and the other group (which includes the Major, Minor, and Warning alarms described in the [“Alarm and error reporting”](#) section) reflects maintenance conditions in the entire system. See [Figure 1-12 on page 1-44](#) and [Table 1-2](#).

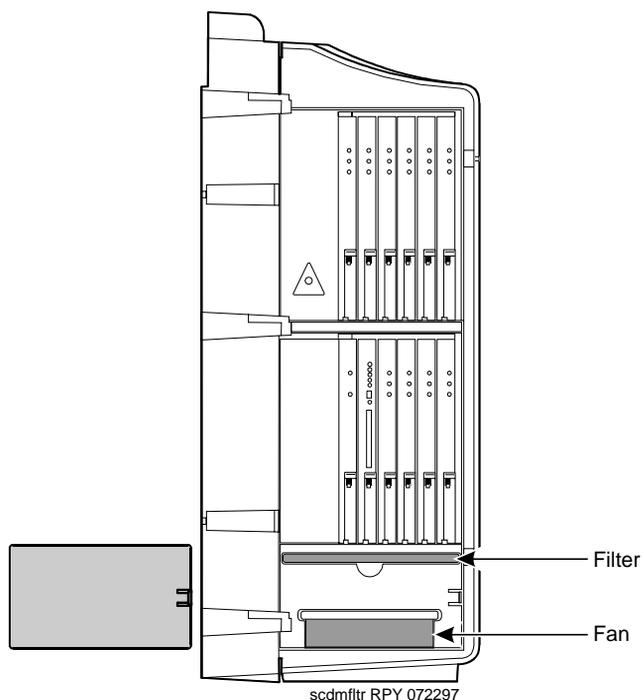
Figure 2-1. Fan/filter removal

1. Remove the left door.
2. Remove the fan access panel from the left side of the cabinet.
3. Pull the fan filter from the chassis.
4. Clean (vacuum or wash with water) or replace the filter as needed and slide the filter back into the chassis.
5. Replace the fan access panel.

If	Then
Filter is dirty or clogged	Tap filter on the ground.
Tapping does not dislodge dirt or clog	Wash with warm water and mild detergent, or clean with a vacuum cleaner (if one is available).
No facility exists for washing or vacuuming	Replace air filter (Comcode 407745009). Refer to Figure 2-1 on page 2-3 for more information on air filters and fans.

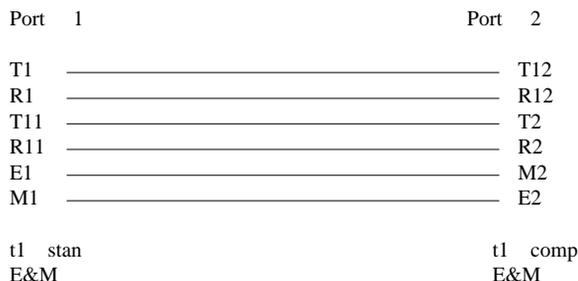
12. Use jumper wires (DT 24M-Y/BL/R/G and DT 24P-W/BRN) and the D Impact Tool to connect wiring between the two ports assigned in Step 9 at the cross-connect field. For example, if the two ports on the Analog Tie Trunk circuit pack are port 1 and 2, connect the wirings as shown below:

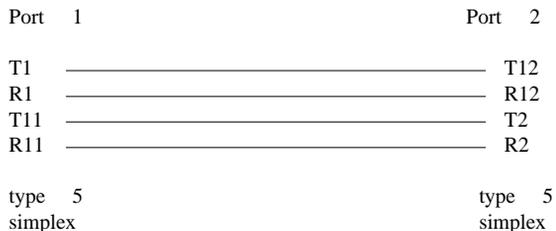
4. Locate the Tie Trunk port terminal connections at the cross-connect field. See [Table 2-4 on page 2-29](#).
5. At the cross-connect field, disconnect outside trunk facilities from the Analog Tie Trunk ports and mark the disconnected wires for later when the Tie Trunk ports are placed back into normal operation. The D Impact Tool (AT-8762) is required to perform this step.
6. Use jumper wires (DT 24M-Y/BL/R/G) and the D Impact Tool to connect wiring between the two ports assigned in [Step 4](#) at the cross-connect field. For example, if the two ports on the Analog Tie Trunk circuit pack are ports 1 and 2, connect the wirings as shown below:

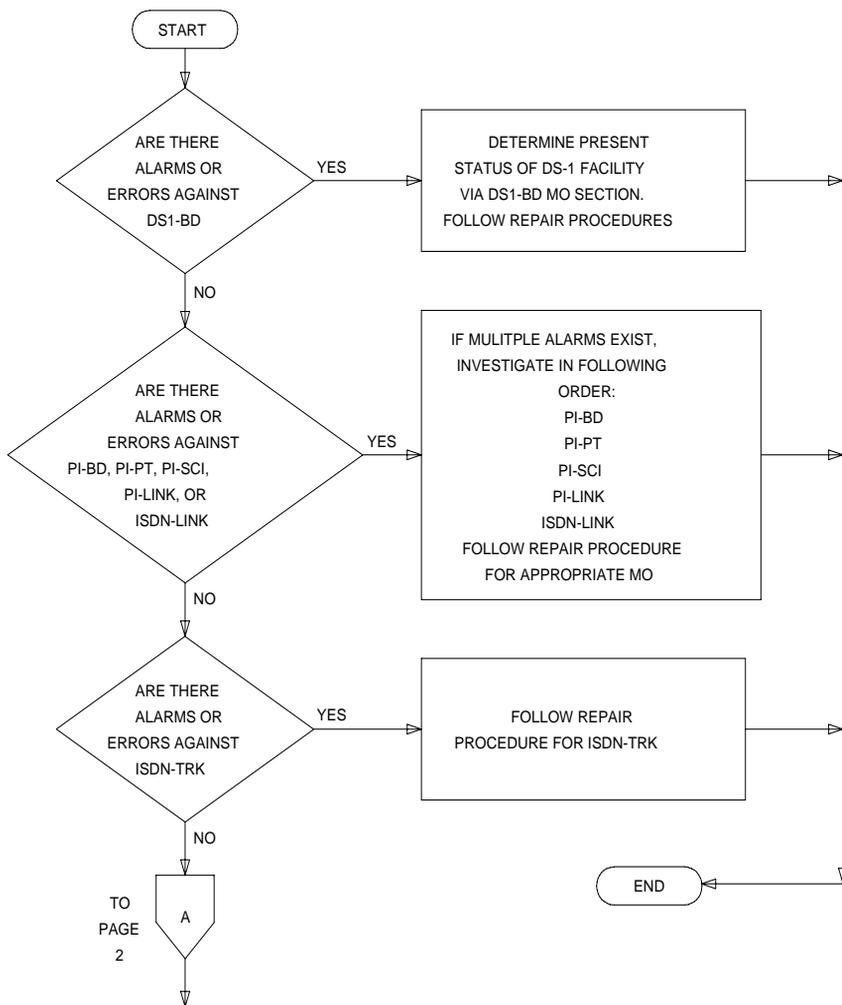
Figure 2-6. Processing of ISDN-PRI problems (page 1 of 2)

The following flowchart, [Figure 2-6](#) and [Figure 2-7](#) on page 2-35, defines a layered approach when troubleshooting ISDN-PRI problems. Since a problem at a lower layer affects upper layers, layers are investigated from low to high. In the flowchart, the DS1 facility is layer 1, the TN765 Processor Interface is layer 2, and the ISDN trunks are layer 3. Transient problems are diagnosed on Page 2 of the flowchart, [Figure 2-7](#) on page 2-35.

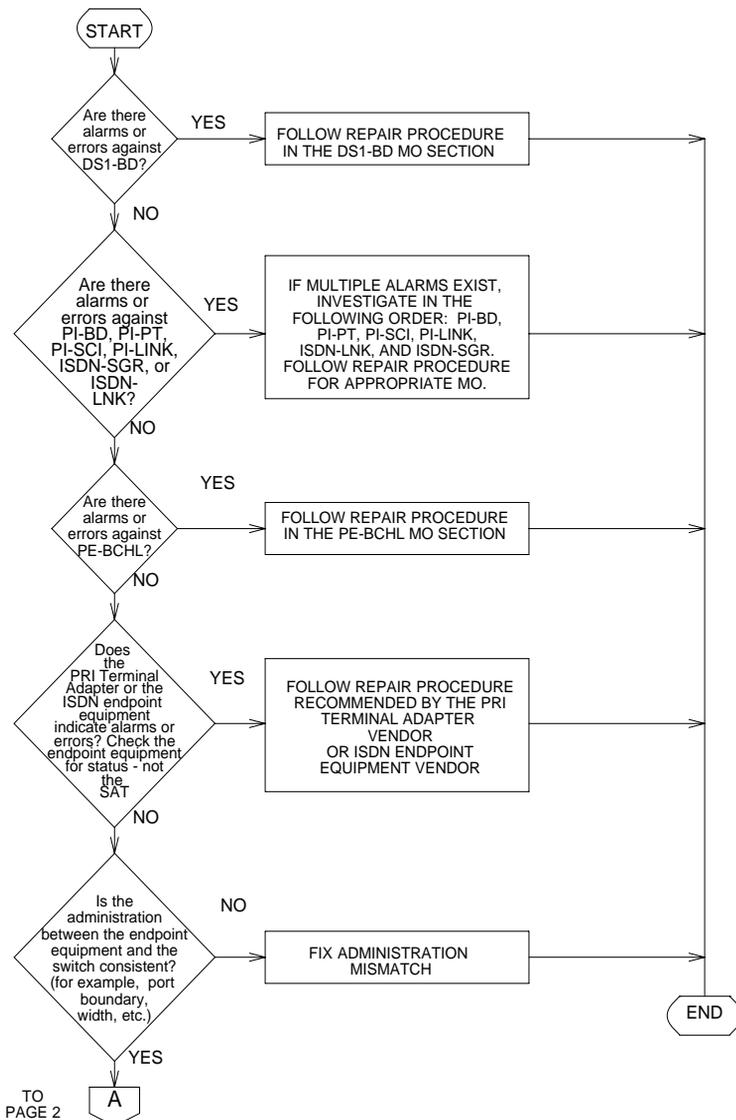
Figure 2-8. Processing of PRI endpoint problems (page 1 of 2)

The following flowchart, [Figure 2-8 on page 2-36](#) and [Figure 2-9 on page 2-37](#), defines a layered approach when troubleshooting PRI endpoint problems. Since a problem at a lower layer affects upper layers, layers are investigated from low to high. In the flowchart, the DS1 facility is layer 1, the TN765 Processor Interface is layer 2, and the ISDN trunks are layer 3.

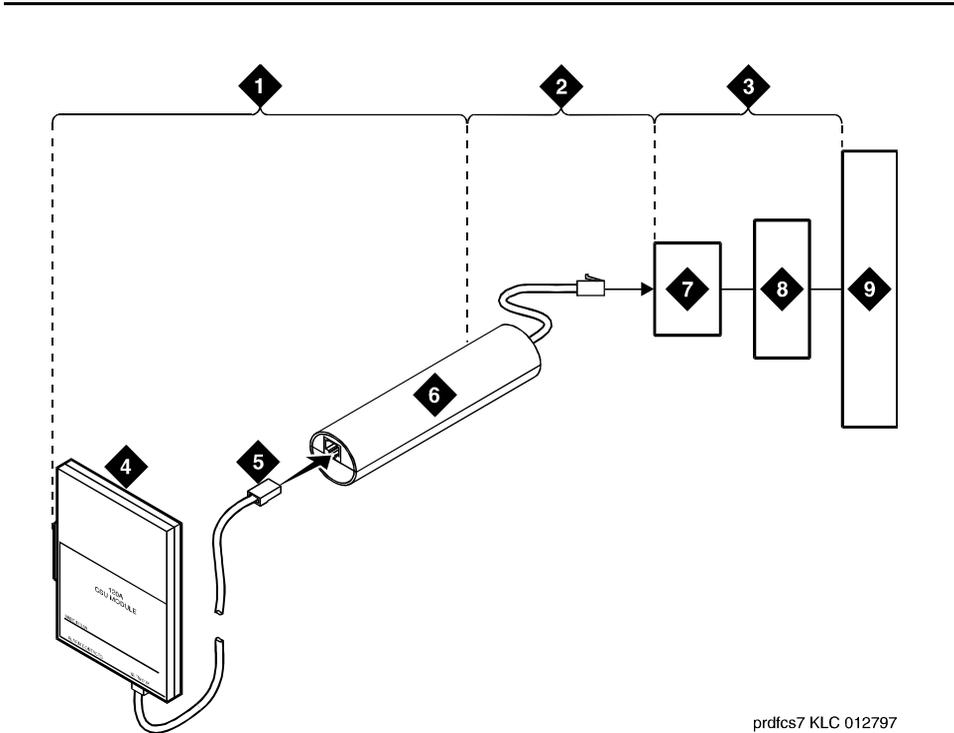
Figure 2-11. Network interface at Smart Jack

| | 9. Central Office |

The addition of the loopback jack and the presence of a Smart Jack divides the DS1 span into 3 separate sections for fault isolation. These sections are shown in [Figure 2-11 on page 2-47](#) through [Figure 2-13 on page 2-49](#) for the different span configurations. They are:

- Test customer premises wiring (section 1 in the following 3 figures) from the ICSU to the loopback jack as described in “DS1 Span Test.”
- Test the CO-to-network interface wiring (section 3 in [Figure 2-11 on page 2-47](#)) using the Smart Jack loopback (CO responsibility). Coordinate this test with the DS1 provider.

Fiber MUXes can take the place of Interface termination feeds as shown in [Figure 2-11 on page 2-47](#), [Figure 2-12 on page 2-48](#), [Figure 2-13 on page 2-49](#), and [Figure 2-14 on page 2-50](#). Test these spans using the same procedures as metallic spans. Note the following points:

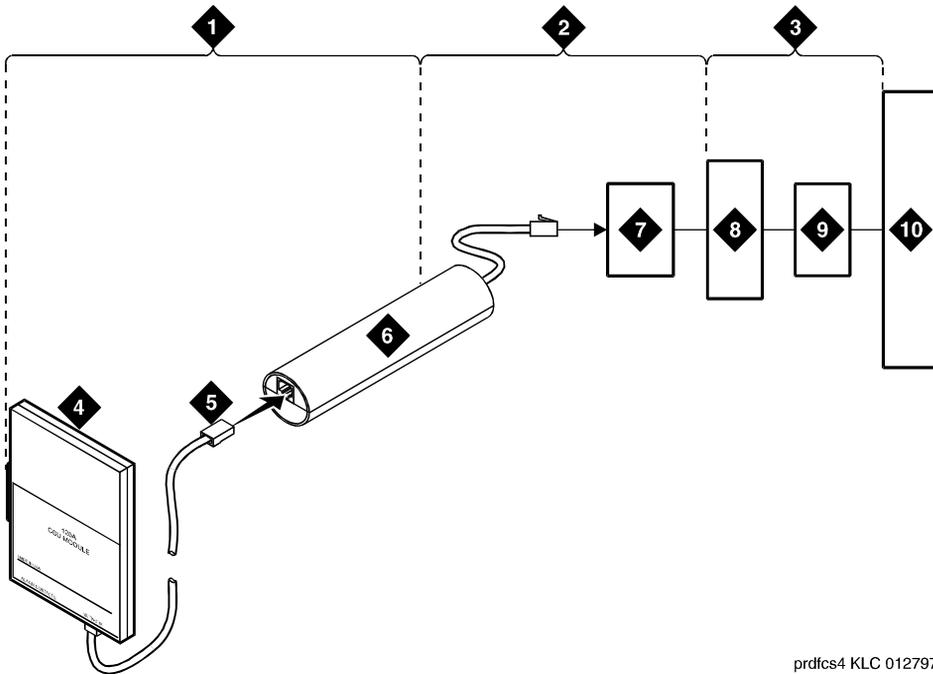
Figure 2-12. Network interface at extended demarcation point (Smart Jack inaccessible)

| 5. RJ-48 to Network Interface (Up to 1000 Feet) (305 m) | 10. Central Office |

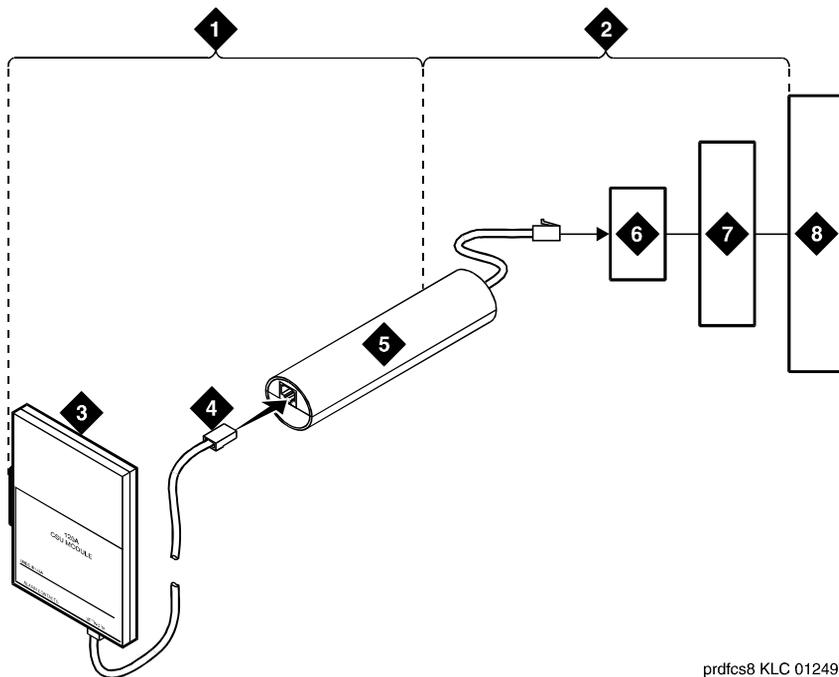
Figure 2-14. Network interface at "dumb" block

When the loopback jack is added to a span that does not contain a Smart Jack, the span is divided into 2 sections. See [Figure 2-14](#) and [Figure 2-15](#) on page 2-51.

1. ICSU to the loopback jack.
2. Loopback jack to the Central Office (CO).

| 4. RJ-48 to Network Interface (Up to 1000 Feet) (305 m) | 8. Central Office |

1. Test customer premises wiring (section 1 in [Figure 2-14 on page 2-50](#)) from the ICSU to the loopback jack as described in the “DS1 Span Test” section.

2. Test the loopback jack-to-”dumb” block and “dumb” block-to-CO wiring (section 2 in [Figure 2-14 on page 2-50](#)). This can be done using a loopback that “overlaps” the section of the span. Any of the following loopbacks can do this:

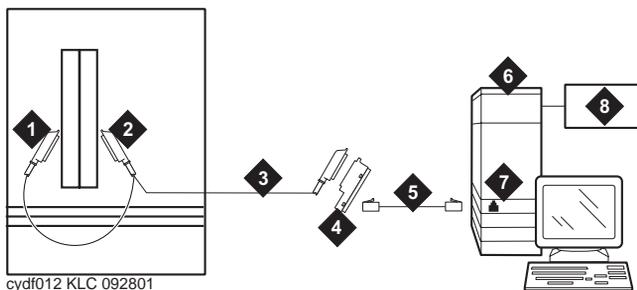
Figure 2-16. Typical ESM connections

The Expansion Services Module (ESM) shown in [Figure 2-16](#) provides T.120 data sharing capability on a MMCH multipoint H.320 video conference. Each conference participant must have endpoints administered and a personal computer with the H.320 video application installed. The DEFINITY ECS must have the expansion service module installed.

1. Port B Y-cable connector to a TN787 Multimedia Interface (MMI) circuit pack
2. Port A Y-cable connector to a TN2207 PRI circuit pack
3. 25-pair Y-cable
4. 356A adapter
5. D8W cord connected to 356A adapter port 1
6. Expansion Service Module (ESM)
7. Port B on compatible primary rate interface (PRI) card

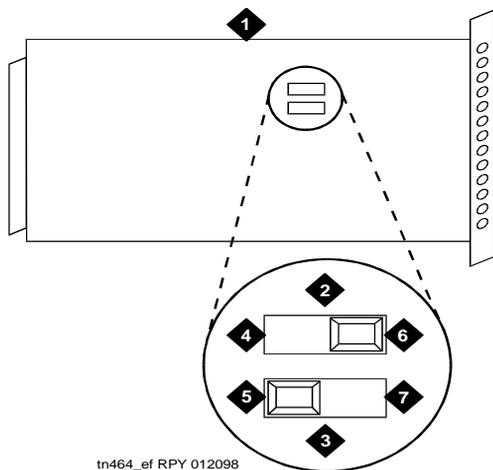
- 1. Backplane Connectors
- 2. 24/32 Channel Selector
- 3. 75/120 Ohm Selector
- 4. Faceplate
- 5. 32 Channel
- 6. 120 Ohm (shown selected)
- 7. 24 Channel (shown selected)

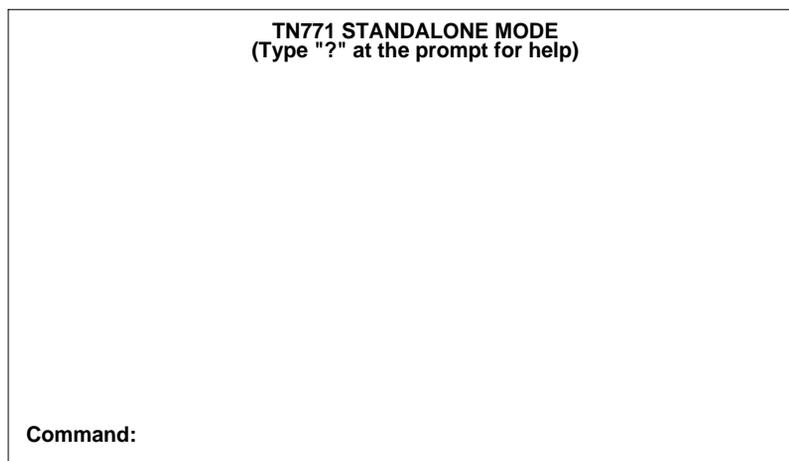
Figure 3-1. Normal Standalone Mode Display

If the standalone mode is entered successfully, the following is displayed on the connected terminal:

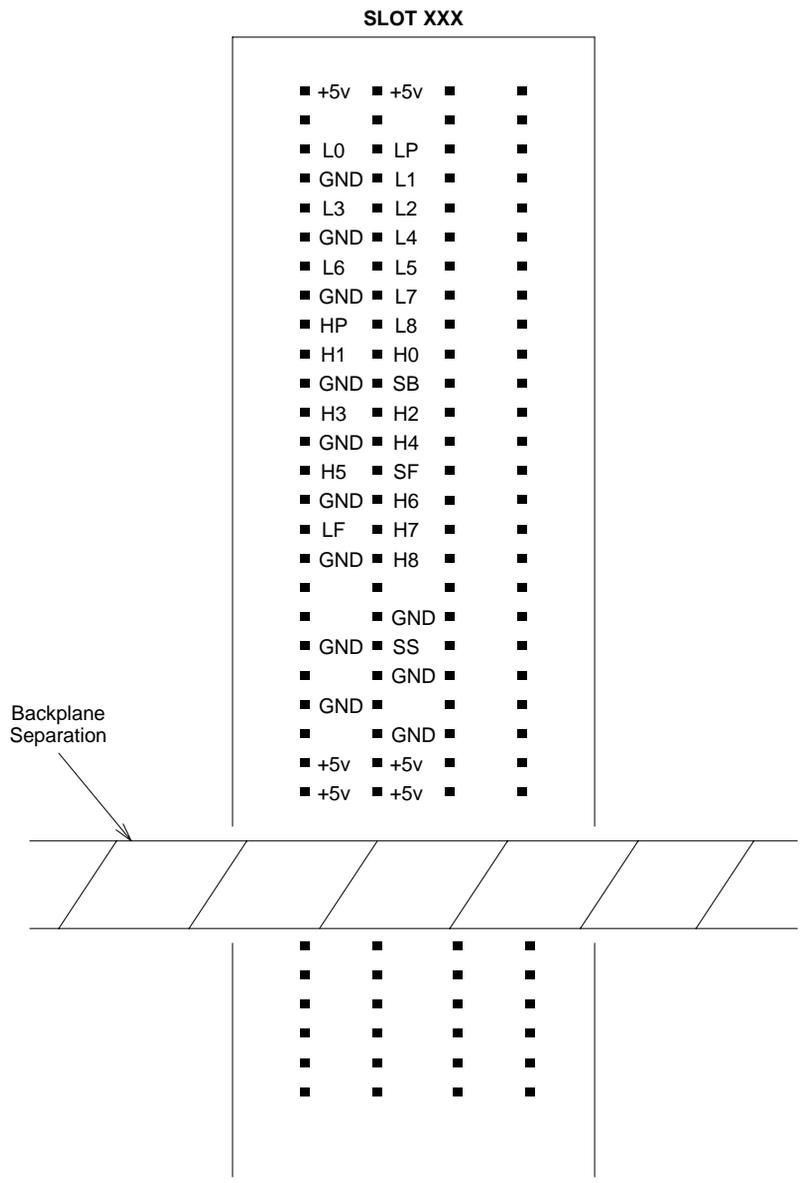
Figure 3-3. Packet Bus Leads on the Backplane - Front View

The information within a standalone mode display is used in the Packet Bus Fault Correction procedures that follow. The TN771 display indicates the specific leads on the backplane to examine for bent or damaged pins. Figure 3-3 on page 3-16 shows the location of the packet bus leads on the backplane as viewed from the front of the carrier, while Figure 3-4 on page 3-17 shows the same slot as viewed from the back of the carrier.

2. Determine if the Packet Bus fault is still present.
3. If the Packet Bus fault is still present:
 - Determine if the backplane pins in the removed circuit pack's slot are bent. Use the output from the Maintenance/Test standalone mode and [Figure 3-3 on page 3-16](#) and [Figure 3-4 on page 3-17](#).
 - If the backplane pins are bent, power down the carrier (refer to the "Removing Power" section in Chapter 5, "Routine Maintenance Procedures" in *DEFINITY Enterprise Communications Server Release 10 Maintenance for R10si* (555-233-123), straighten or replace the pins, reinsert the circuit pack, restore power (refer to the "Restoring Power" section in Chapter 5, and repeat Procedure 2, beginning with Step 2, for the same circuit pack.

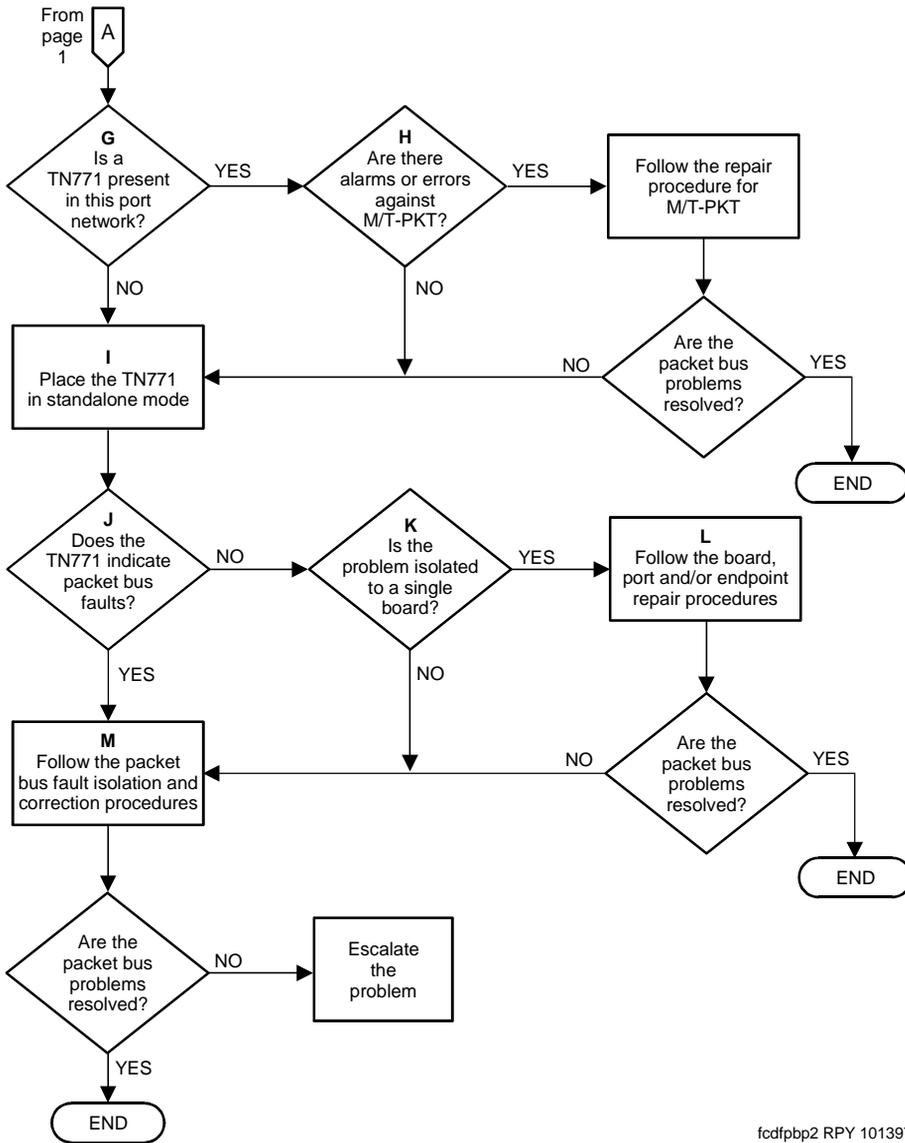
Figure 3-6. Packet Bus Flowchart (Page 2 of 2)

See the "[Flowchart Description and Supplement](#)" section following the flowchart for a description of the flowchart as well as for supplementary information, the availability of which is indicated by the uppercase letters that appear in the flowchart.

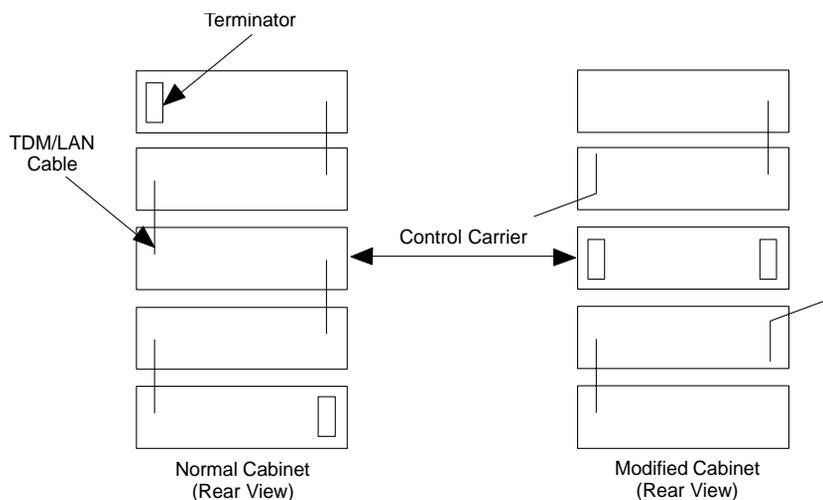
Figure 3-7. Carrier Rewiring Example

In Procedure 4, the TDM/LAN Cable Assemblies and TDM/LAN termination resistor packs are replaced. If this action does not resolve the Packet Bus fault, the carriers are reconfigured by moving the termination resistor packs in such a manner that certain carriers are disconnected from the bus. This is done by moving the termination resistors on the carrier backplanes. To terminate the Packet Bus at the end of a particular carrier, first unplug the cable that connects the carrier to the next carrier and then replace the cable with a termination resistor (see [Figure 3-6](#)). When the length of the Packet Bus is modified via this procedure, circuit packs that are essential to system operation (for example, Processor Complex, Tone-Clock) must still be connected to the new “shortened” Packet (and TDM) Bus. In addition, the Maintenance/Test circuit pack (in standalone mode) must be connected to the “shortened” bus.

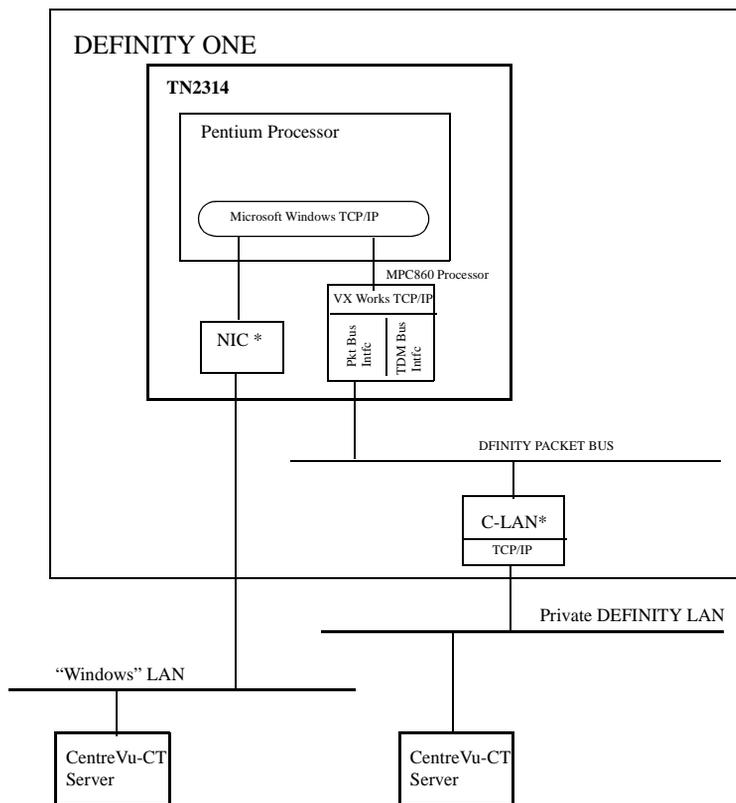
Figure 6-1. Hardware configuration for the ADJLK-IP link

The Adjunct IP link is the Adjunct Switch Application Interface (ASAI) proprietary link between DEFINITY ONE and CentreVu-CT. CentreVu-CT is connected to an Ethernet LAN. On DEFINITY ONE, the LAN interface is provided by the Ethernet interface on the TN2314 circuit pack or by the C-LAN (Control LAN) TN799 circuit pack. A C-LAN board is normally used only if a private LAN is required for security reasons. For the first release of this connectivity feature, only one of the interfaces (TN2314 or C-LAN) can be used on the same system.

* Only one of these connectivity arrangements can be used

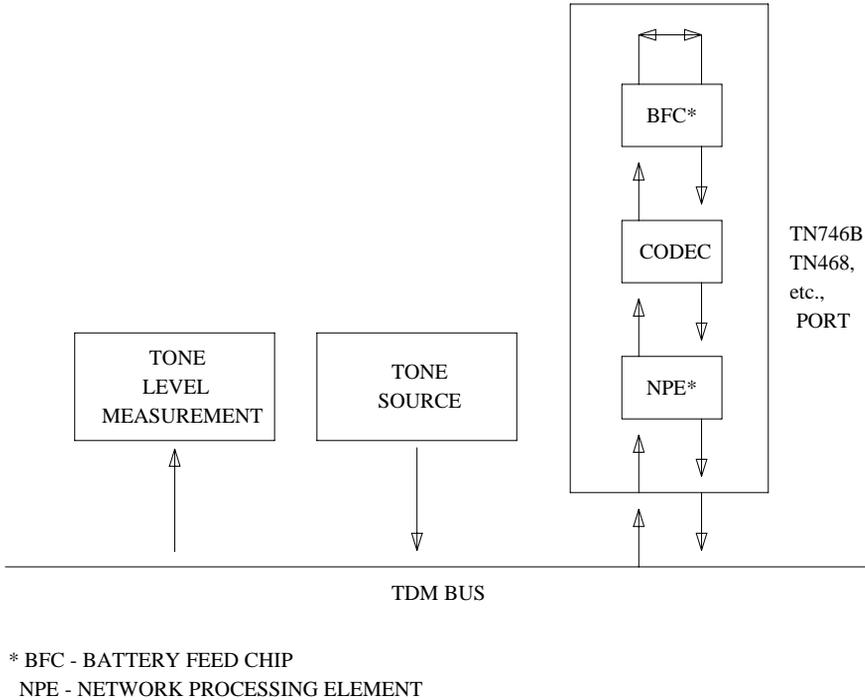
Figure 6-2. Analog Loop Around Test

This test is designed to check the on-board transmission capabilities of the NPE, the codec, and the battery feed chip of the analog port. A Tone Detector and a Tone Generator talk and listen on the same pair of time slots as the Analog Port. The Analog Port is then instructed to go into loop around mode (see the following below). The test passes if the signal measured by the Tone Detector is within acceptable limits.

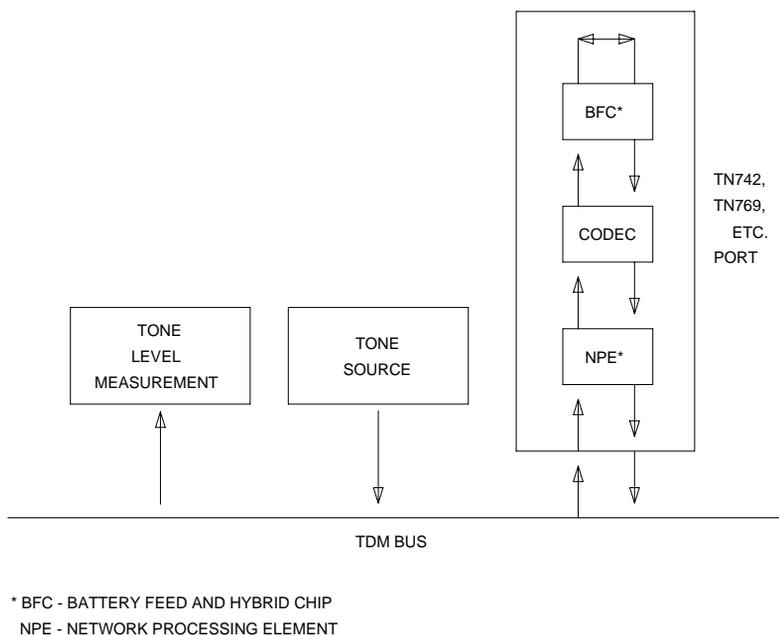
Figure 6-3. Analog loop around and conference test

This test is designed to check the on-board transmission capabilities of the NPE, the code, and the battery feed chip of the Analog Port. A Tone Detector and a Tone Generator talk and listen on the same pair of time slots as the Analog Port. The Analog Port is then instructed to go into loop around mode (see [Figure 6-3 on page 6-82](#)). The test passes if the signal measured by the Tone Detector is within acceptable limits.

This Loop Around Test is sensitive to the length of the loop, the equipment in the loop, or the equipment terminating the loop, such as off-premises stations. If this test is causing a false alarm, then disable the test by changing the Tests field to "no" using the **change station** command for this station.

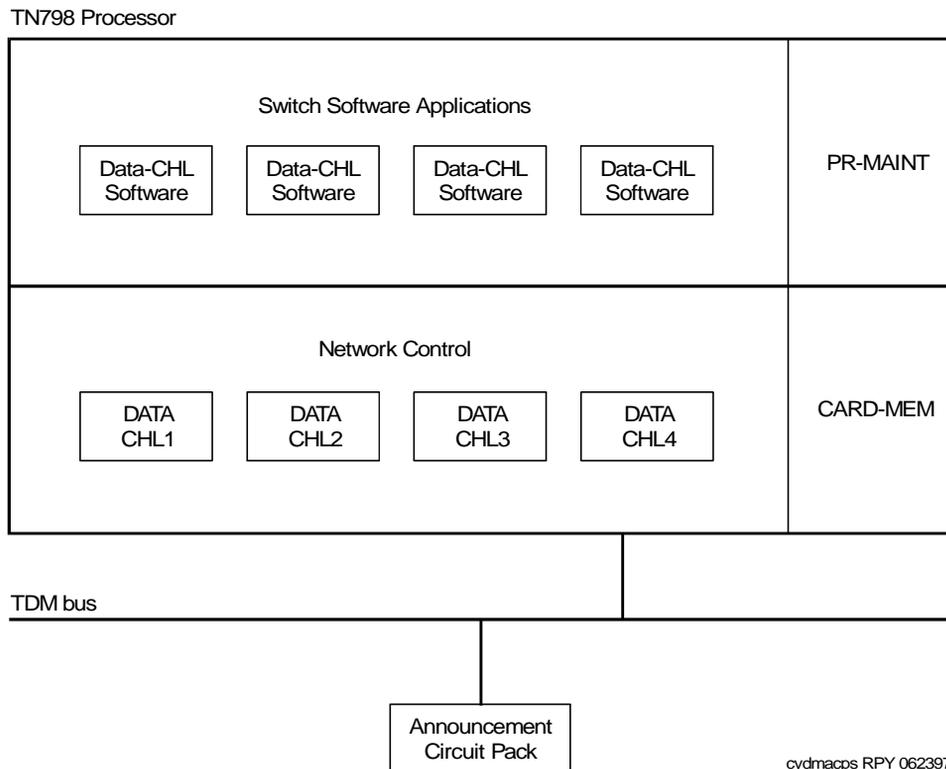
Figure 6-4. Connection of announcement circuit pack to the system

Figure 6-4 shows the connection of the Announcement Circuit Pack to the system. To save or restore announcements, an ANNOUNCEMENT Data Extension must be administered, and at least one DATA-CHL (Network Control Data Channel) must be in the in-service/idle state.

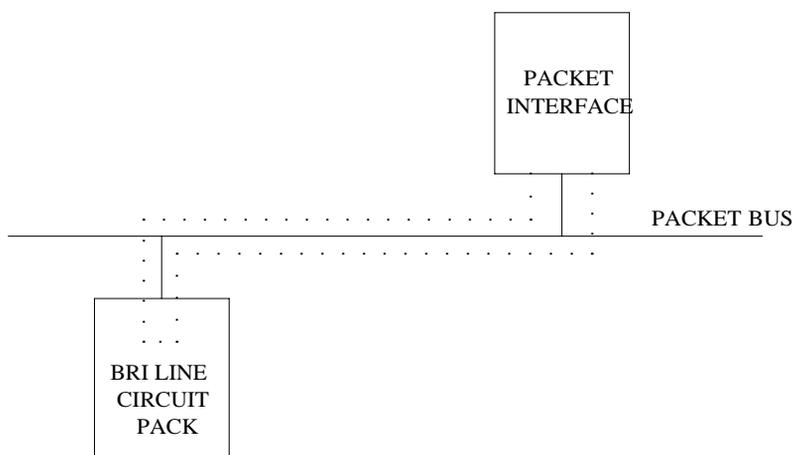
Figure 6-5. BRI Port Local LAN Looparound Path

This test verifies the connectivity of a BRI port across the LAN Bus and executes only if the port is out-of-service. The test aborts if calls associated with the port are in-progress. Failures of this test indicate either on-board faults associated with the ASAI-PT hardware on the circuit pack or problems with the LAN Bus, which is used to form connectivity between the switch and the ASAI-PT.

The dotted lines in [Figure 6-5](#) show how a Looparound Test is performed across the Packet Bus for the D-channel.

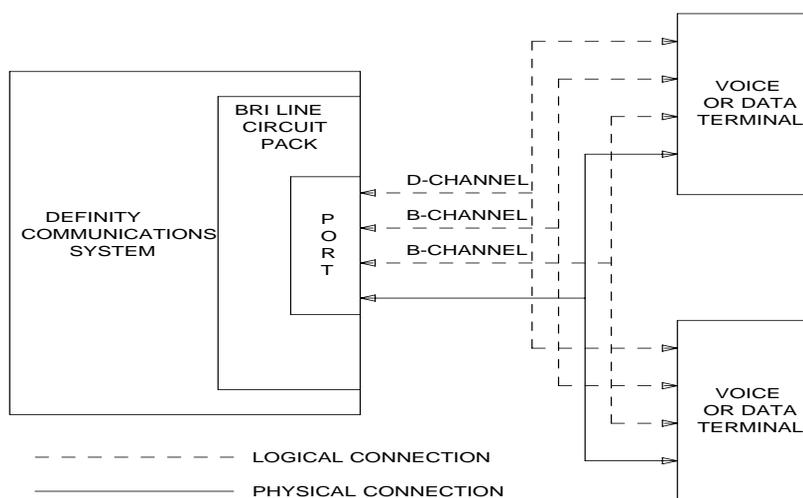
Figure 6-6. ISDN-BRI Port Interactions

[Figure 6-6 on page 6-250](#) illustrates the physical connection (solid line) between an ISDN-BRI Port and its associated ISDN-BRI set(s). Each physical connection allows for two B-channels and one D-channel. Each ISDN-BRI circuit pack can support up to 12 of these *physical* connections to different voice and voice/data sets or ASAI or Avaya adjuncts. On a TN2198 each ISDN-BRI circuit pack can support up to 12 *physical* connections to a NT1, which, in turn, connects to 2 terminals.

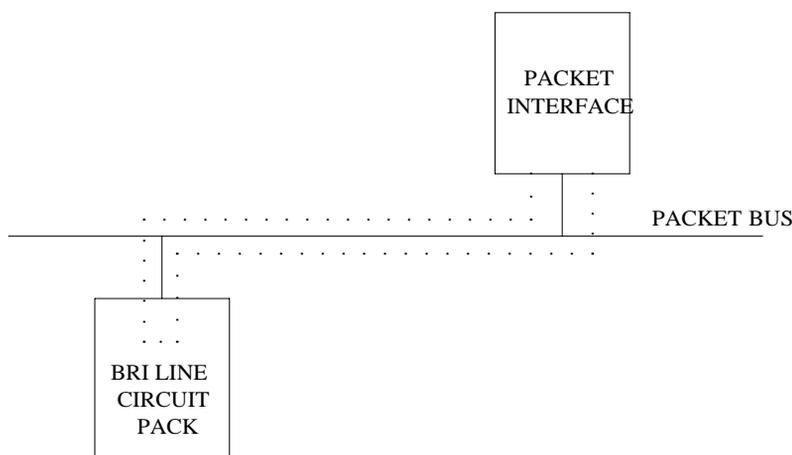
Figure 6-7. Path of the BRI Port Local LAN Loop Around

This test, which verifies the connectivity of a BRI port across the LAN Bus, executes only if the port is out-of-service. The test aborts if calls associated with the port are in-progress. Failures of this test indicate either on-board faults associated with the BRI-PORT hardware on the circuit pack or problems with the LAN Bus, which is used to form connectivity between the switch and the BRI-PORT.

The dotted lines in [Figure 6-7 on page 6-257](#) show how a Loop Around Test is performed across the Packet Bus for the D-channel.

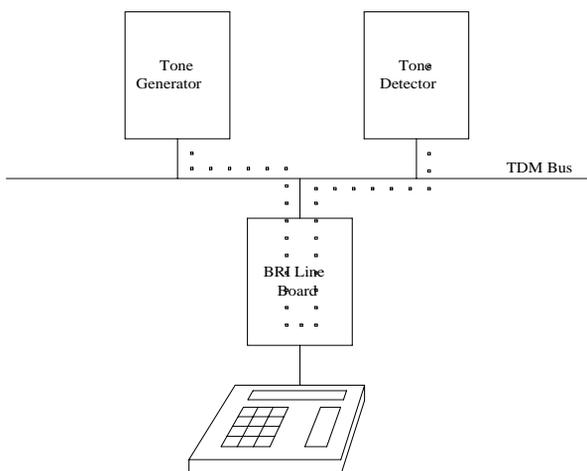
Figure 6-8. Path of the BRI Port Local TDM Loop Around

The dotted lines in [Figure 6-8](#) show how a Loop Around Test is performed for the B-channels. The figure shows a terminal connected to a BRI line board using a TN556. If a TN2198 is used, the terminal would be connected to a NT1, and the NT1 to the BRI board.

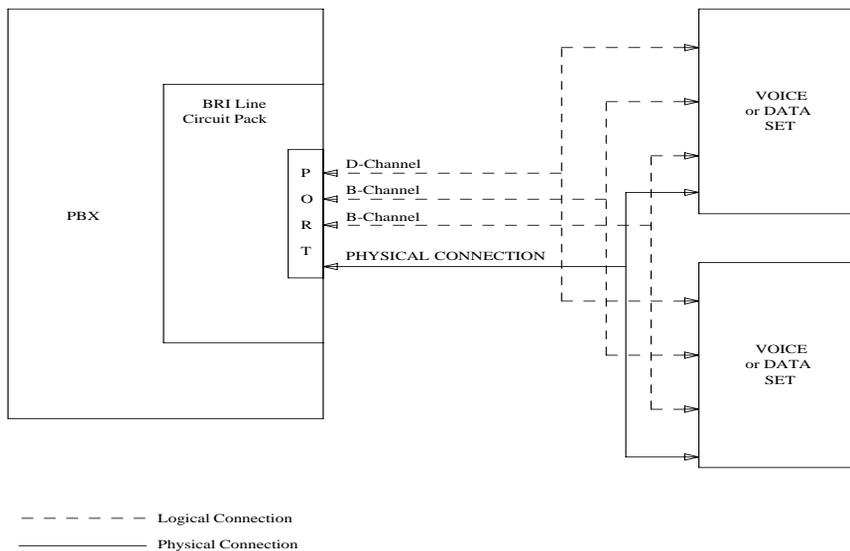
Figure 6-9. ISDN-BRI Set Interactions

Figure 6-9 illustrates the physical connection (solid line) between an ISDN-BRI Circuit Pack and a voice or voice/data set. Each physical connection allows for two B-channels, as stated above, plus one D-channel. Each ISDN-BRI circuit pack can support up to 12 of these PHYSICAL connections to different voice and voice/data sets or ASAI and Avaya adjuncts.
