Maintenance

DEFINITY ONE™
Communications System
Release 10

Volumes 1 and 2

555-233-130
Issue 1
December 2001

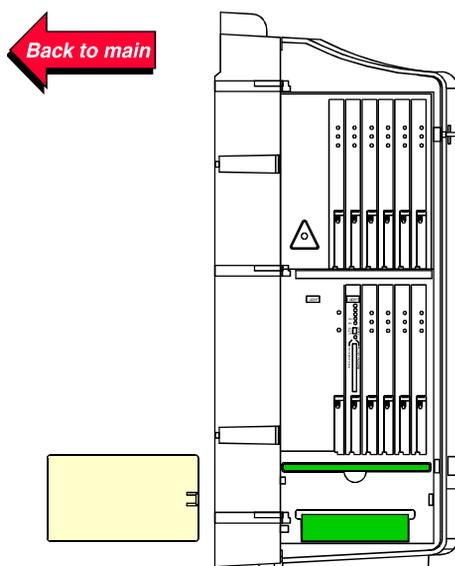
Figure 6-10. Fan/Filter Removal

1. Remove the left door.
2. Remove the fan/filter access panel. See [Figure 6-10](#).

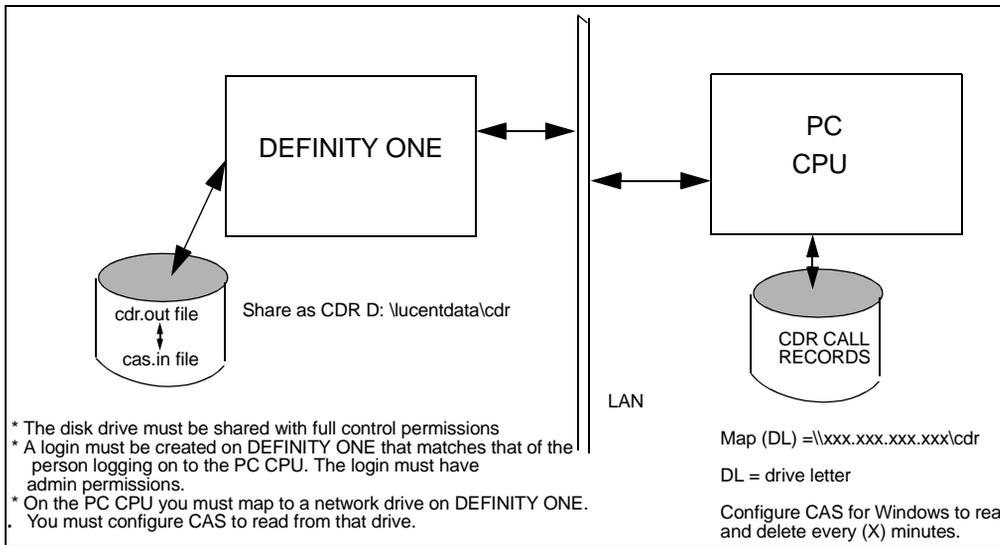
Figure 6-11. CDR Configuration

1. The CDR directory (d:/LucentData/Cdr) on DEFINITY ONE has to be shared with full control permissions from DEFINITY ONE. For more information about the Cdr directory, see "Set up Call Accounting" in Chapter 3 of *DEFINITY ONE™ Communications System and Avaya IP600 Internet Protocol Communications Server Release 10 Installation and Upgrades (555-233-109)*.
2. A login has to be created on DEFINITY ONE that matches the login of the person logging into the WINDOWS 95 PC running the CAS application.
3. The login used for CAS on DEFINITY ONE has to have administration rights.
4. On the WINDOWS 95 PC, the network drive used by CAS has to be mapped to the CDR directory on DEFINITY ONE.
5. CAS on the WINDOWS 95 PC has to be configured to read the mapped drive.

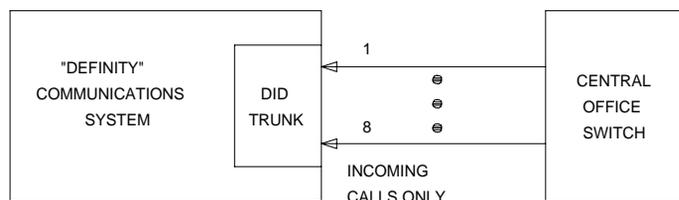
Figure 6-12. DID Trunk Interactions

The DID Trunk circuit packs support eight, incoming-only, ports. Each port provides an interface between the 2-wire analog line from the CO and the DEFINITY system. The DID port receives 3 to 5 digits from the CO that is used to directly connect an outside caller to the called station without assistance from an attendant. See [Figure 6-12](#).

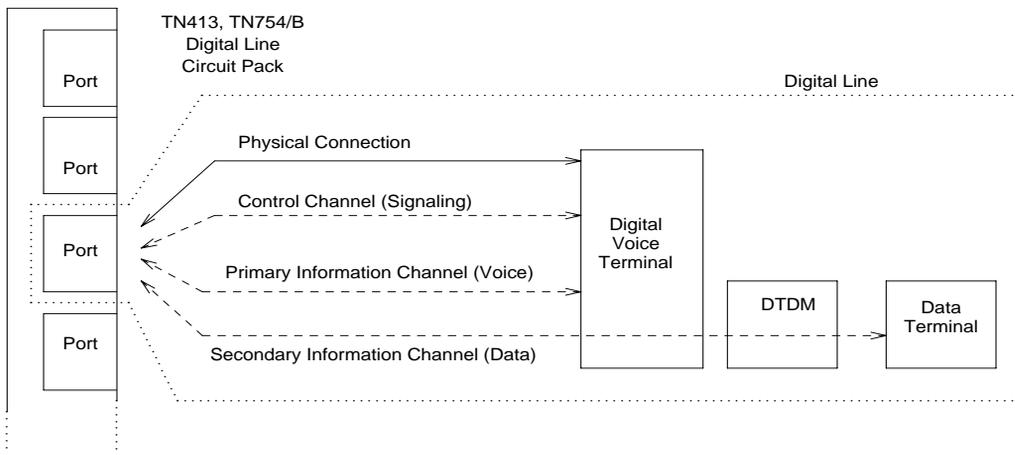
Figure 6-13. Digital Line Connectivity

Each digital line port supports two 64 kbps information channels (primary and secondary) and one 8kbps signaling channel. Digital voice terminals always use the primary information channel. Thus only one voice terminal can be connected to each port. The secondary information channel can be used to connect a data terminal via a Digital Terminal Data Module (DTDM) or a Data Adaptor (DA). All other devices currently supported by Digital Line circuit packs communicate on the primary information channel. [Figure 6-13](#) shows examples of digital line connectivity.

It should be noted that TN2181 and TN2224B/CP support both modes as shown in [Figure 6-13](#) and [Figure 6-14](#) on page 6-423.

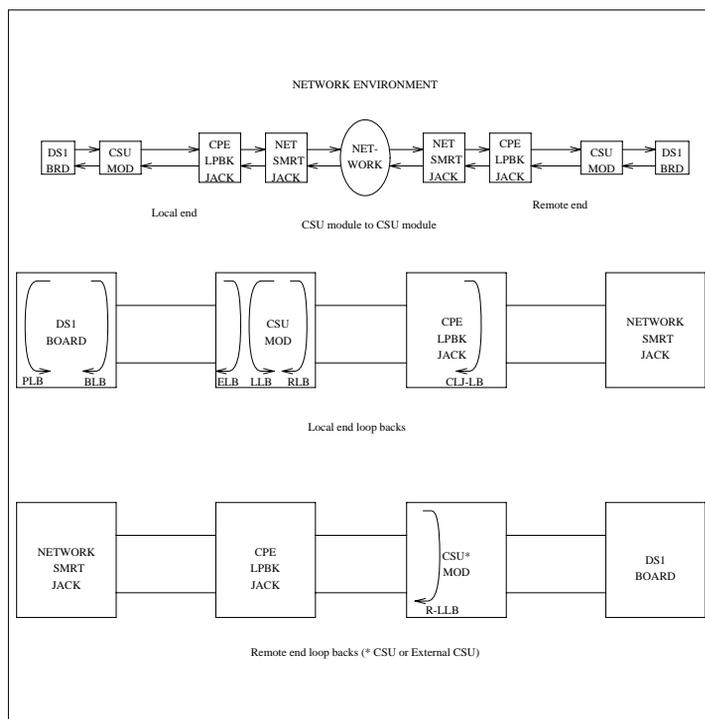
Figure 6-15. High Level Overview Of Loopback Points

The TN767E and 120A1 CSU Module support on-demand loopback tests that assist in the detection of faults between the TN767E circuit pack and the CSU Module, between the Integrated CSU and the optional Customer Premises Loopback Jack, or between the Integrated CSU and remote CSU. These loopback tests are explained in detail later in this DS1-BD section, but [Figure 6-15 on page 6-481](#) gives a high level overview of the loopback points.

- PLB = Payload Loopback
- BLB = Board Loopback
- ELB = Equipment Loopback
- LLB = Line Loopback
- RLB = Repeater Loopback
- CLJ = Loopback Jack Loopback
- R-LLB = Remote Line Loopback
- SMRT = Smart Jack
- LPBK = Loopback

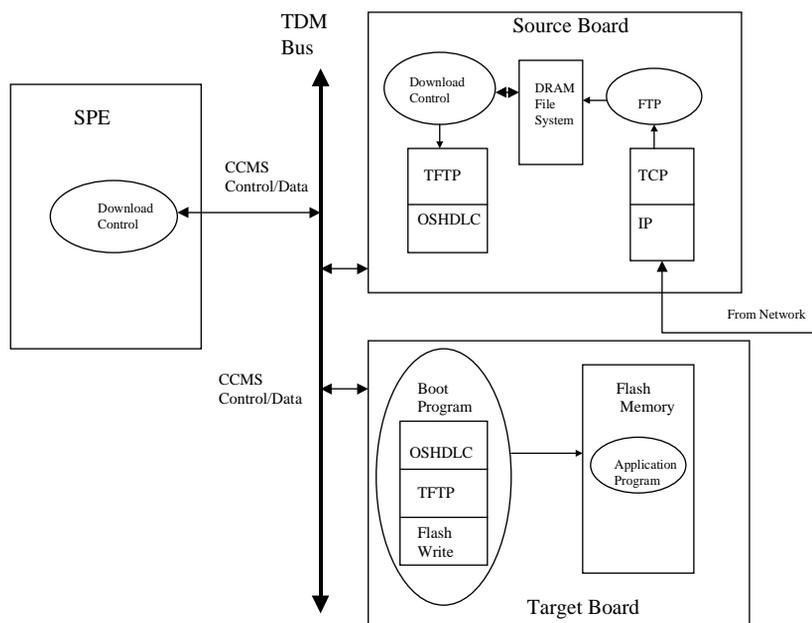
Figure 6-16. Firmware Download Architecture for TN799C (C-LAN board)

TFTP protocol error - One reason for this type of failure may be that the target board is located in a DS1-C remote EPN using ami-zcs line coding to communicate with the PPN. To have a successful firmware download you must have a clear channel between the source and target board, or the source and target must reside in the remote EPN. Some examples of the correct type of line coding for this feature are: b8zs, and hdb3.

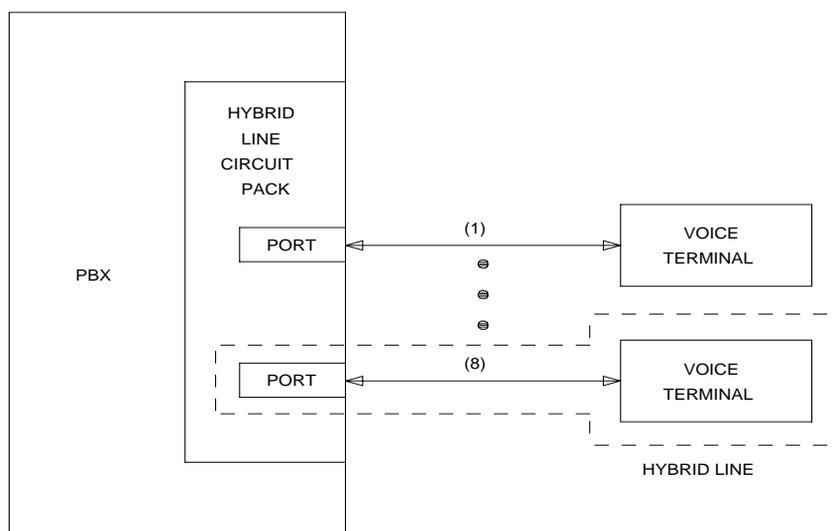
Figure 6-17. Hybrid Station Interactions

The TN762B Hybrid Line circuit pack supports eight of these multifunction analog telephone sets, as shown in the following figure. The Hybrid Line sets use three pairs of wires: an analog voice pair, a transmit/receive pair, and a power pair.

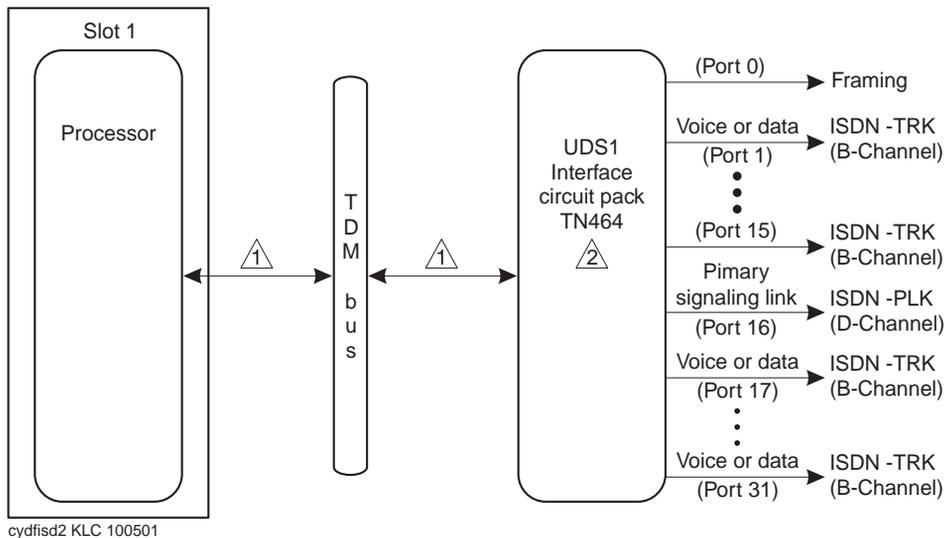
Figure 6-18. ISDN-PRI Signaling Link Port Interactions (32-Channel - TN464F/GP)

In a 32-channel system (see [Figure 6-18 on page 6-672](#)), the DS1 ISDN Trunk or PRI endpoint port (B-channels) may use any of the ports 1-15 or 17-31, but the ISDN-PRI Signaling Link Port must be the 16th port on the TN464F/GP circuit pack. In certain configurations (NFAS), the 16th port may be used as a B-channel. Refer to [“ISDN-SGR \(ISDN-PRI Signaling Group\)”](#) on page 6-677 for further details.

1. B- and D-channel messages are routed over the TDM Bus. For additional reliability, a duplex D-channel can be administered for a signaling group and located on a different TN464F/GP circuit pack.
2. TN464F/GP

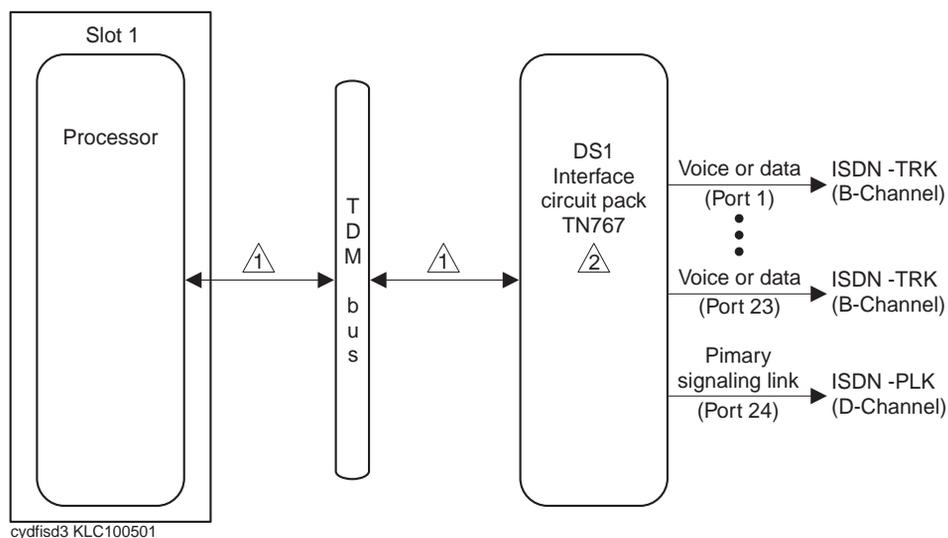
Figure 6-19. ISDN-PRI Signaling Link Port Interactions (24 Channel - TN767/464F/GP)

In a 24-channel system, the DS1 ISDN Trunk or PRI endpoint port (B-channels) may use any of the first 23 ports. The ISDN-PRI Signaling Link Port must be the 24th port (See [Figure 6-19 on page 6-673](#)). In certain configurations (NFAS), the 24th port may be used as a B-channel. Refer to [“ISDN-SGR \(ISDN-PRI Signaling Group\)” on page 6-677](#) for further details.

1. B- and D-channel messages are routed over the TDM Bus. For additional reliability, a duplex D-channel can be administered for a signaling group and located on a different TN464F/GP circuit pack.
2. TN767B (or higher) or TN464F/GP

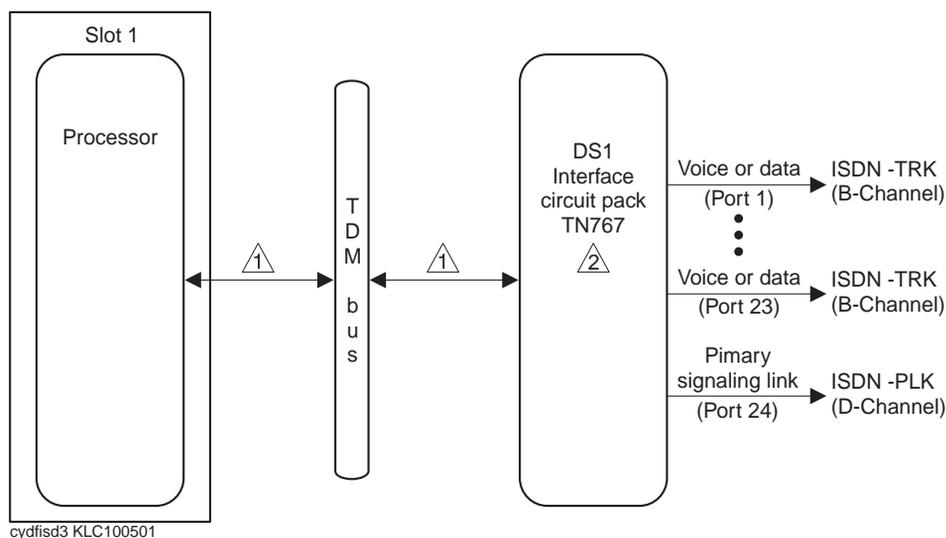
Figure 6-20. ISDN-PRI Signaling Link Port Interactions (24 Channel - TN767B/464F/GP)

For 24-channel interfaces, the first 23 ports on the circuit pack are used as B-channels. The 24th port may be used as a B-channel or as a D-channel depending on the type of Signaling Group used (see [Figure 6-20 on page 6-678](#)).

1. B- and D-channel messages are routed over the TDM Bus. For additional reliability, a duplex D-channel can be administered for a signaling group and located on a different TN464F/GP circuit pack.
2. TN767B (or higher) or TN464F/GP.

The ISDN-PRI Signaling Link Port itself depends on the health of the DS1/UDS1 Interface circuit pack on which it resides. This test will fail if there are problems with either the ISDN-PRI Primary D-channel port or the DS1/UDS1 circuit pack. See [Figure 6-20 on page 6-678](#) for DS1 connections, [Figure 6-21 on page 6-679](#) for UDS1 connections.

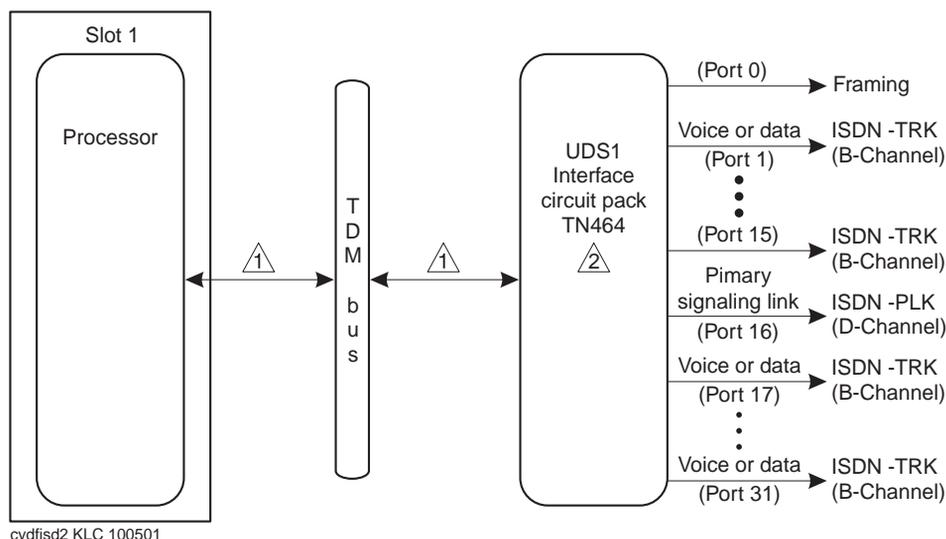
Figure 6-21. ISDN-PRI Signaling Link Port Interactions (32-Channel - TN464F/GP)

For 32-channel interfaces, ports 1-15 and 17-31 on the circuit pack are used as B-channels. The 16th port may be used as a B-channel or as a D-channel depending on the type of Signaling Group used (see [Figure 6-21 on page 6-679](#)).

1. B- and D-channel messages are routed over the TDM Bus. For additional reliability, a duplex D-channel can be administered for a signaling group and located on a different TN464F/GP circuit pack.
2. TN464F/GP

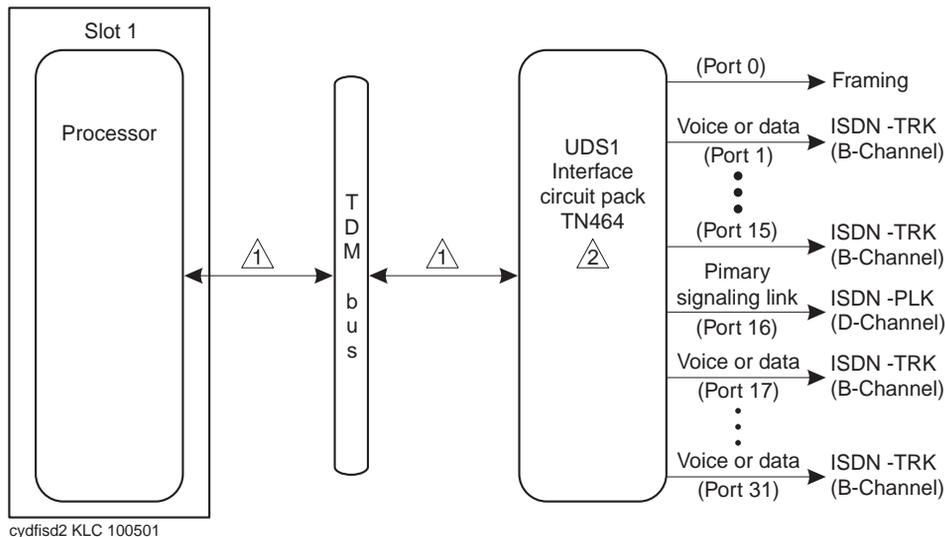
On 32 channel interfaces, any of ports 1-15 and 17-31 on the DS1 interface circuit pack can be a B-channel. The 16th port may be used as a B-channel or as a D-channel depending on the type of ISDN-PRI Signaling Group (ISDN-SGR) to which it belongs. For more details, refer to [“ISDN-SGR \(ISDN-PRI Signaling Group\)”](#) on page 6-677, [“DS1-BD \(DS1 Interface Circuit Pack\)”](#) on page 6-479, and [“UDS1-BD \(UDS1 Interface Circuit Pack\)”](#) on page 6-1198.

- 1. B- and D-channel messages are routed over the TDM Bus. For additional reliability, a duplex D-channel can be administered for a signaling group and located on a different TN464F/GP circuit pack.
- 2. TN464F/GP

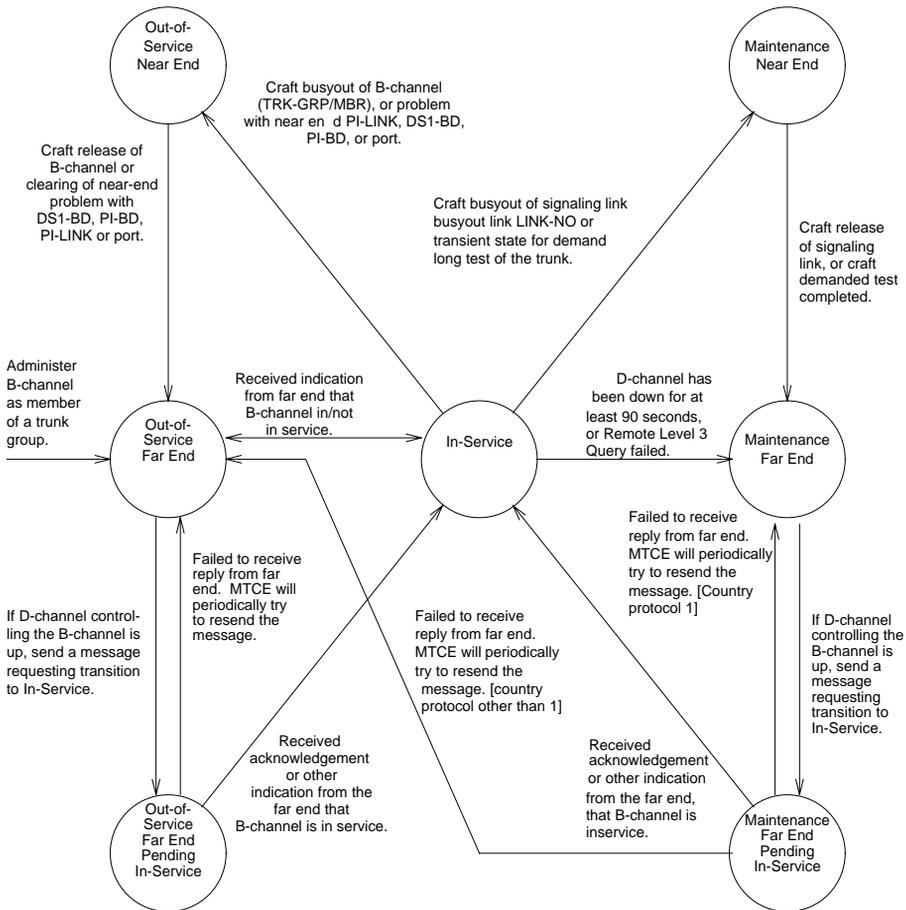
Figure 6-24. Common Progressions in Service States

The following diagram of the DS1 ISDN Trunk service states shows the common progression from one service state to another and the event that caused the change of state.

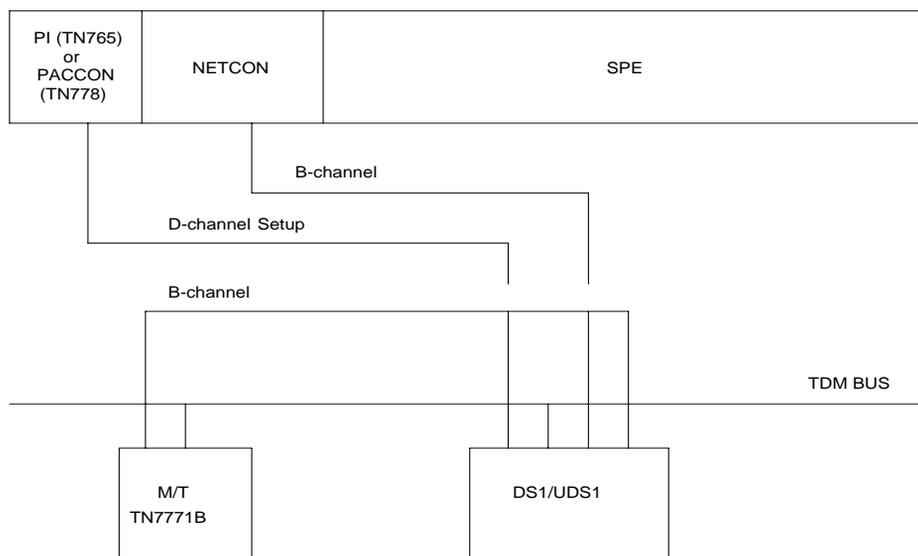
Figure 6-25. ISDN-PRI Outgoing Test Call

In the second method, the test call connection is established over the TDM Bus of the transmit and receive sides of the ISDN-PRI trunk to a digital trunk testing port on the Maintenance/Test circuit pack. The Maintenance/Test Digital Port generates a pseudo bit stream. A pictorial description of the outgoing ISDN-PRI test call connectivity is contained in [Figure 6-25 on page 6-714](#).

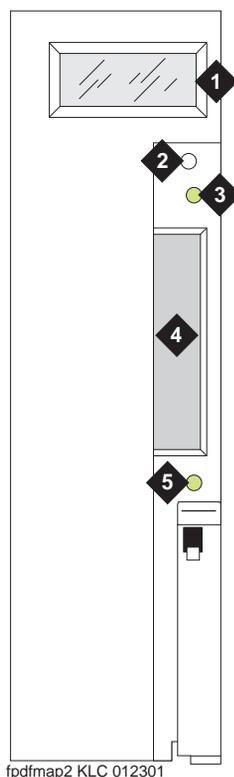
Figure 6-26. TN802 faceplate

Figure 6-26 shows the TN802 faceplate.

Step	Description	Comments
1.	Restore IP Trunk administration	At the Windows 2000 desktop, double-click on the IP Trunk Back UP Restore icon. The IP Trunk Backup/Restore Utility screen appears.
2.	Select utility	In the IP Trunk Backup/Restore Utility dialog screen, click Files, Restore . The IP Trunk Backup screen appears
3.	Select restore	In the IP Trunk Backup screen, click on the Restore button.
4.	Wait	Wait until the yellow Disk-In-Use LED (Note 5 in Figure 6-26 on page 6-727) light is out.

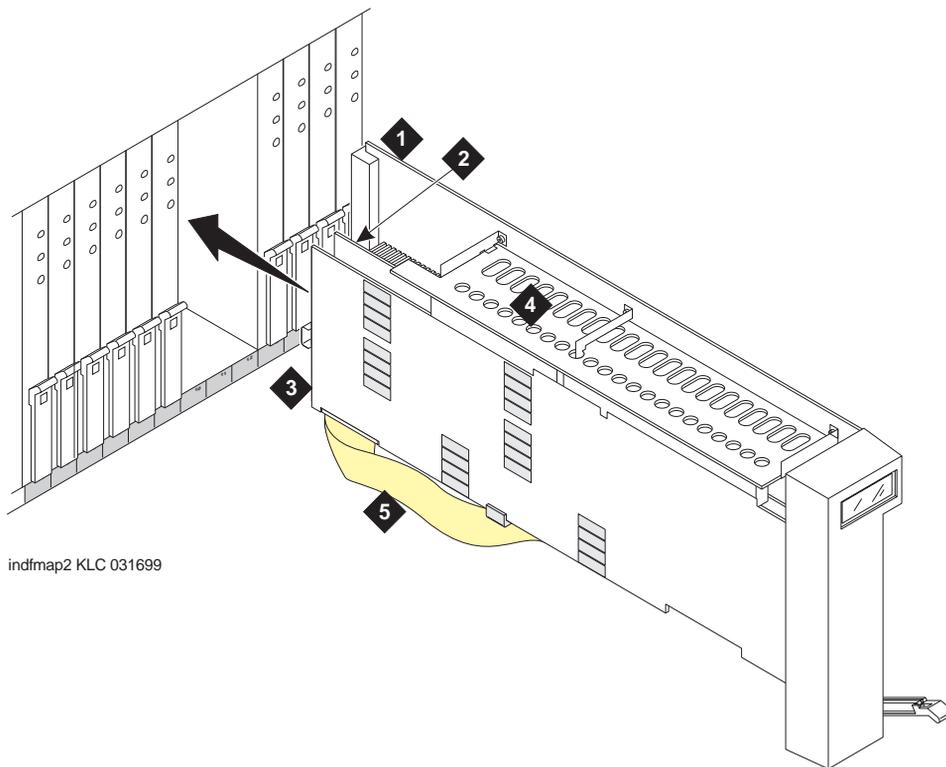
Figure 6-27. TN802 board assembly

Figure 6-27 shows the circuit pack with the two additional boards connected through the side plane.

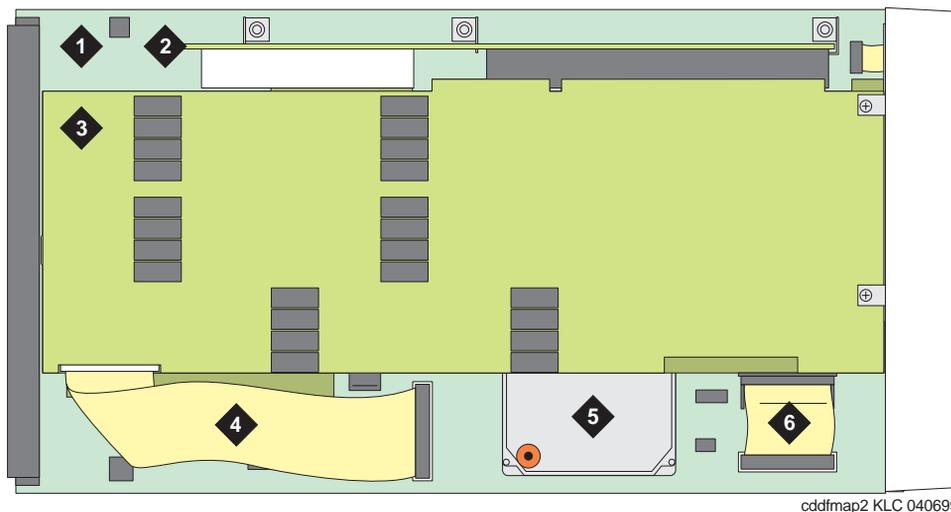
Figure 6-28. TN802 board assembly and cables (side view)

Figure 6-28 shows a side view of the three boards and interconnecting cables that make up the TN802.

- a. Verify the IP address
- b. Check the physical connections to and from the TN802 circuit pack.
- c. Check the internal cables on the TN802 circuit pack (Notes 4 and 6 in [Figure 6-28 on page 6-732](#)).
- d. Try pinging another device on the same subnet.

- a. Check that the internal cables on the TN802 circuit pack (Notes 4 and 6 in [Figure 6-28 on page 6-732](#)) have not worked loose.
 - b. Otherwise, replace the circuit pack.
3. At the command prompt, type **ping 10.32.64.97** (the internal IP trunk server address) and press Enter.

- a. Check that the internal cables on the TN802 circuit pack (Notes 4 and 6 in [Figure 6-28 on page 6-732](#)) have not worked loose.
 - b. Otherwise, replace the circuit pack.
4. At the command prompt, type **ping 10.32.64.96** (the IP address of the internal Motorola MPC860 processor) and press Enter.

- a. Check that the internal cables on the TN802 circuit pack (Notes 4 and 6 in [Figure 6-28 on page 6-732](#)) have not worked loose.
- b. Otherwise, replace the circuit pack.

The TN802 hard drive (Note 5 in Figure 6-28 on page 6-732) is field-replaceable.

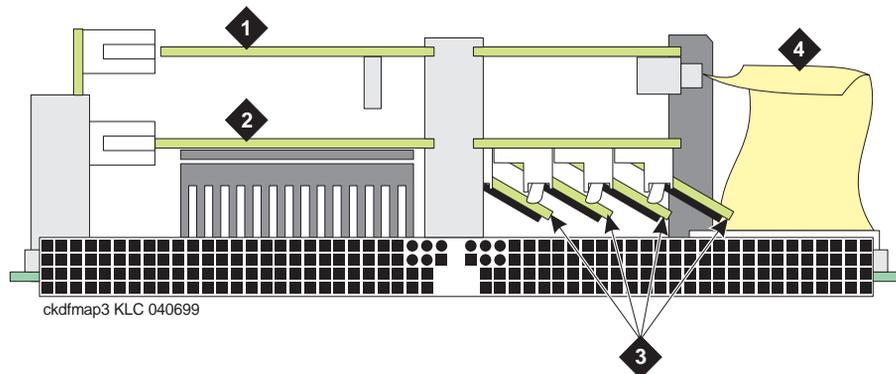
Figure 6-29. TN802 board assembly and cables (end view)

Figure 6-29 shows the end view of the three boards and interconnecting cables on the TN802.

- 1. Analogic board
- 2. Texas Microsystems Inc. (TMI) board
- 3. SIMMs (memory)¹
- 4. SCSA (Signal Computing System Architecture) ribbon cable

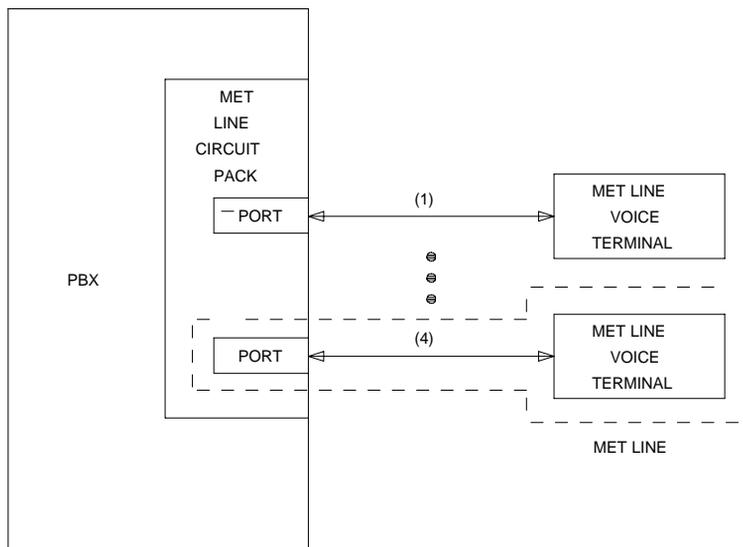
Figure 6-30. MET Line Interactions

The TN735 MET Line circuit pack supports four of these METsets. Each MET set uses three pairs of wires: an analog voice pair, a transmit pair, and a receive pair. Power is sent over the transmit and receive pairs. The MET Line circuit pack supports all 10-, 20-, and 30-button sets.

MET Line interactions are shown in [Figure 6-30](#).

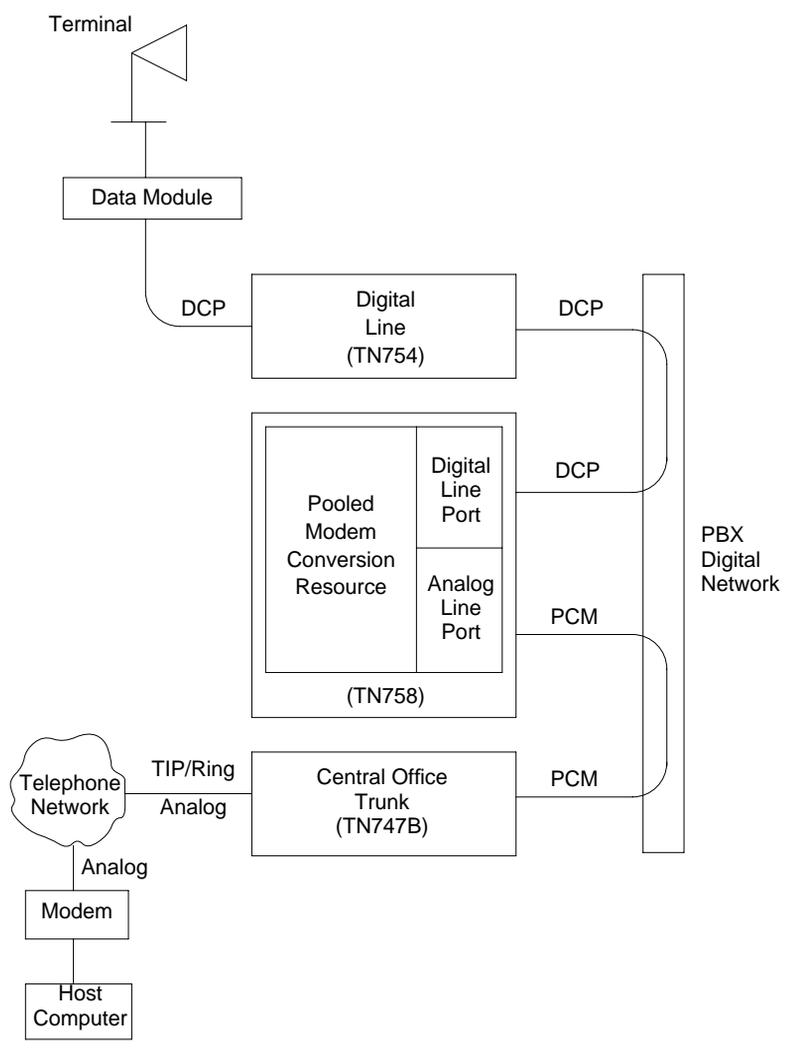
Figure 6-31. Typical Modem Pool Switched Connection with Integrated Pooled Modem

Each Modem Pool conversion resource contains two ports. One of these, an Analog Line Port, is connected (via the PBX network) to the Analog Line or Central Office Trunk Port that is the source of the modem signal. The second port is referred to as the digital port and is connected (again through the PBX network) to the Digital Line or Trunk port associated with the Data Module in the connection. The analog modem signals enter the analog port of the conversion resource in standard Pulse Code Modulation (PCM) format but are converted into Data Communications Protocol (DCP) format before going to the Digital Line or trunk in the connection.

There are two primary types of Modem Pool conversion resources available: an Integrated Pooled Modem and a Combined Modem Pool. The integrated TN758 Pooled Modem circuit pack contains two independent 300 or 1200 baud conversion resources. Each conversion resource contains two interfaces to the PBX digital network: an analog port and a digital port. The analog port is connected through the PBX network to the analog line or trunk port containing the analog modem signals. The digital port connects through the PBX network to the digital line or trunk port in the call. [Figure 6-31](#) shows a typical end-to-end connection using a conversion resource on the integrated Pooled Modem circuit pack.

Refer to [Figure 6-31 on page 6-795](#) while reading the following paragraph.

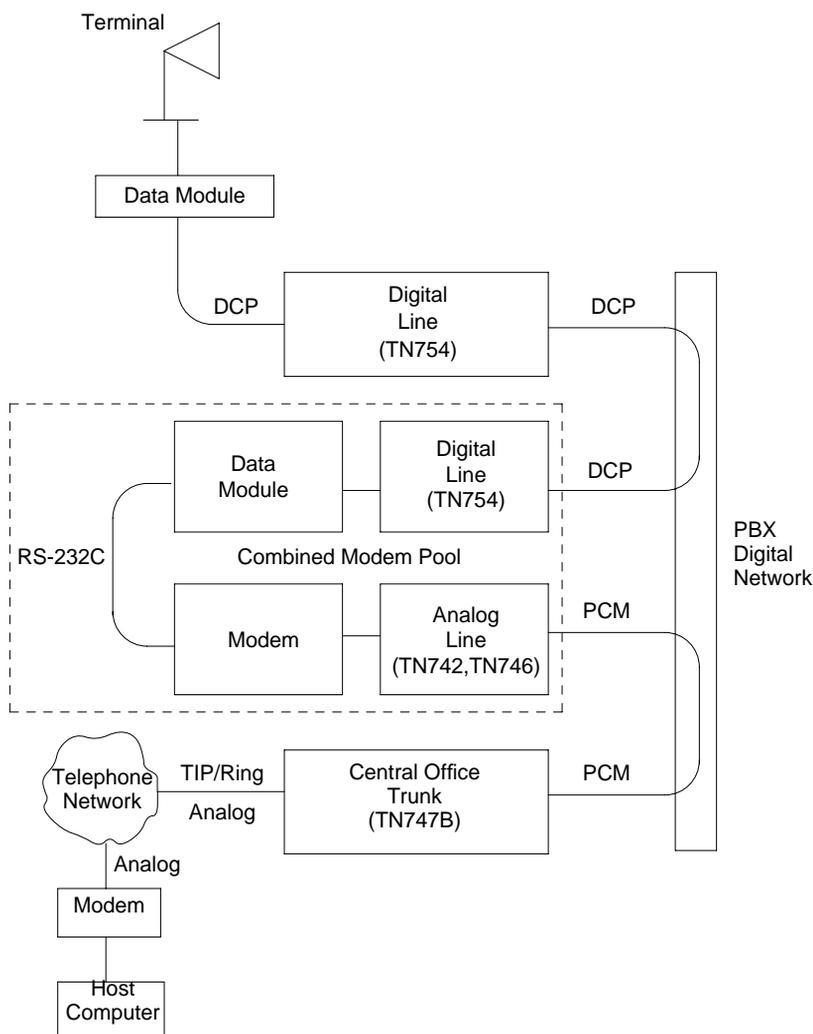
Figure 6-32. Typical Modem Pool Switched Connection with Combined Modem Pool

The Combined Modem Pool conversion resource is the second type available. The function served by the Combined Modem Pool is similar to that of the integrated Pooled Modem circuit pack, but the physical implementation is much different. It has the advantage of supporting any speed the external modem can support. The integrated Pooled Modem circuit pack can only support 300 or 1200 baud transmission rates. The Combined Modem Pool conversion resource consists of a port on a TN742 or TN746 Analog Line circuit pack, an external modem, a Data Module, and a port on a TN754 Digital Line circuit pack. The tip and ring interface of the Analog Line is connected to the modem, the EIA 232C interface of the modem connects to the Data Module, and the DCP interface on the Data Module is connected to the Digital Line port.

The analog modem signals pass through the Analog Line port to the modem. The modem converts these to EIA 232C signals which are passed on to the Data Module. The Data Module further converts the signals to the DCP protocol for the Digital Line port which passes the signals on to the PBX network. See [Figure 6-32 on page 6-797](#).

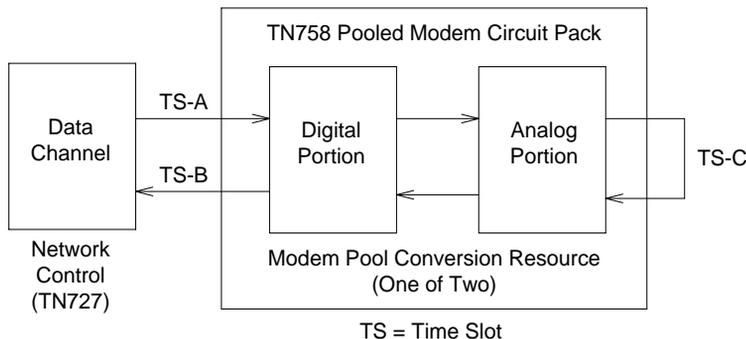
Figure 6-33. Modem Pool Conversion Resource Loop Around Test Set-up

The Modem Pool Conversion Resource Loop Around Test is set up as follows:

Test data patterns are transmitted from the Network Control Channels 1 or 3 over network time slot A through the digital port, looped around through the analog port via time slot C back to the Network Control Channel circuit via time slot B where the patterns are checked for accuracy. Finally, the test forces a disconnect by breaking the connection between the Data Channel and Modem Pool Port (time slot A) and verifying that the Data Channel and Modem Pool Port go on-hook within the proper time.

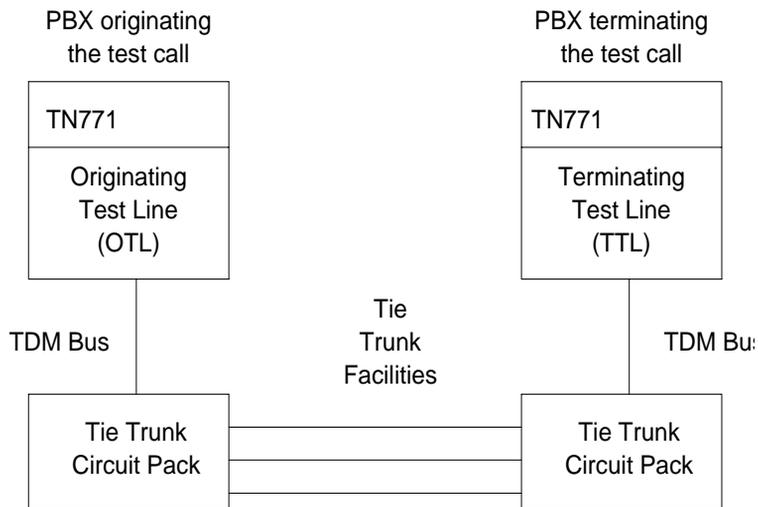
Figure 6-34. ATMS Tie Trunk Test Call

The Maintenance/Test Analog Port is port number 1 on the TN771 Maintenance/Test circuit pack. This port is used by the Automatic Transmission Measurement System (ATMS) as an Originating Test Line (OTL) or Terminating Test Line (TTL) for test calls over analog trunks. [Figure 6-34](#) shows a typical ATMS configuration.

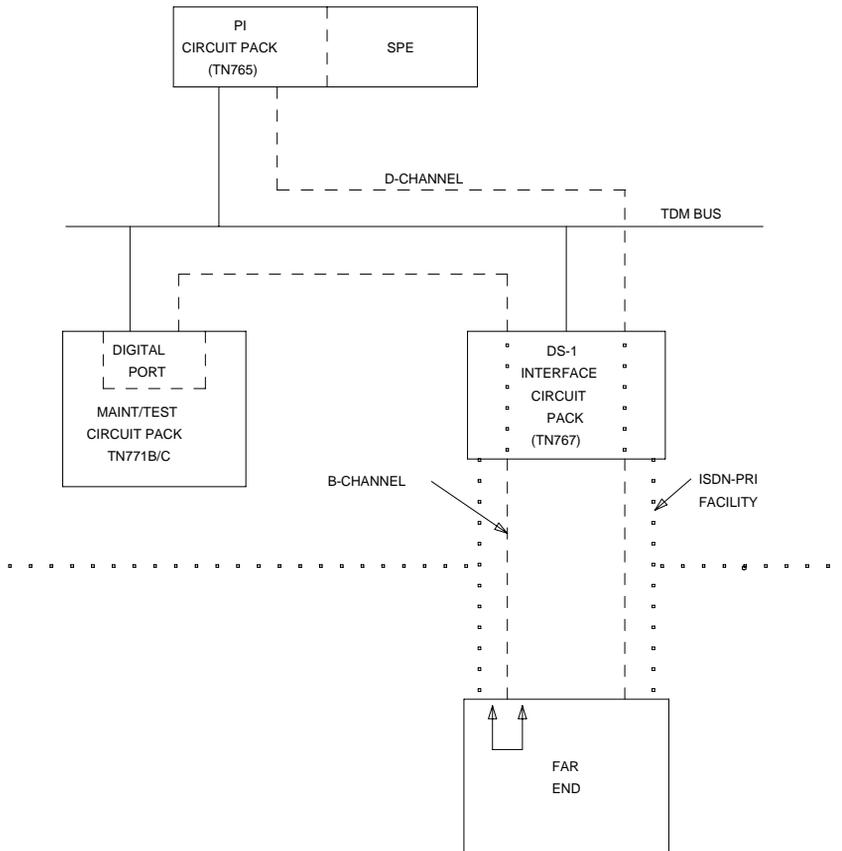
Figure 6-35. ISDN-PRI Outgoing Test Call

The Maintenance/Test Digital Port is a port on the TN771D (or later vintage) Maintenance/Test circuit pack, which is required for G3iV1.1-286 or G3iV2-386. Ports 2 and 3 are Digital Ports. The Maintenance/Test Digital Port provides the ability to perform digital (that is, ISDN-PRI) trunk testing via the TDM Bus. For an ISDN-PRI test call, connections are set up in the system as shown in [Figure 6-35 on page 6-822](#).

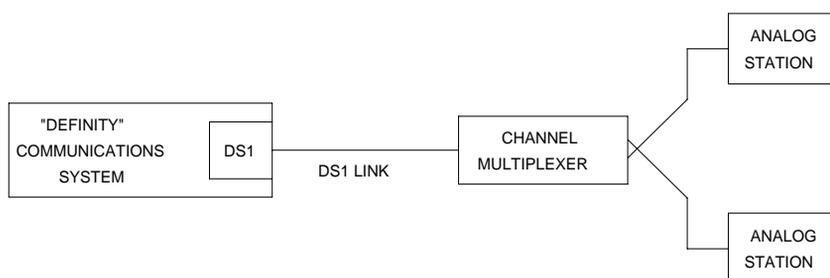
Figure 6-36. DS1 OPS Line Interactions

An analog Off-Premises Station (OPS) can be connected to the system through a DS1 link. A TN767 DS1 Interface circuit pack supports up to 24 DS1OPSs. Since the DS1OPS is an analog telephone set, a channel multiplexer is necessary as the remote DS1 endpoint that converts the digital signal of a DS1 port to the OPS Line and vice versa. See [Figure 6-36](#) for details.

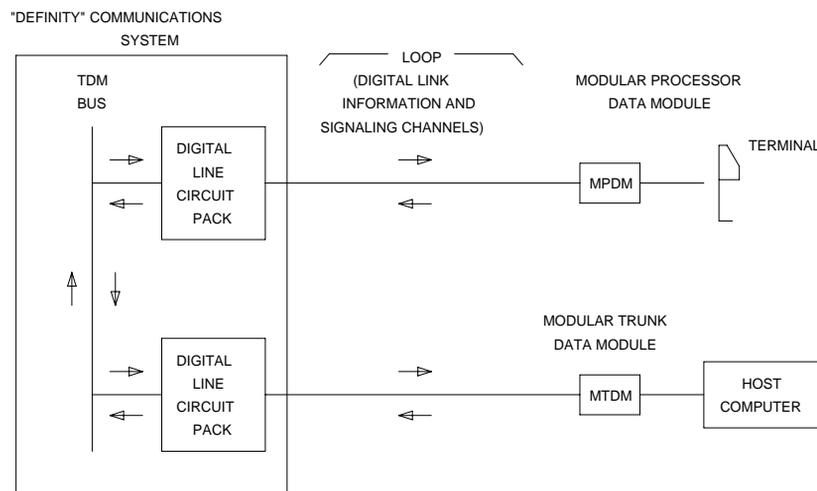
Figure 6-37. Typical Data Module Application

As illustrated in [Figure 6-37](#), data modules provide an interface between the system TN754, TN784, TN413 [G3iV2-386], or TN754 [G3iV2-386] Digital Line circuit pack and data equipment such as terminals, host computers, and modems. Data modules are used for both dial-up and permanent circuit-switched data calls. DA data modules provide this interface when the system uses a TN2136 [G3iV2-386] Digital Line circuit pack.

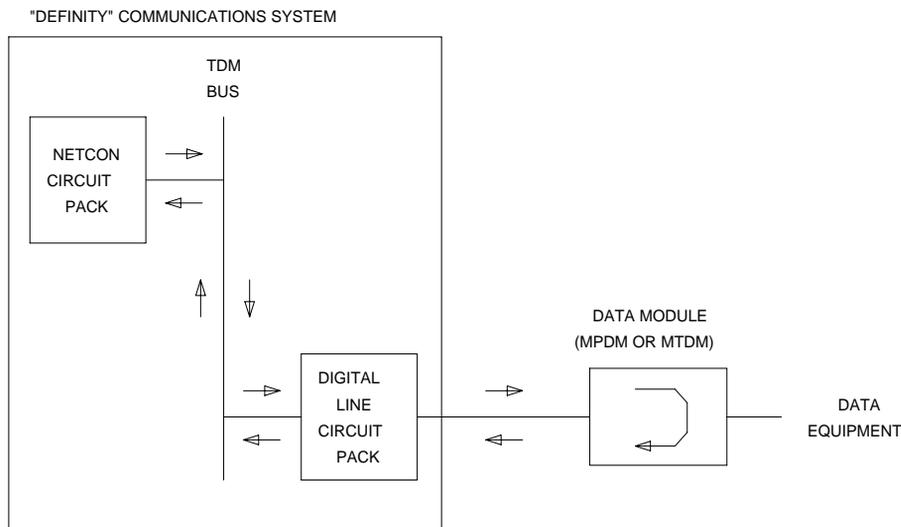
Figure 6-38. Internal Loop Around Test

This test verifies that a data message can be sent from the PBX, through the building wiring, through an internal looparound path in the data module under test, and back to the PBX. Figure 6-38 shows the hardware configuration used for this test.

A signaling message is sent through the digital port circuit pack to the data module under test to request it to enter loop around mode. A test pattern is then sent from the SPE through the Network Control circuit pack (Netcon), over the TDM Bus, through the digital port circuit pack, to the data module where the message is looped around, and sent back through the digital port circuit pack, the TDM Bus, the Network Control circuit pack, and to the SPE where it is checked for consistency.

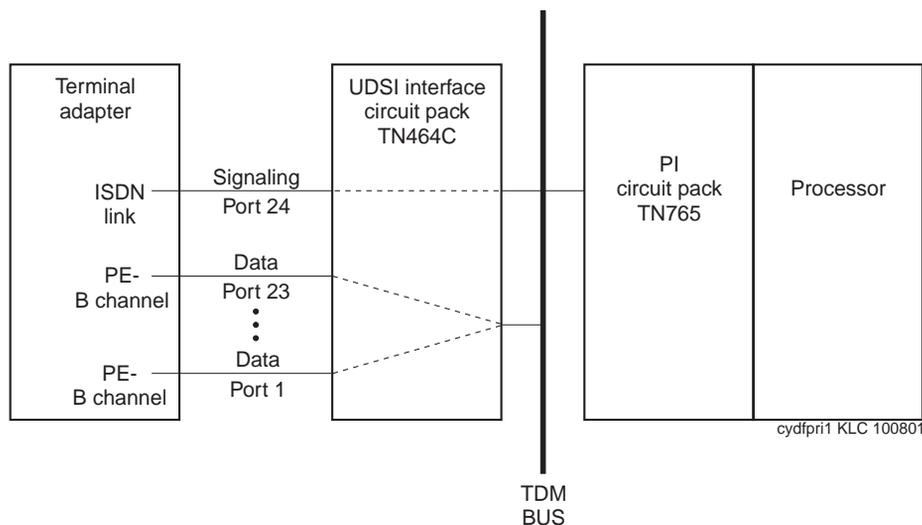
Figure 6-39. PRI Endpoint Port Interactions [INTEL]

A PRI Endpoint Port is a port on a UDS1 interface circuit pack. Therefore, this port depends on the health of the UDS1 interface circuit pack for proper operation (see [Figure 6-39](#)). As noted earlier, a PRI Endpoint Port B-channel also depends on an ISDN-PRI Signaling Link Port D-channel (ISDN-LNK) to carry the signaling traffic. If there is a problem with the ISDN-PRI Signaling Link Port, the PRI Endpoint Port is affected. The ISDN-PRI Signaling Link Port, in turn, depends on the PKT-INT (Packet Interface).

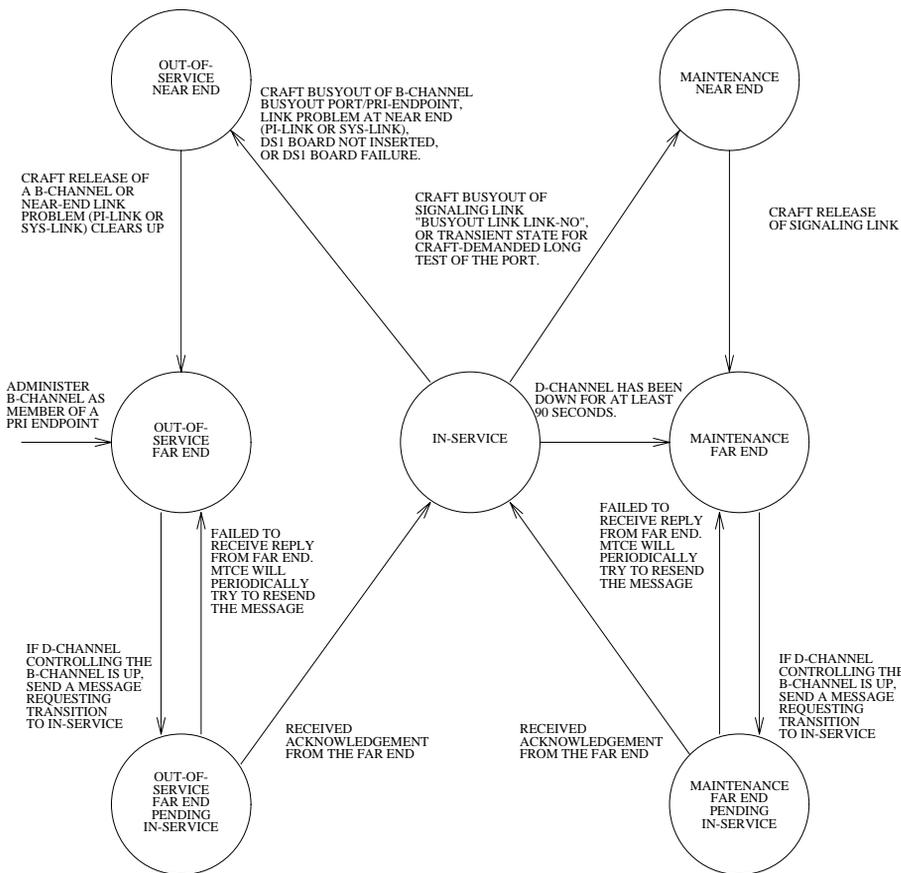
Figure 6-40. Common Progressions in Service States

The following diagram of the PRI Endpoint Port service states shows the common progression from one service state to another and the event that caused the change of state.

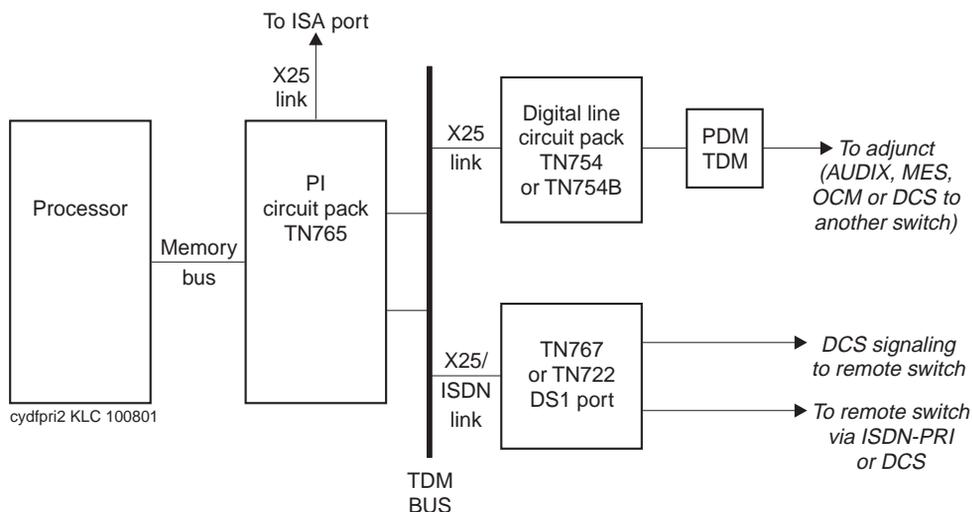
Figure 6-41. Processor Interface Link Interactions

Figure 6-41 shows the Processor Interface Communications Link (PI-LINK) Interactions.

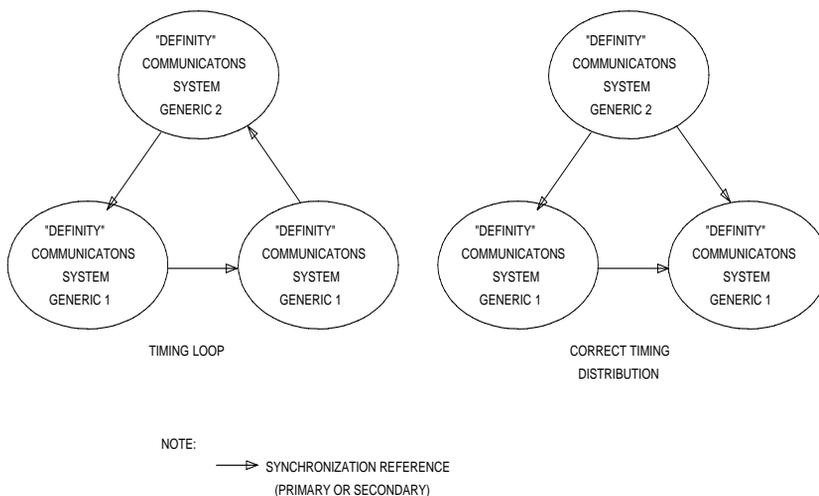
Figure 6-42. Synchronization Timing Loop

The system synchronization planner must avoid creating a *timing loop* when administering the primary and secondary synchronization references in a system. A timing loop exists whenever a system receives timing from another system whose timing reference is directly or indirectly derived from itself. Timing loops can lead to loss of digital data between systems that are exchanging data with any system within the loop. An invalid timing signal is also generated by any system within the loop, thus propagating the invalid timing signal to any system(s) using a system within the loop as a synchronization reference. [Figure 6-42 on page 6-1041](#) shows a timing loop and a correct distribution of timing between the systems.

A correctly designed network has no loops and each piece of equipment in the network is supplied by a clock of equal or lower stratum (that is, the inputs to a Stratum 3 clock should NEVER be from a Stratum 4 device). **It is strongly recommended that the network administrator be consulted before administering any synchronization changes.**

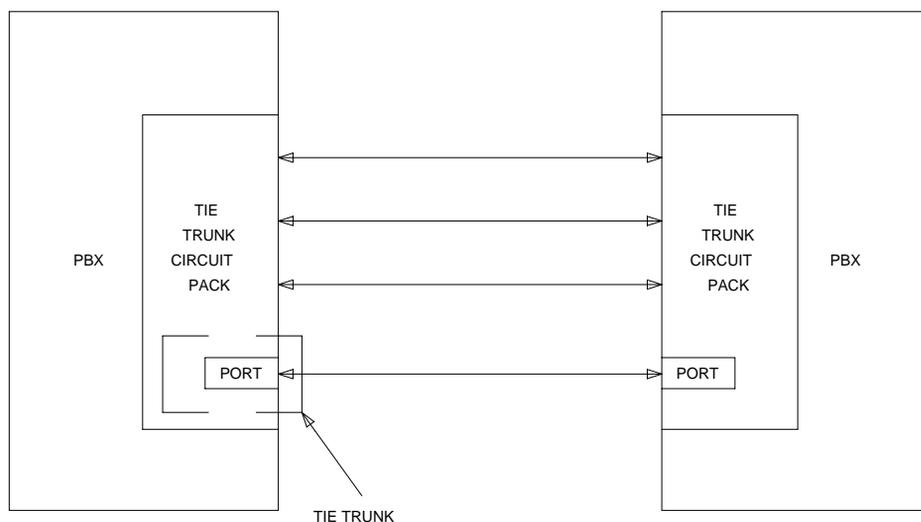
The Tie Trunk circuit pack fits into a port slot and contains four trunk circuits (see [Figure 6-45 on page 6-1133](#)). Each tie trunk for the TN497 circuit packs has 2-wire audio connection/signal leads (A and B).

Figure 6-45. Tie Trunk Interactions

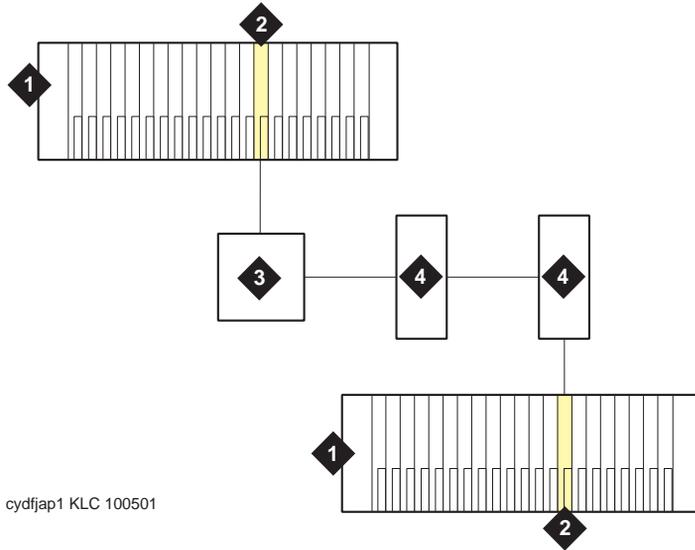
Figure 6-46 shows the hardware connections for public network access in Japan. The upgrade procedure requires removing the JRC (Japan Radio Corporation) external converter.

Figure 6-46. Japanese TTC public network connections

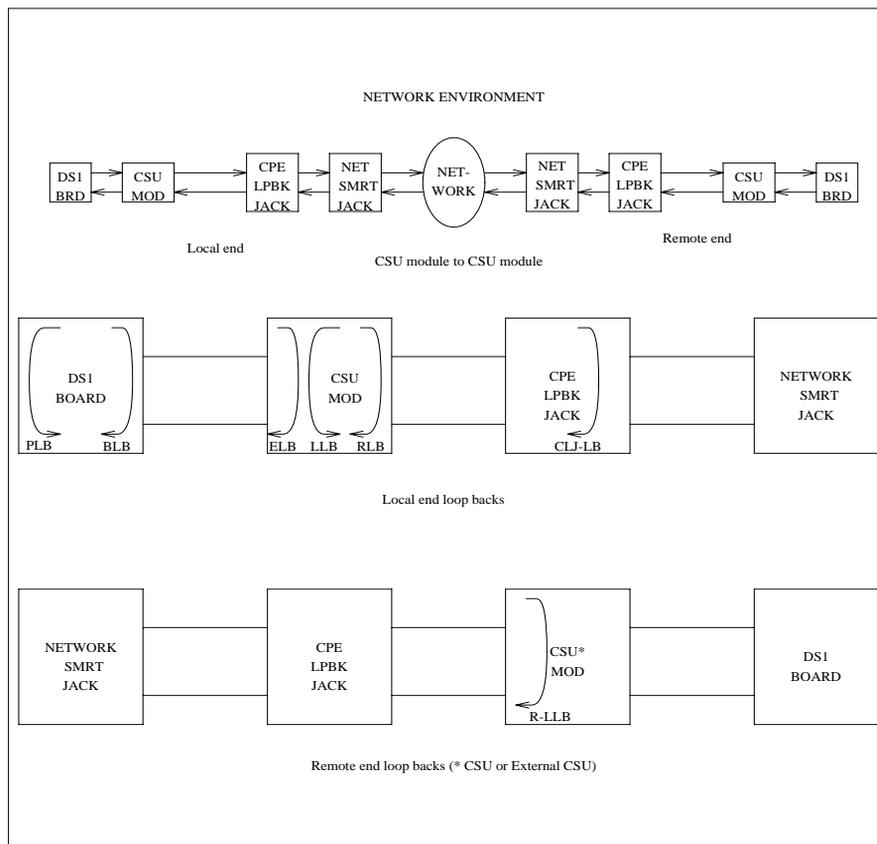
The UDS1-BD and 120A1 CSU Module support on-demand loopback tests that assist in the detection of faults between the UDS1-BD circuit pack and the CSU Module, between the Integrated CSU and the optional Customer Premises Loopback Jack, or between the Integrated CSU and remote CSU. These loopback tests are explained in detail later in this UDS1-BD MO, but [Figure 6-48](#) gives a high level overview of the loopback points.

Figure 6-48. High Level Overview Of Loopback Points

The following list of acronym definitions are for [Figure 6-48](#):

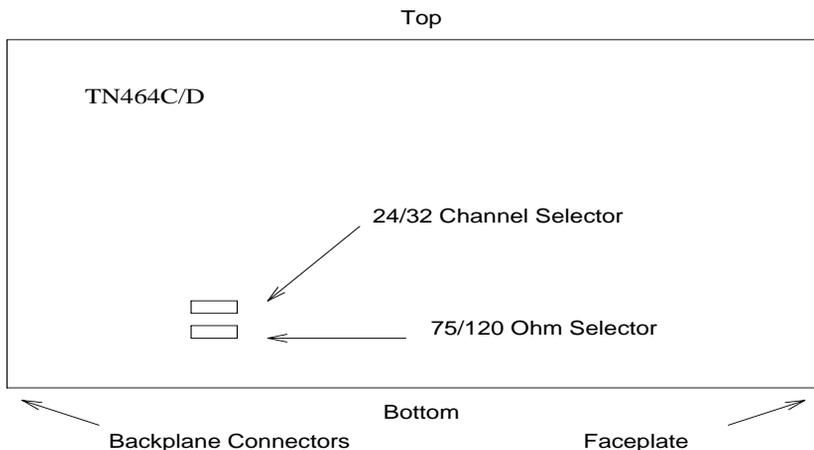
Two option jumpers located on the side of the TN464C/D circuit pack must be installed correctly. The figures on the following page show how to configure the circuit pack for 24-channel or 32-channel DS1, and for 75*W (coaxial) or 120*W trunk connections. The channel selection must match the parameters administered on the corresponding **DS1 Circuit Pack** Form. (US applications use 24 Channels.)

Figure 6-49. TN464C/D DS1 Option Jumpers
