Maintenance

DEFINITY ONE™
Communications System
Release 10

Volumes 1 and 2

555-233-130
Issue 1
December 2001

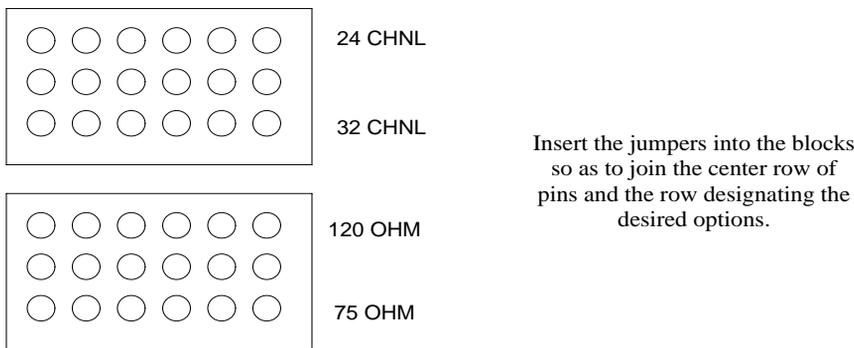
Two option jumpers located on the side of the TN464C/D circuit pack must be installed correctly. The figures on the following page show how to configure the circuit pack for 24-channel or 32-channel DS1, and for 75*W (coaxial) or 120*W trunk connections. The channel selection must match the parameters administered on the corresponding **DS1 Circuit Pack** Form. (US applications use 24 Channels.)

Figure 6-50. TN464C/D DS1 Option Jumpers (Continued)

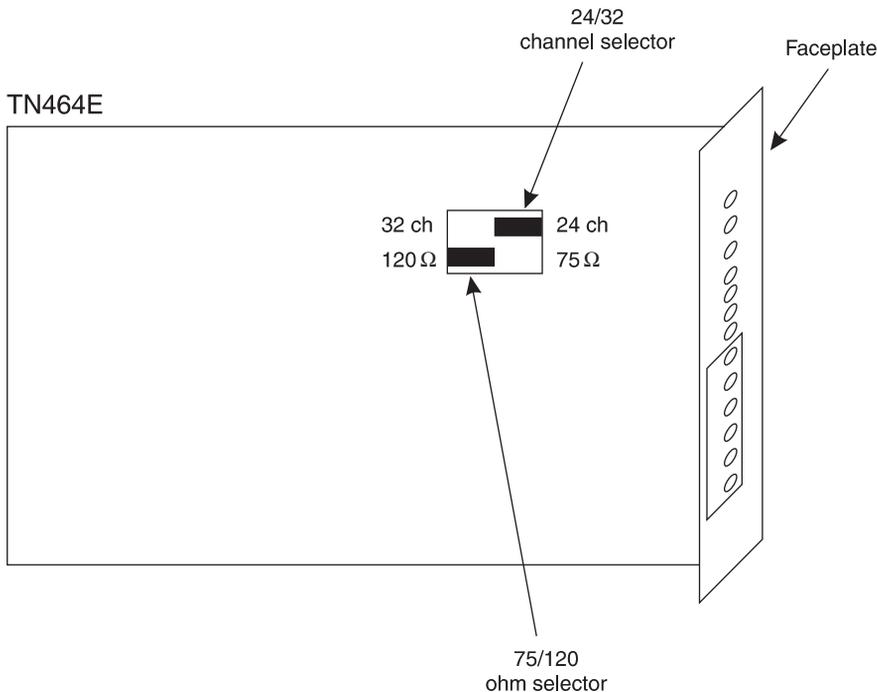
The option switch located on the component side of the TN464E/F circuit pack must be set correctly. [Figure 6-51 on page 6-1211](#) shows how to configure the circuit pack for 24-channel or 32-channel DS1. The channel selection must match the parameters administered on the corresponding **DS1 Circuit Pack Form**. (US applications use 24 Channels.)

Figure 6-51. TN464E/F DS1 Option switches

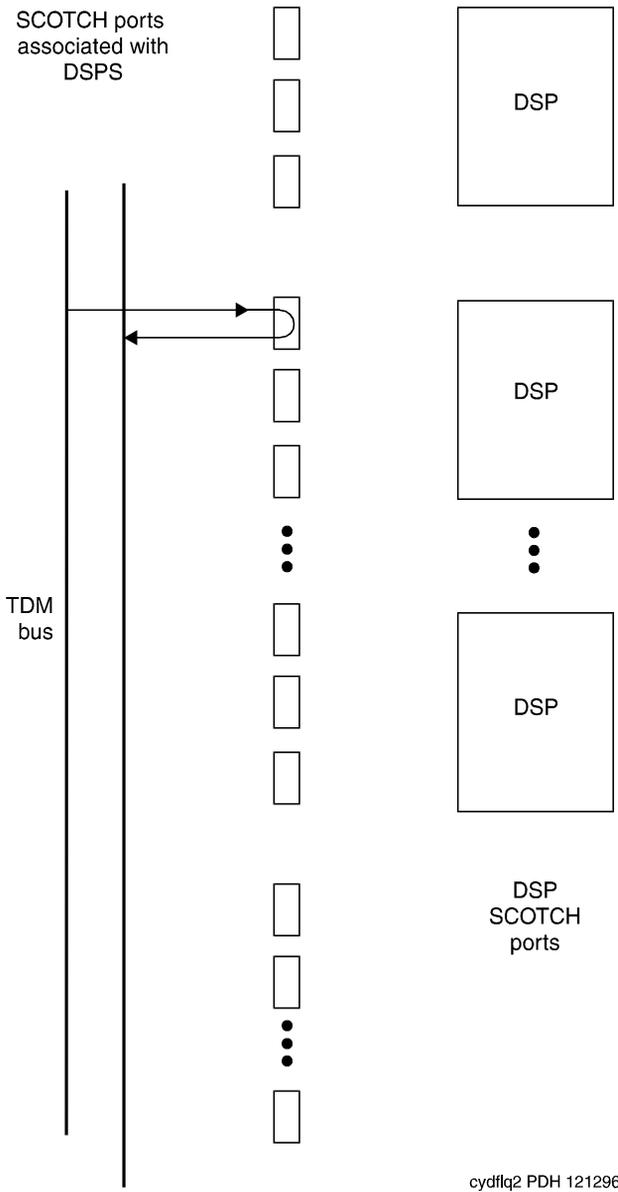
1. A Looparound test across the TDM bus.
2. A conference Circuit Test.

The tests are run in the above order; if one test fails, an error code is returned and the remaining tests in the sequence are not executed.

Figure 6-52. VC Circuit Pack DSP Port Local TDM Loopback Test

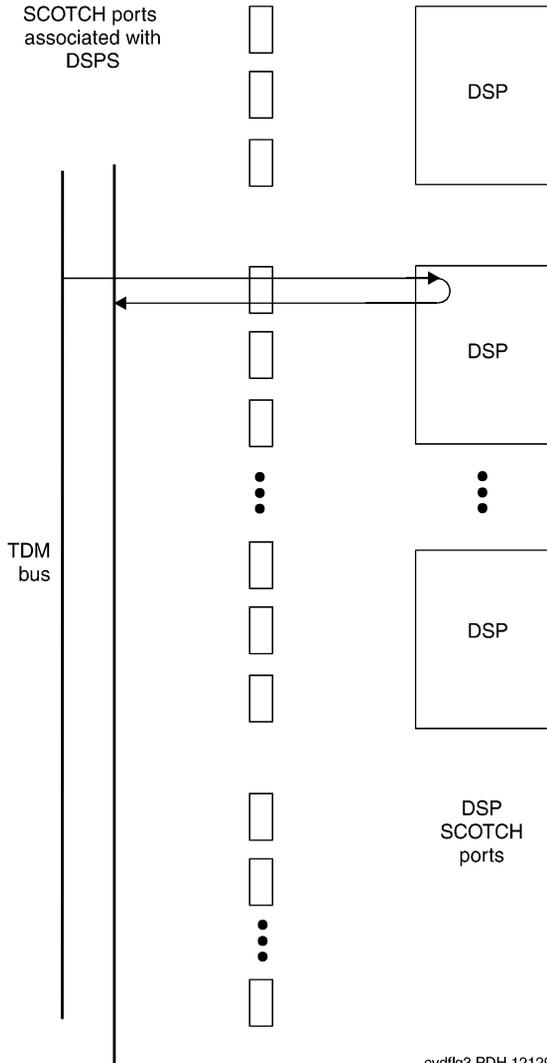
This test verifies the connectivity of a VC-DSPPT across the TDM bus. It aborts if calls associated with the port are in progress. Failure of this test indicates an on-board fault associated with the port hardware on the circuit pack.

Figure 6-53. VC Circuit pack DSP Port DSP Looparound Test

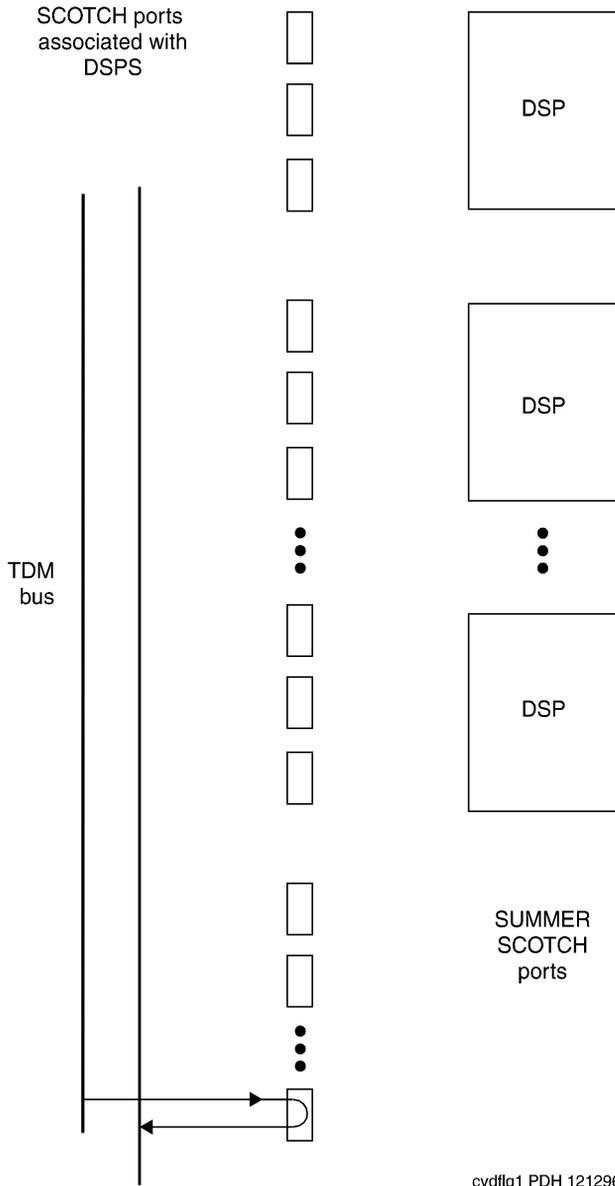
- A Looparound test across the TDM bus.
- A conference circuit test.

The tests are run in the above order. If the first test fails, the switch returns an error code, and the second test is not executed.

Figure 6-54. VC Circuit Pack Summer Port Loopback Test
