Integration Validation and Troubleshooting

Overview

This chapter contains procedures for validating the switch integration and guidelines for troubleshooting problems with the integration.

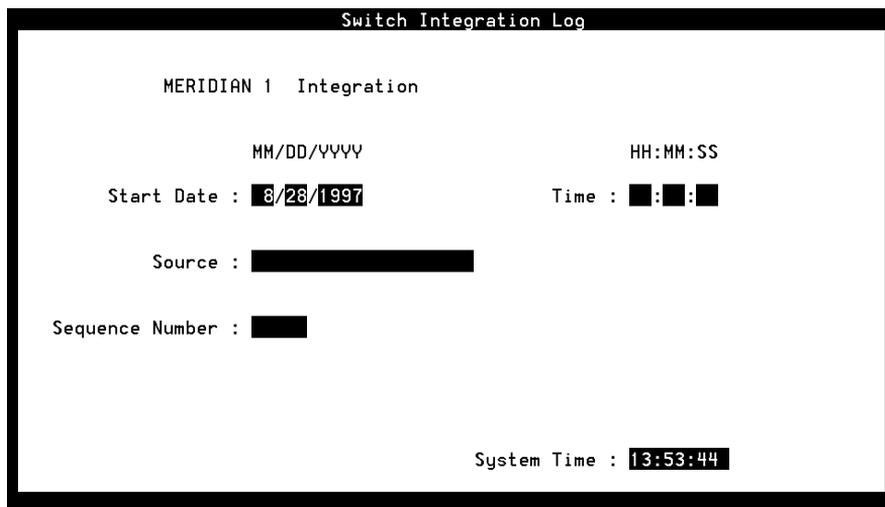
Figure 5-1. Switch Integration Log Window

The system displays the Switch Integration Log window ([Figure 5-1](#)) with the current date and time displayed.
